**TASMANIA DEPARTMENT OF MINES
UNPUBLISHED REPORT 1979/56**

Test pits on a property near Deviot

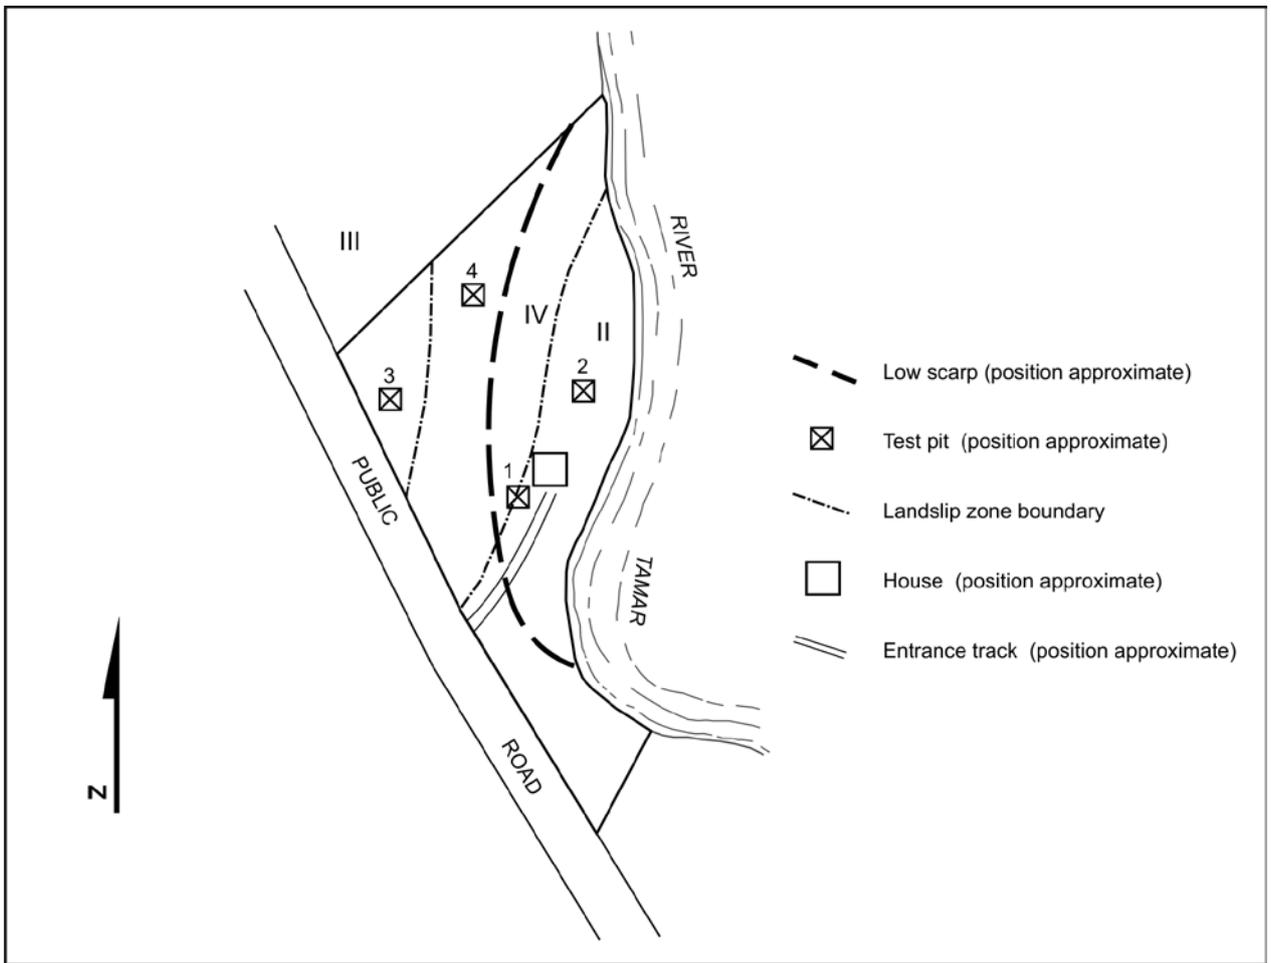
Figure 1

Four test pits were dug on the property (fig. 1). In view of the material encountered in these pits, together with the recent exposures in nearby road cuttings, some alteration can be made to the landslip zoning of the area, which is currently wholly in Class V on the landslip zone map.

Weathered basalt underlies the flat area at shallow depth around test pits 1 and 2 and in road cuttings near the entrance track to the house. There is only a small drop from the flat area to high tide mark and there is little danger of this area slipping and it can be reclassified as Class II with reasonable safety. This flat extends north along the foreshore and north of the house, where near-surface basalt has not been located. The Class II boundary has been marked 10 m from the base of the small scarp. In the north-west corner of the land, the slope uphill from the scarp is low (about 5°) and a small area has been reclassified as Class III. In test pit 3 a hard layer of boulders was encountered and the clay in both of holes 3 and 4 was stiff. This zone extends no closer than 15 m from the top of the scarp. The method of formation of the scarp has not been determined and it may be an ancient slip or the boundary of an erosional surface. At most points it is quite steep (although only about 3 m high) and the area around it should not be developed with the information available at present. It has been placed in Class IV on the zone map.

It should be reasonably safe to develop the area in Class II. If the area in Class III is developed the special building regulations for Landslip B land should be used. The excavation of deep cuttings or excessive clearing, particularly around the scarp, should be avoided as these could change the stability of the area. Good surface drainage should be maintained on the land and if the Class III area is built on, the safest place for discharge of sullage and stormwater, from a stability viewpoint, would be the flat area between the scarp and the river.
