1980/6. Savage River Mines open-cut: notes for the guidance of Inspectors of Mines.

Abstract

A geological investigation of the Savage River Mines open-cut was made on 10-12 December 1979 with the object of providing guidance for the Department's Inspectors of Mines.

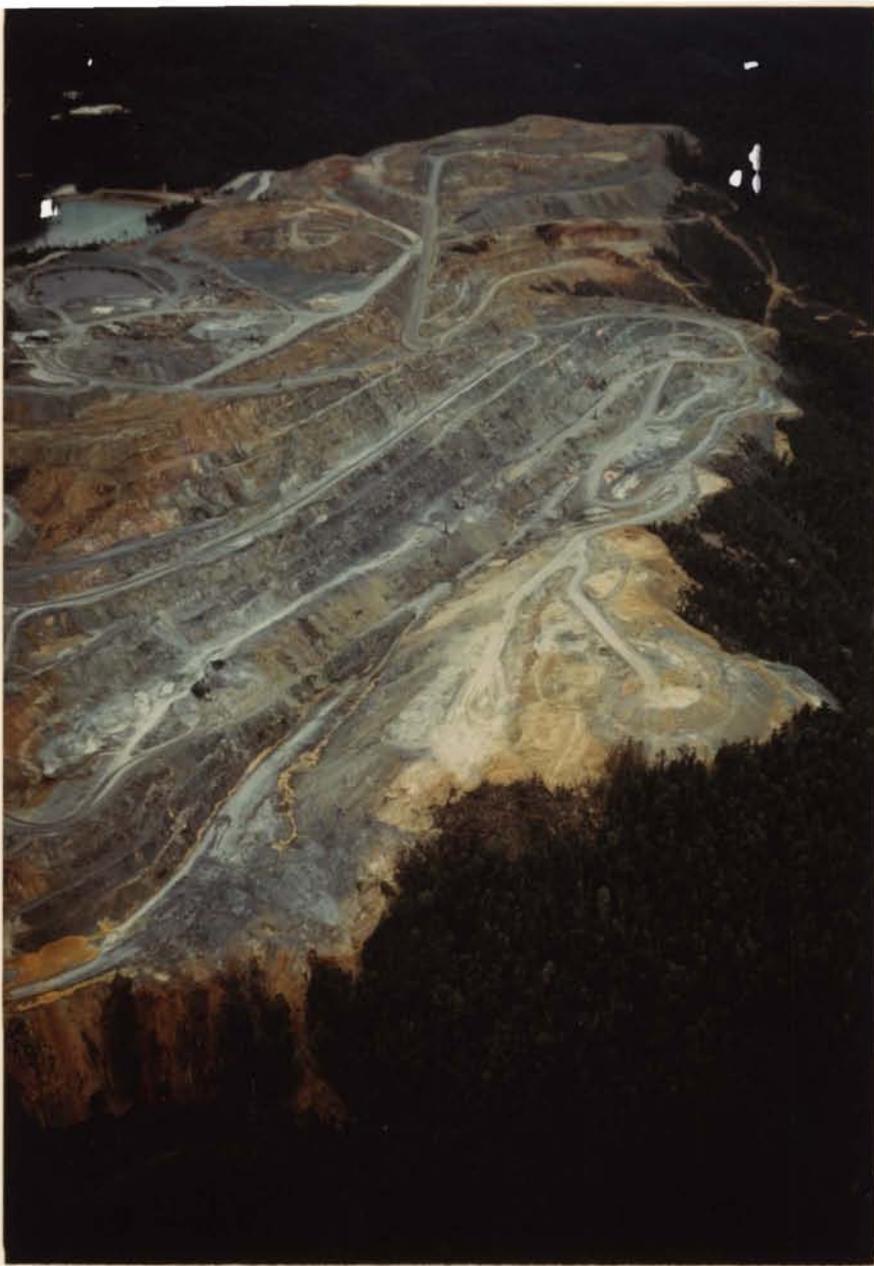
Both the east and west walls are deeply weathered in the upper benches, and two very deep zones of Tertiary weathering occur at the northern and southern ends of the pit (fig. 1, plate 1). The weathering at the southern end of the pit is associated with basalt which caps the ridge. The basalt appears completely decomposed for its entire thickness and the underlying metamorphic rocks are weathered to a considerable depth. The weathering at the northern end appears to be associated with a Tertiary valley and continues down to the existing floor level of the pit, and could continue to its proposed depth (plate 3).

Plate 1. Aerial view of Savage River open-cut
(for explanation see Figure 1).

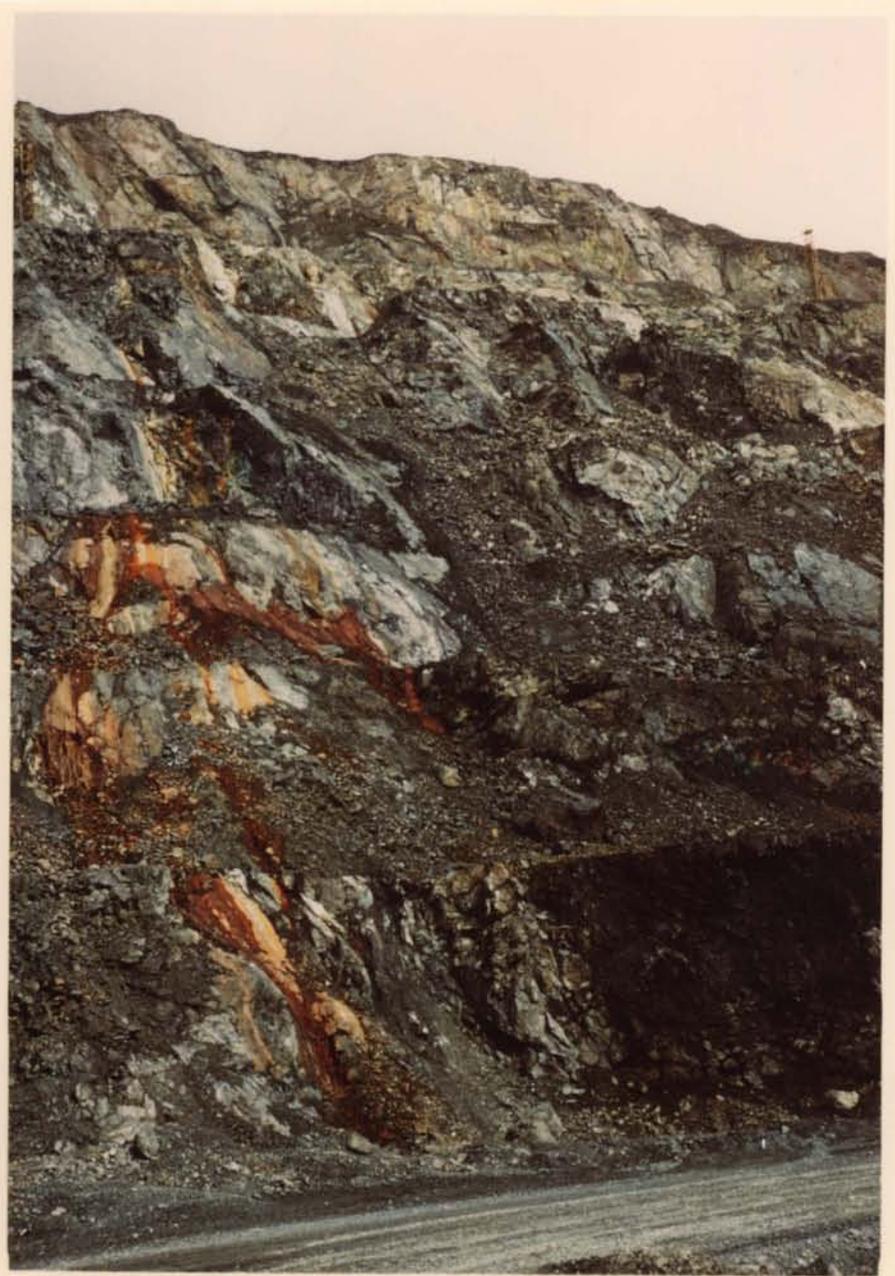
A set of ESE-WNW faults appear on the east wall of the pit. These faults are frequently associated with wide crush zones and intensive jointing (plate 2). The fault crush and gouge is frequently completely mylonitized to a soft clay and is invariably moist (plate 4). Numerous landslides and rock falls have been associated with these faults in the past (plate 5).

Plate 2. Central part of east wall. Zone of
WNW-ESE faults, and failures.

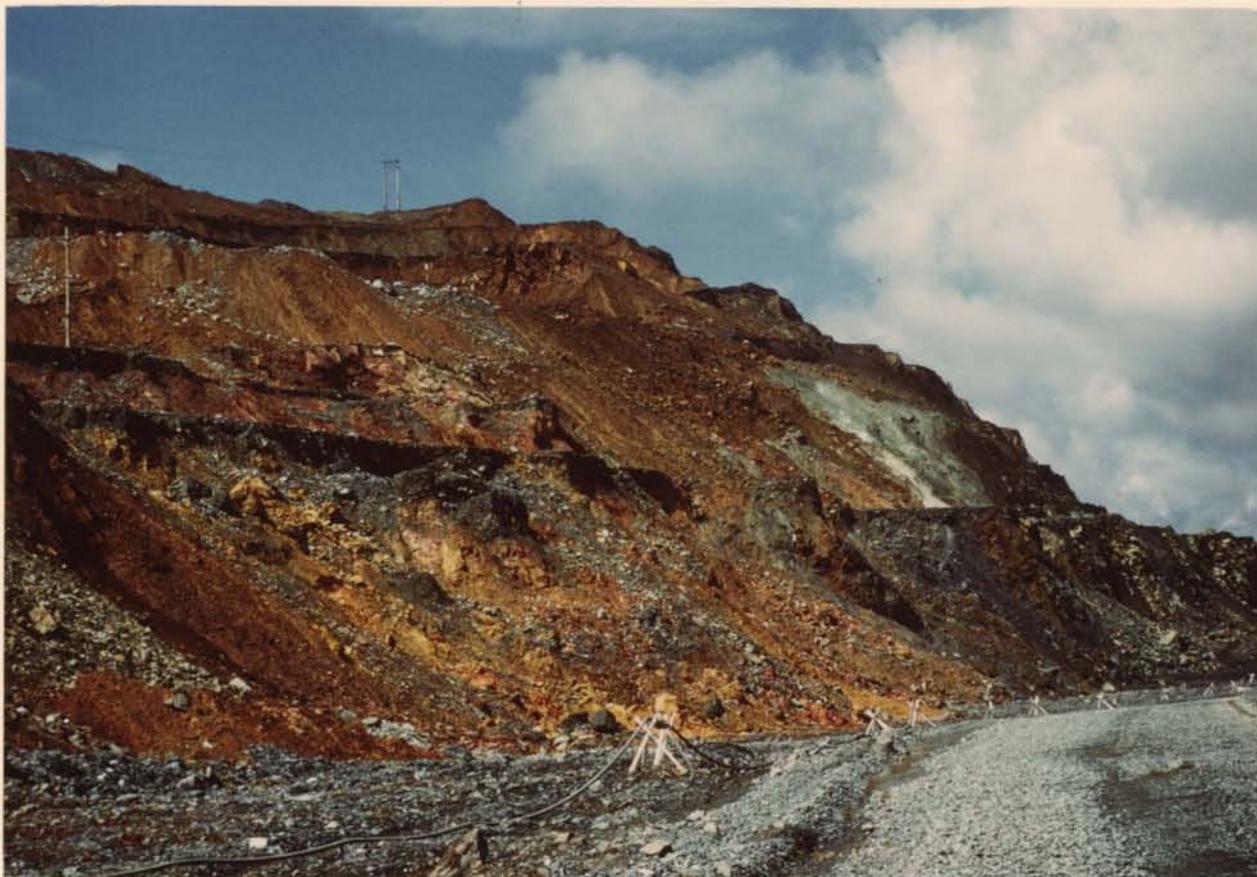
Plate 3. *North end of east wall. Zone of Tertiary weathering and landslides.*

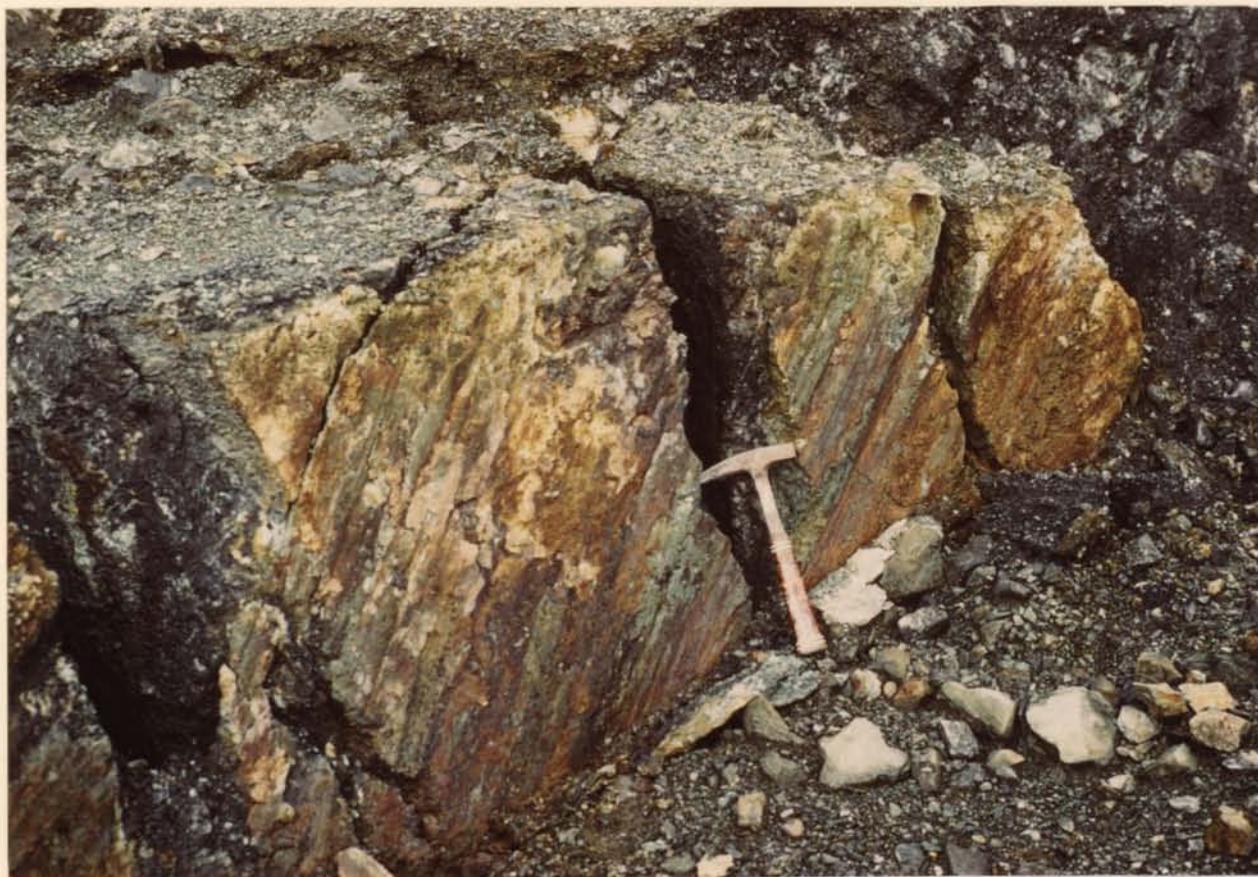
Plate 4. *Central part of east wall. Mylonised rock - a soft clay with slickensides on face.*

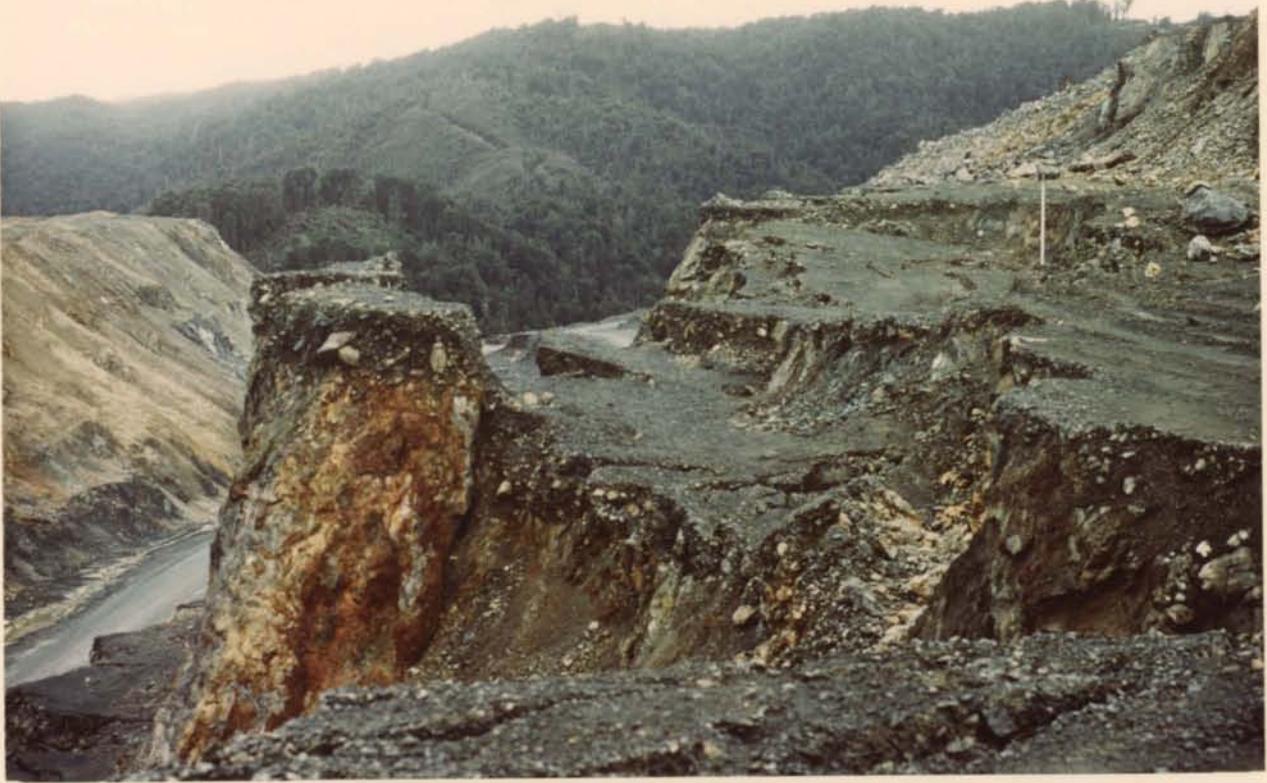
Plate 5. *Central part of east wall. Rotational wedge failure, Bench 9.*

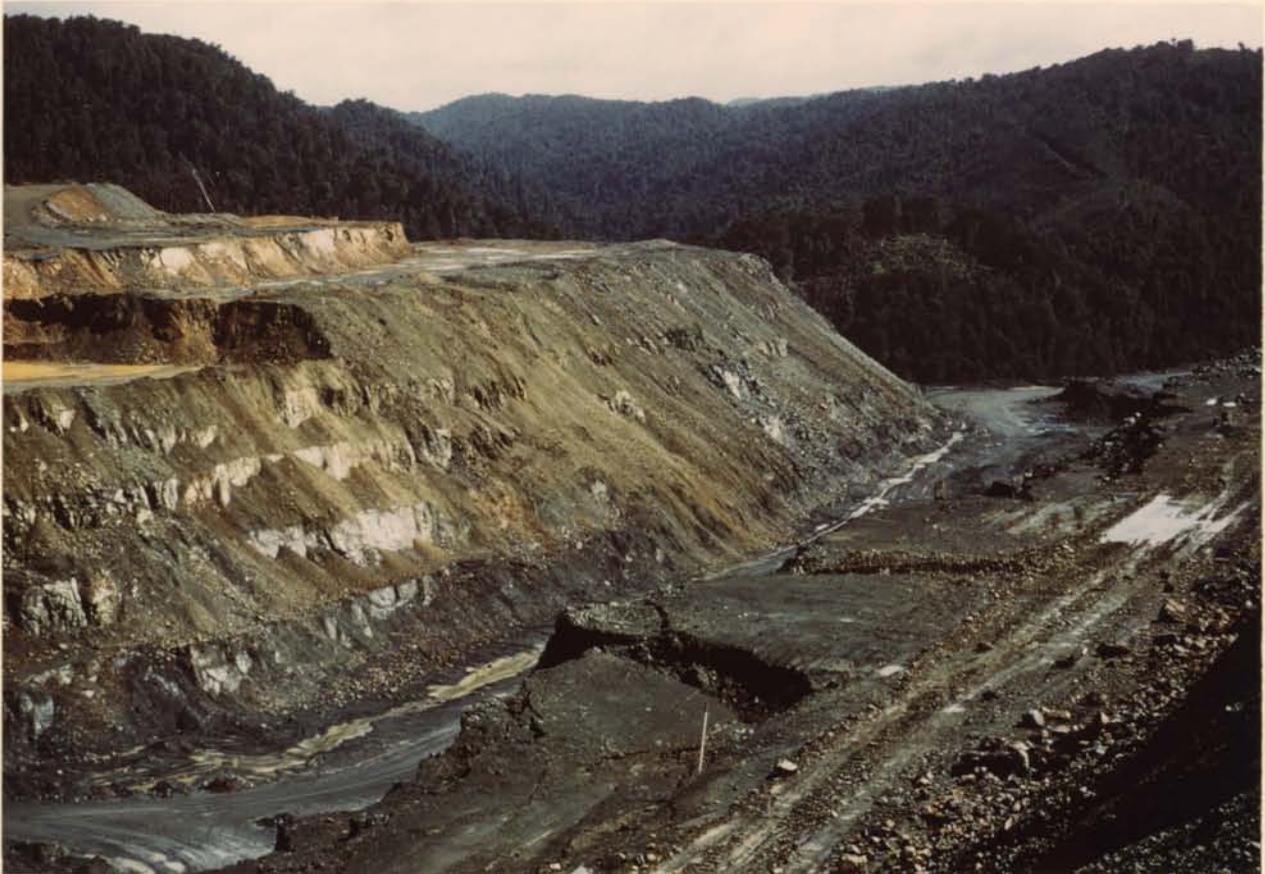
The intersection of steeper joints or an intersection of a joint with a fault or a plane of schistosity has resulted in numerous very large wedge failures in which several benches have fallen (plates 6, 7). Large planar failures appear to be more associated with weakness along the schistosity between competent and incompetent layers. Toppling failures along the schistosity and low angle planes dipping into the pit are widespread along the west wall and appear to have occurred at most levels at the northern end of the west wall (plates 8, 9).

Plate 6. *Central part of east wall, looking across to west wall. Bench failure on east wall. Side casting on west wall.*

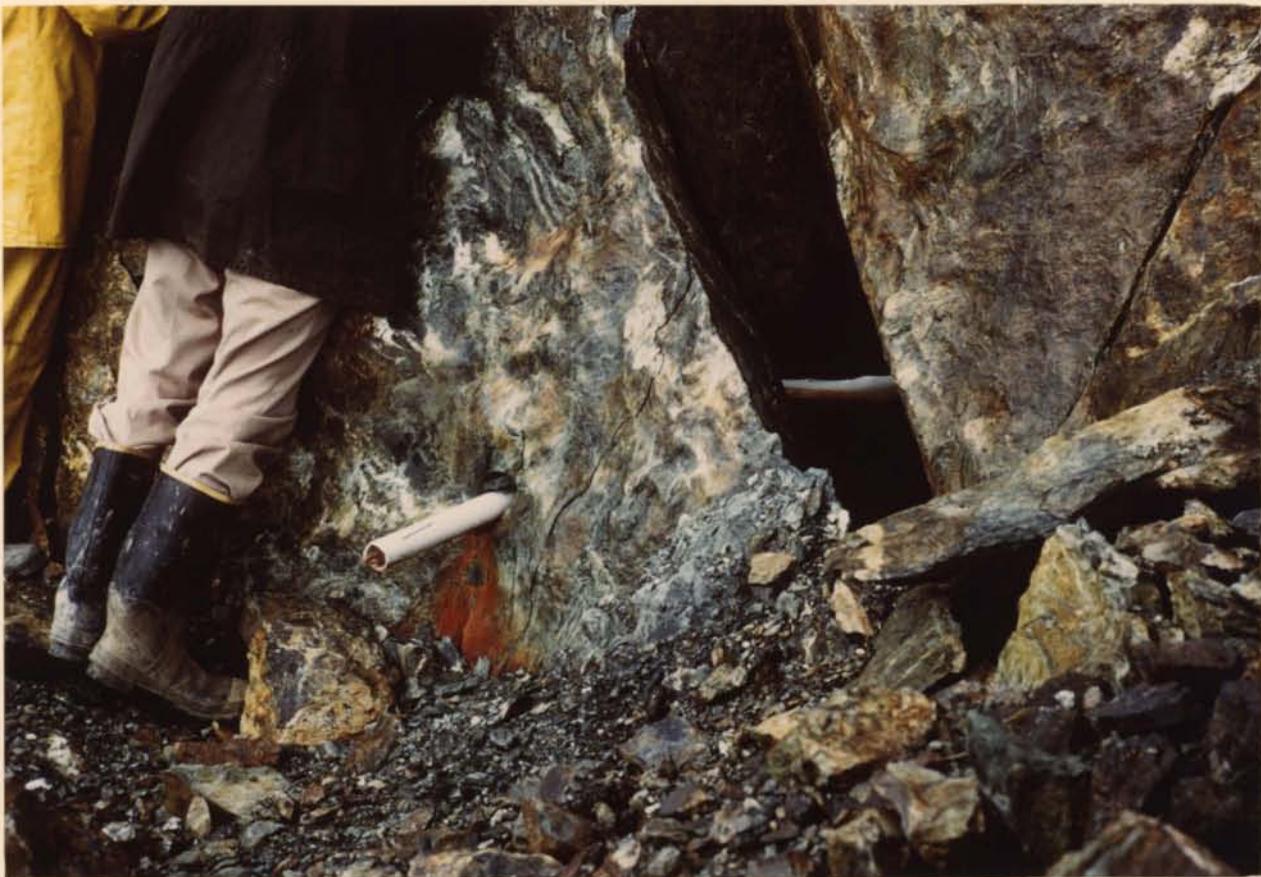
Plate 7. Central part of east wall. Movement caused by rotational wedge failure.

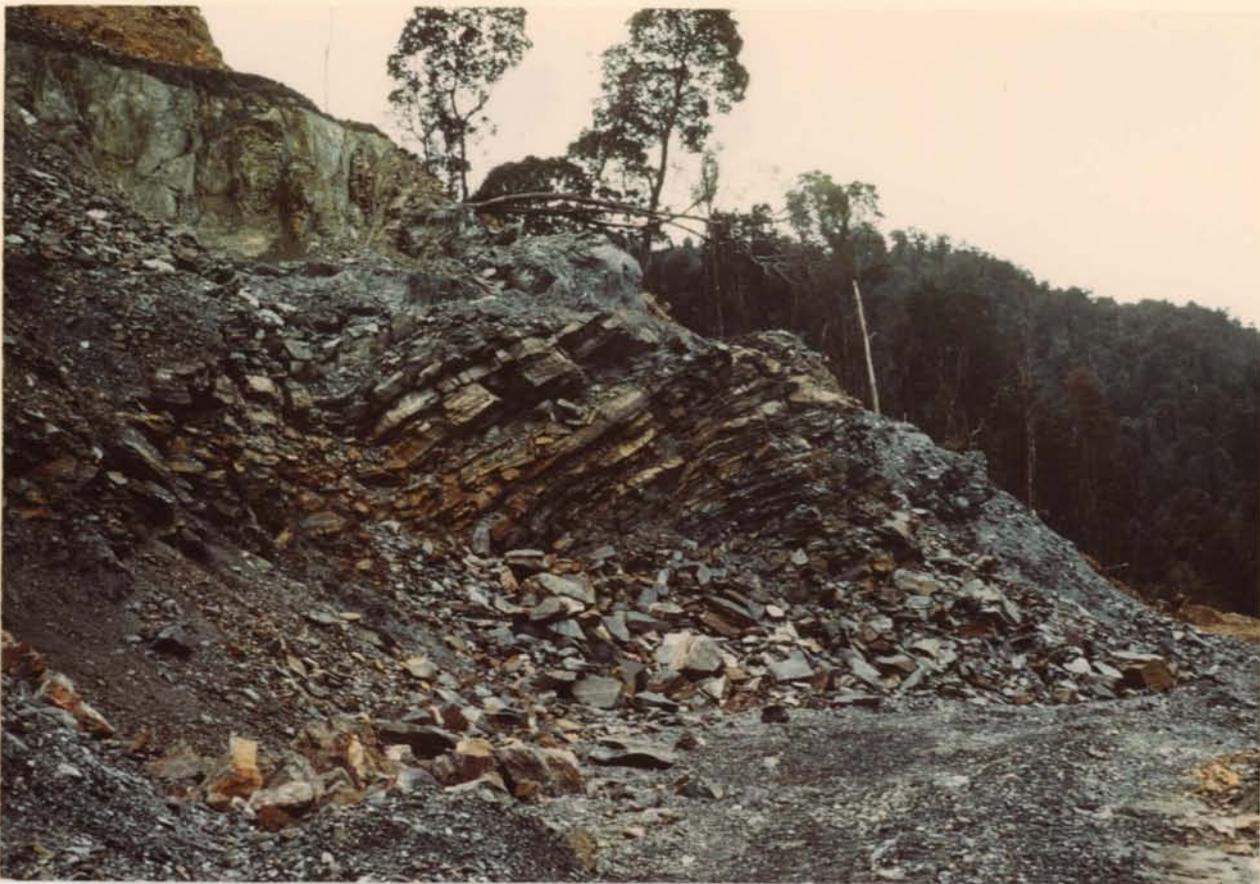
The northern section of the west wall is dominated by toppling failures, the cause of which appear to be overblasting, as the result of the choke blasting technique. Some method of pre-splitting appears to be required to protect these benches. The southern section is poorly exposed and it is impossible to determine its slope stability because of the debris which covers the benches. At present the benches become obliterated very quickly.

Plate 8. Northern end of west wall. Progressive toppling failure. Original attitude and schistosity are seen below upper tree.

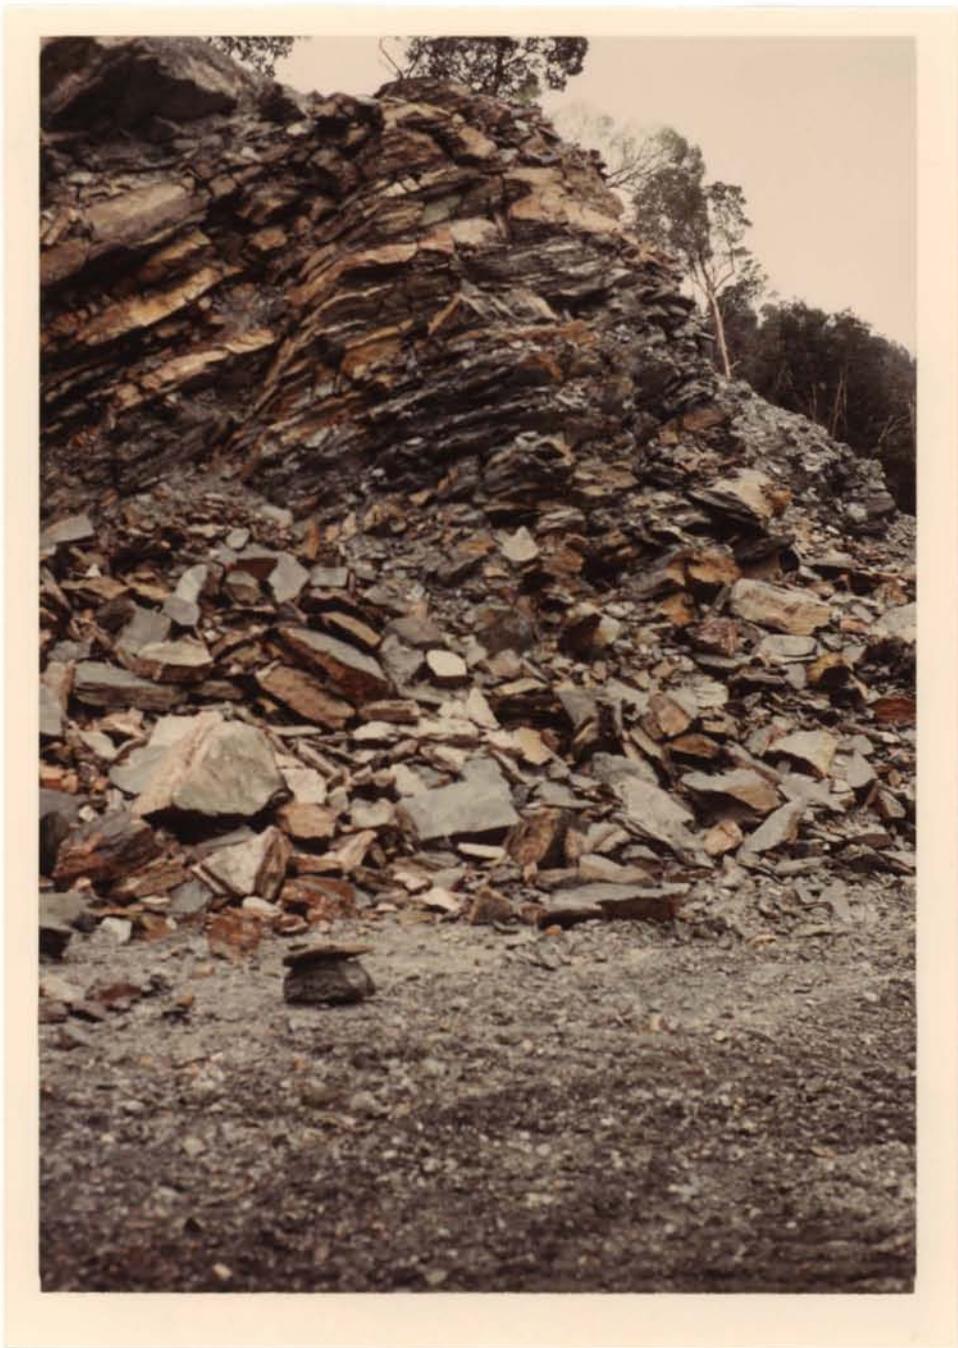
Plate 9. Northern end of west wall. Failure probably due to overblasting by choke blasting technique.

The blasting technique used appears to the writers to be the problem. No differentiation between bench or berm wall cutting and production blasting is made in the pit. The use of angle drill holes and pre-splitting techniques to make berm walls safe should be a high priority for future safety. The amount of overbreak and damage to existing benches by production blasting is, to say the least, alarming. Evidence for overblasting is present on most benches.

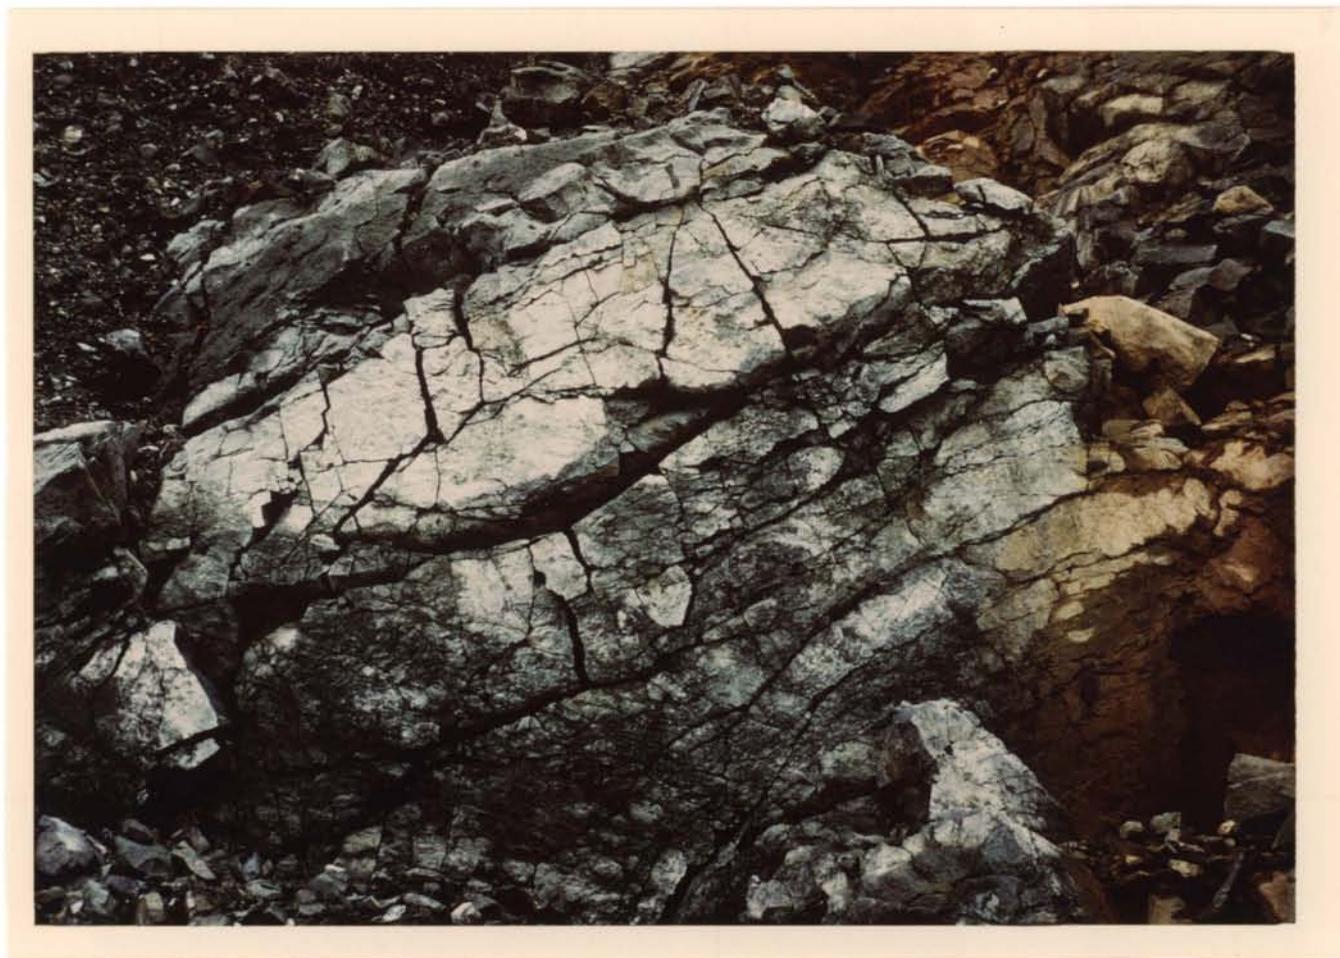
This brief summary of the geology indicates that the Savage River open-cut is in an area of complex geology comprising rocks with a wide range of strengths (from massive competent dolerite to very incompetent clays) in an area of high and intensive rain. Under these conditions any design for deepening the pit to the depths proposed by the company (see later) that does not take into account the variability of the geology and sensitivity of the rocks is one of great danger (plate 10).

Plate 10. *Central part of west wall. Damage to a competent rock caused by overblasting.*
