1980/18. The stability of a building allotment at Kayena, West Tamar.

D.J. Sloane

LOCATION KAYENA ROAD

TAMAR VALLEY LANDSLIP ZONE MAP CLASSIFICATION : ZONE IV AND ZONE I

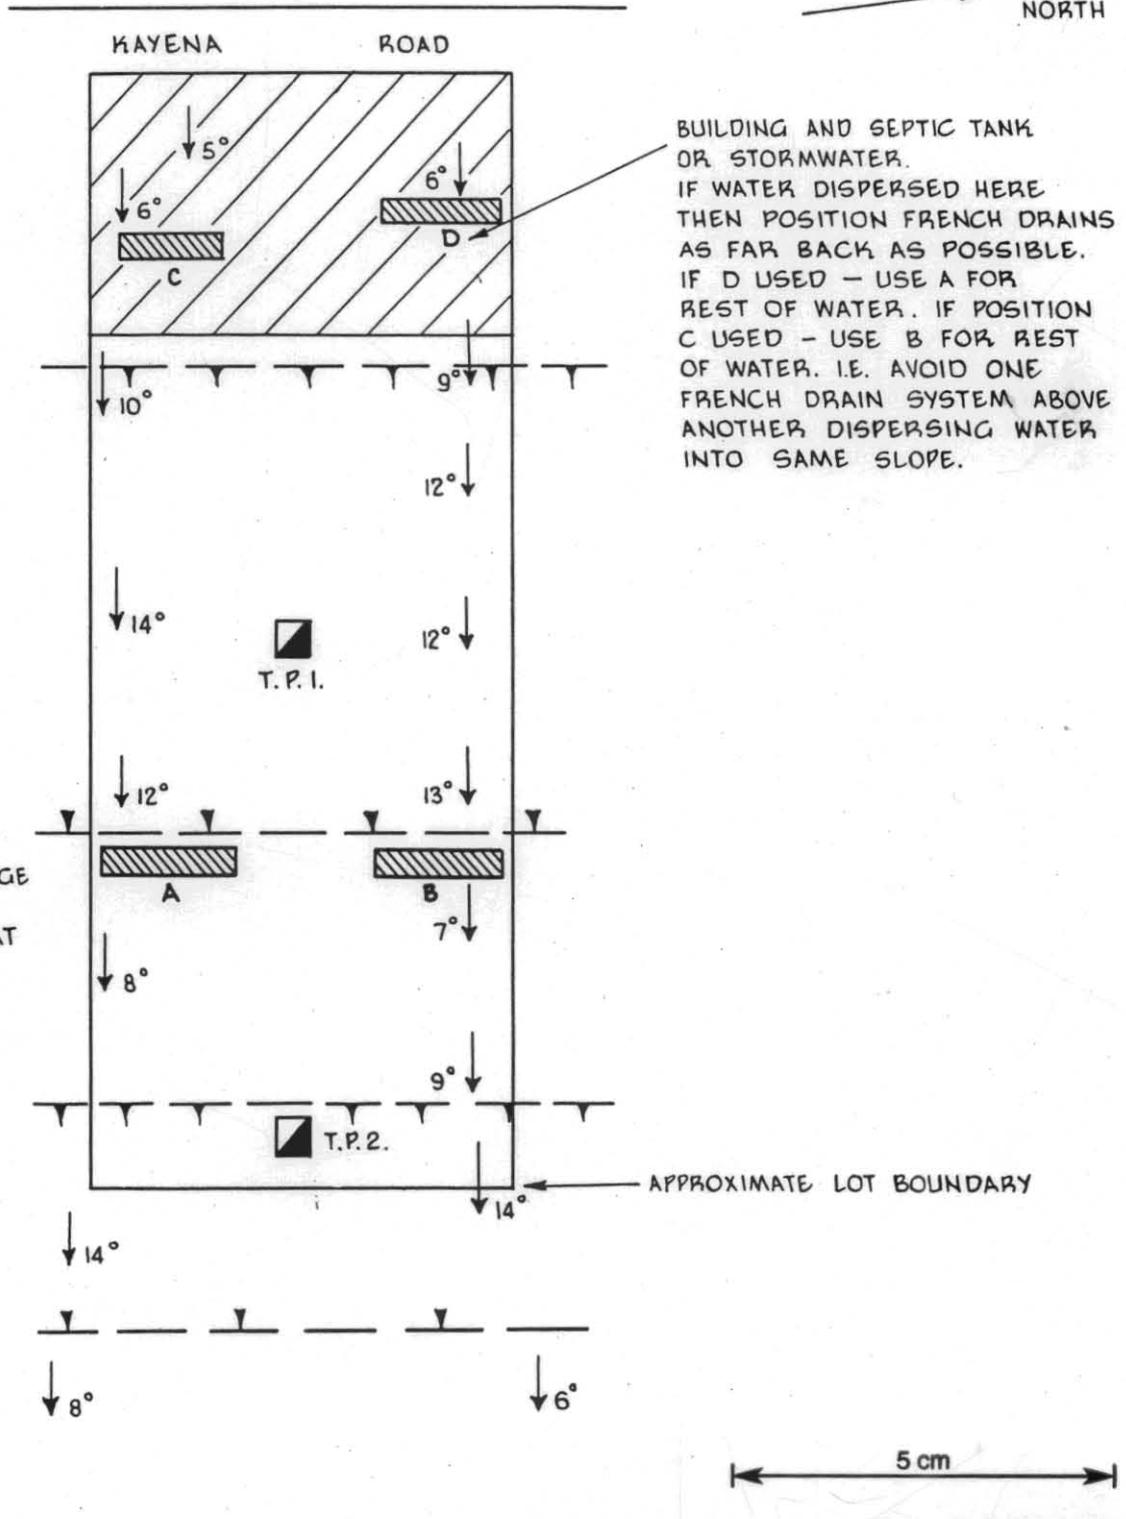
C AND D EXAMPLE POSITIONS ONLY. PLACE AS CLOSE TO KAYENA ROAD AS POSSIBLE.

BUILDING AND SEPTIC TANK OR STORMWATER. IF WATER DISPERSED HERE THEN POSITION FRENCH DRAINS AS FAR BACK AS POSSIBLE. IF D USED - USE A FOR REST OF WATER. IF POSITION C USED - USE B FOR REST OF WATER. I.E. AVOID ONE FRENCH DRAIN SYSTEM ABOVE ANOTHER DISPERSING WATER INTO SAME SLOPE.

A AND B ARE POSITIONS OF DRAINAGE IF C AND D NOT ALLOWED. LOCATED AT REAR OF SMALL 8° SLOPE SEGMENT.

It is recommended that building be restricted to the area within 25m of the Kayena Road boundary. It is also recommended, depending on the opinion of the Health Inspector, that either stormwater or sullage and septic tank effluent be disposed of within this area. The remainder of the waste water should be piped down the slope and discharged in a

suitable french drain system at the rear of the small bench, as indicated on Figure 1. This water will then have a distance of 15m to 20m to disperse and is unlikely to saturate the lower 14° slope. If the Department of Health does not allow dispersal on the area adjacent to Kayena Road, it would be permissible to drain both waste water and stormwater down onto the lower bench, provided they are again split up with stormwater draining to the north and sullage and septic tank effluent draining to the south. These areas are indicated on Figure 1. In view of the measured clay properties, especially linear shrinkage values, it is advised that foundations be designed to accommodate these soil movement problems. Flexible pipes should be used for piping waste water down the slope between the upper and lower bench.
