1980/22. The stability of a building allotment at Orana Place, Riverside

D.J. Sloane

Abstract

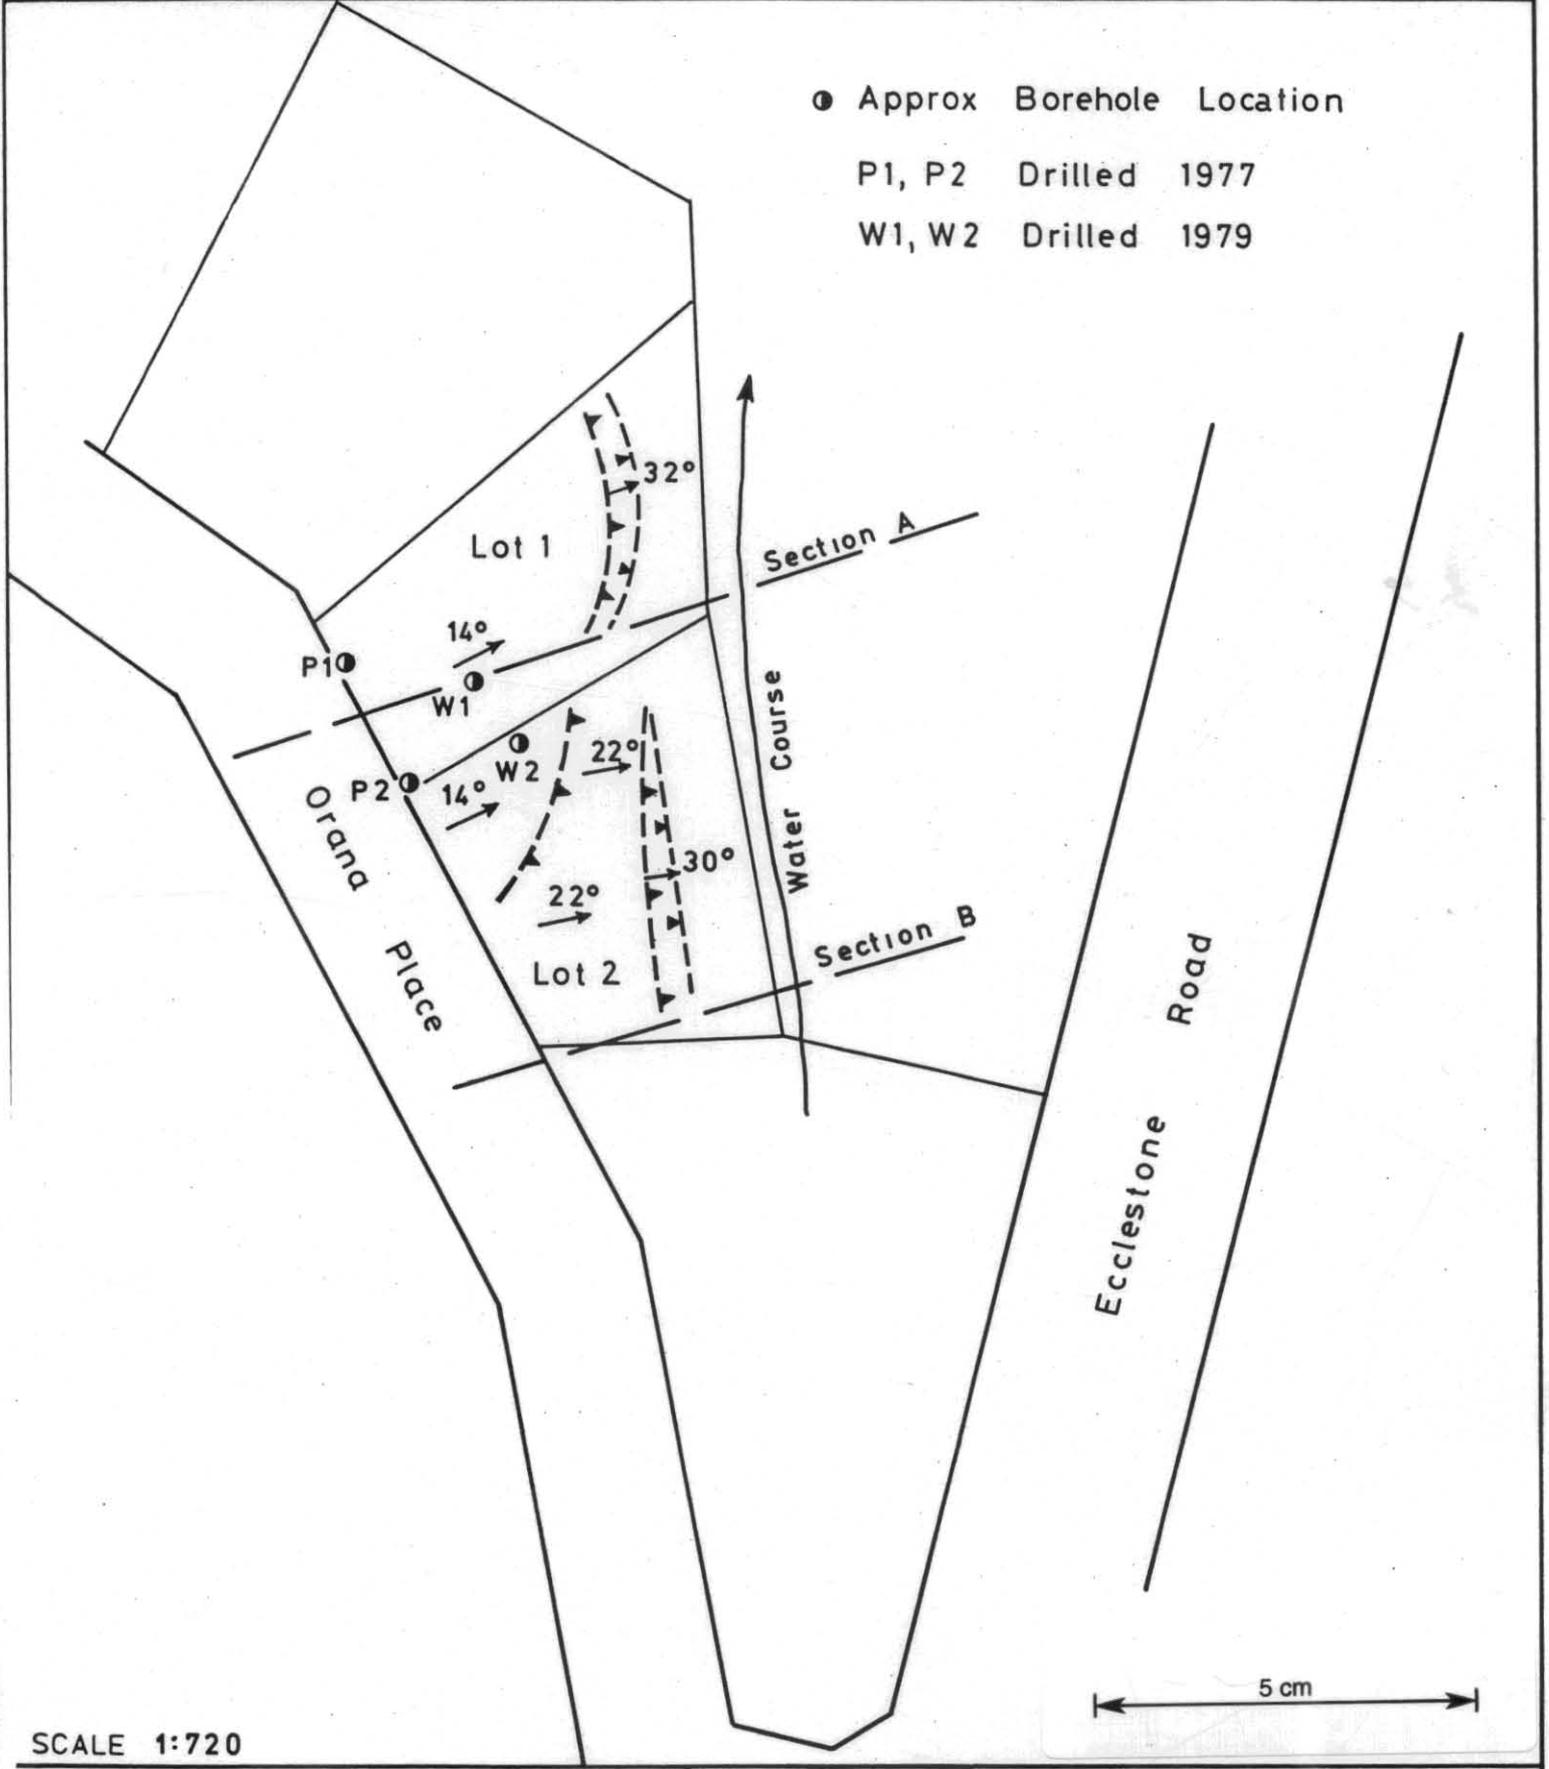
Figure 1.

The morphology of the allotment is indicated on the sketch map (fig. 1). The area is steeply sloping with regional slopes between 14° and 25° (fig. 2). Locally slopes up to 32° are present, adjacent to the small watercourse at the base of the slope. Steep (32°) fill slopes are present on the upper side of the allotment adjacent to Orana Place. To the east of the hill-slope is an old terrace level associated with the River Tamar and to the west is an undulating plateau region. The regional slope has been formed along a major NNW - SSE trending fault scarp, with the harder intrusive rocks underlying the plateau region and the softer sediments underlying the old terrace area to the east.

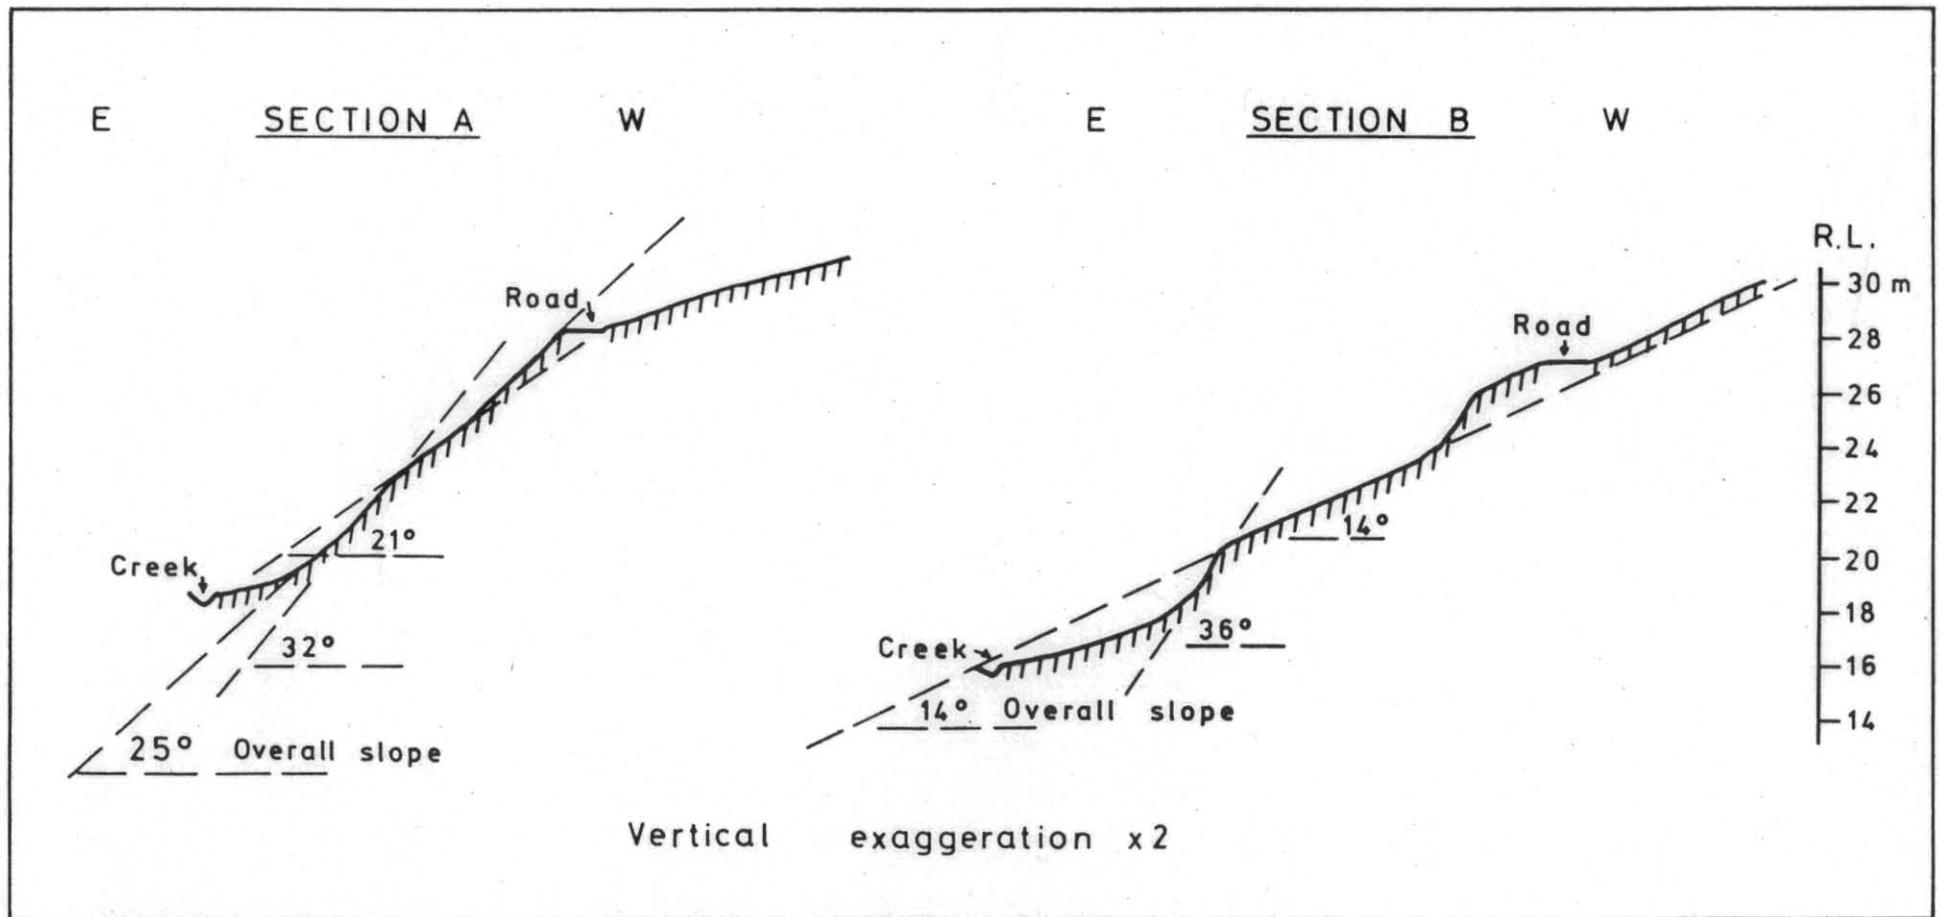
Figure 2. Sections across proposed subdivision, Orana Place, Riverside

From the geometry of the slope, failure is likely to occur within two to three metres of the ground surface. For slab failure analysis the slope is considered to be an infinite 14° slope composed of homogeneous materials. A residual value of ϕ' of 11° and C' of 13.6 kPa has been considered for the purpose of the stability calculations. Long term stability conditions necessitate the consideration that cohesion is zero, which produces a safety factor of 0.35 for totally saturated conditions and 0.78 for completely dry conditions. If a two metre thick slab is considered, approximately 13% of

If full cohesion is considered for the short-term, then drainage for a three metre thick slab must be provided to a depth of about 1.5 m to produce a short-term factor of safety of 1.6. The allotment is therefore considered unstable in the long-term and marginally unstable in the short term.

The area considered in the analysis is shown in Figure 2 (section A B), using what are considered to be the better slope conditions to be found on the proposed subdivision. ϕ_r and C_r , as measured in the laboratory from slow shear box testing, have been used in the calculations. Recent evidence suggests that these values may not be as conservative as may appear and actual residual values may be much lower.

In summary, the allotment is considered unstable in the long term. In the short term, and using the C_r and ϕ_r values obtained in the laboratory, the slope must be drained to a depth of at least 1.5 m to produce a safety factor of 1.6 against first time failure. Drainage to a greater depth would be required to increase this value above 1.6.
