**TASMANIA DEPARTMENT OF MINES
UNPUBLISHED REPORT 1980/5x**

**Inspection of a proposed house site
at Orana Place, North Riverside**

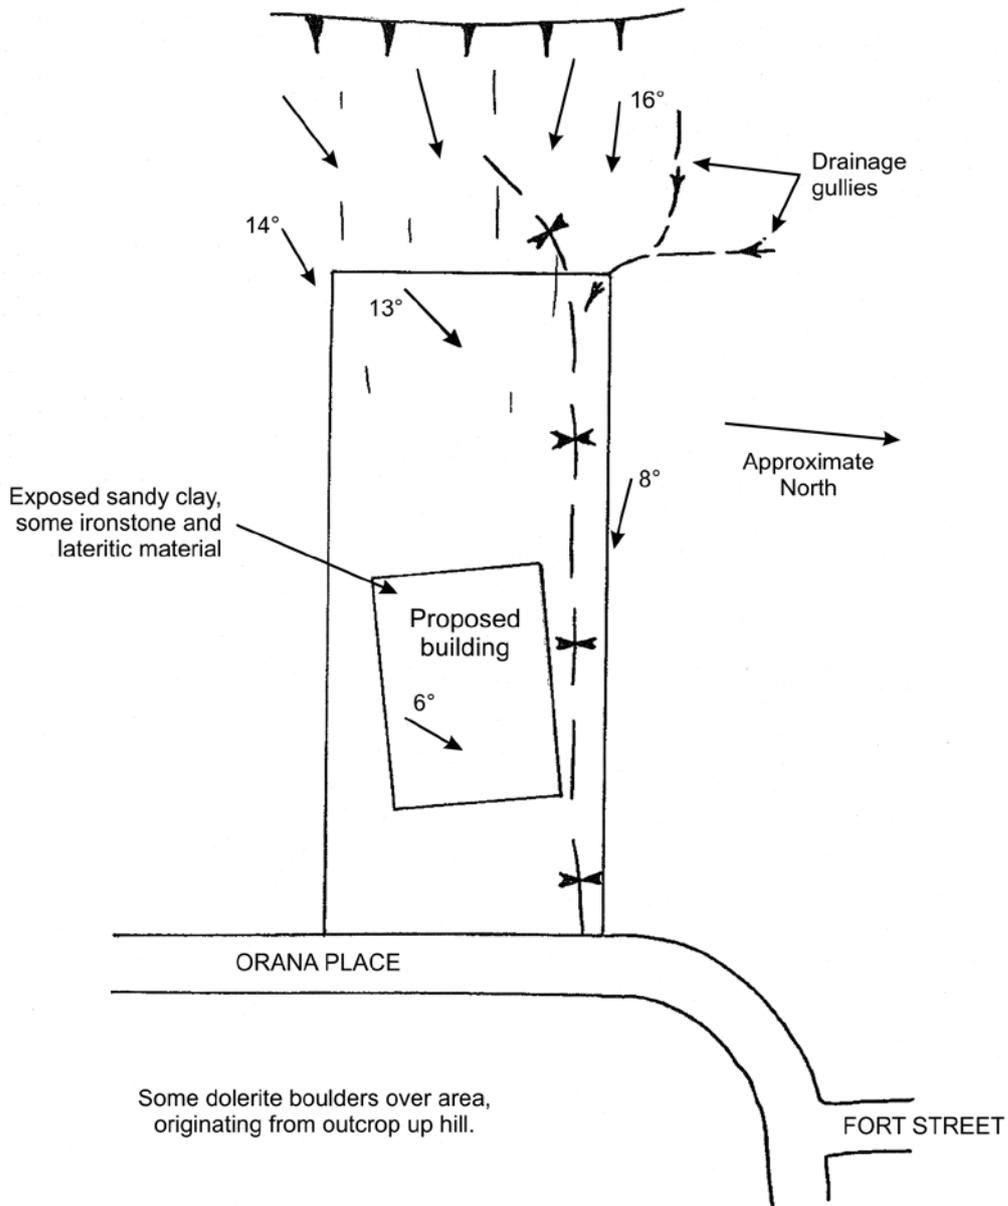
Figure 1

The slope angle and morphology of the allotment is shown on Figure 1. The area is underlain by Tertiary clay and sandy clay and is also located in a small drainage gully. It is therefore advisable that a further cut-off French drain and surface drain be constructed at the rear of the block to intercept both surface and seepage water, thus preventing saturation of the clayey sediments beneath the house. The expansive nature of the underlying sediments should be noted with respect to foundation design.

If these precautionary measures are implemented there should be no instability problems as the area on which the house is to be built has a maximum slope of about six degrees.
