1981/2. Geological investigation of past quarry site, Poets Road, West Hobart

A.T. Moon

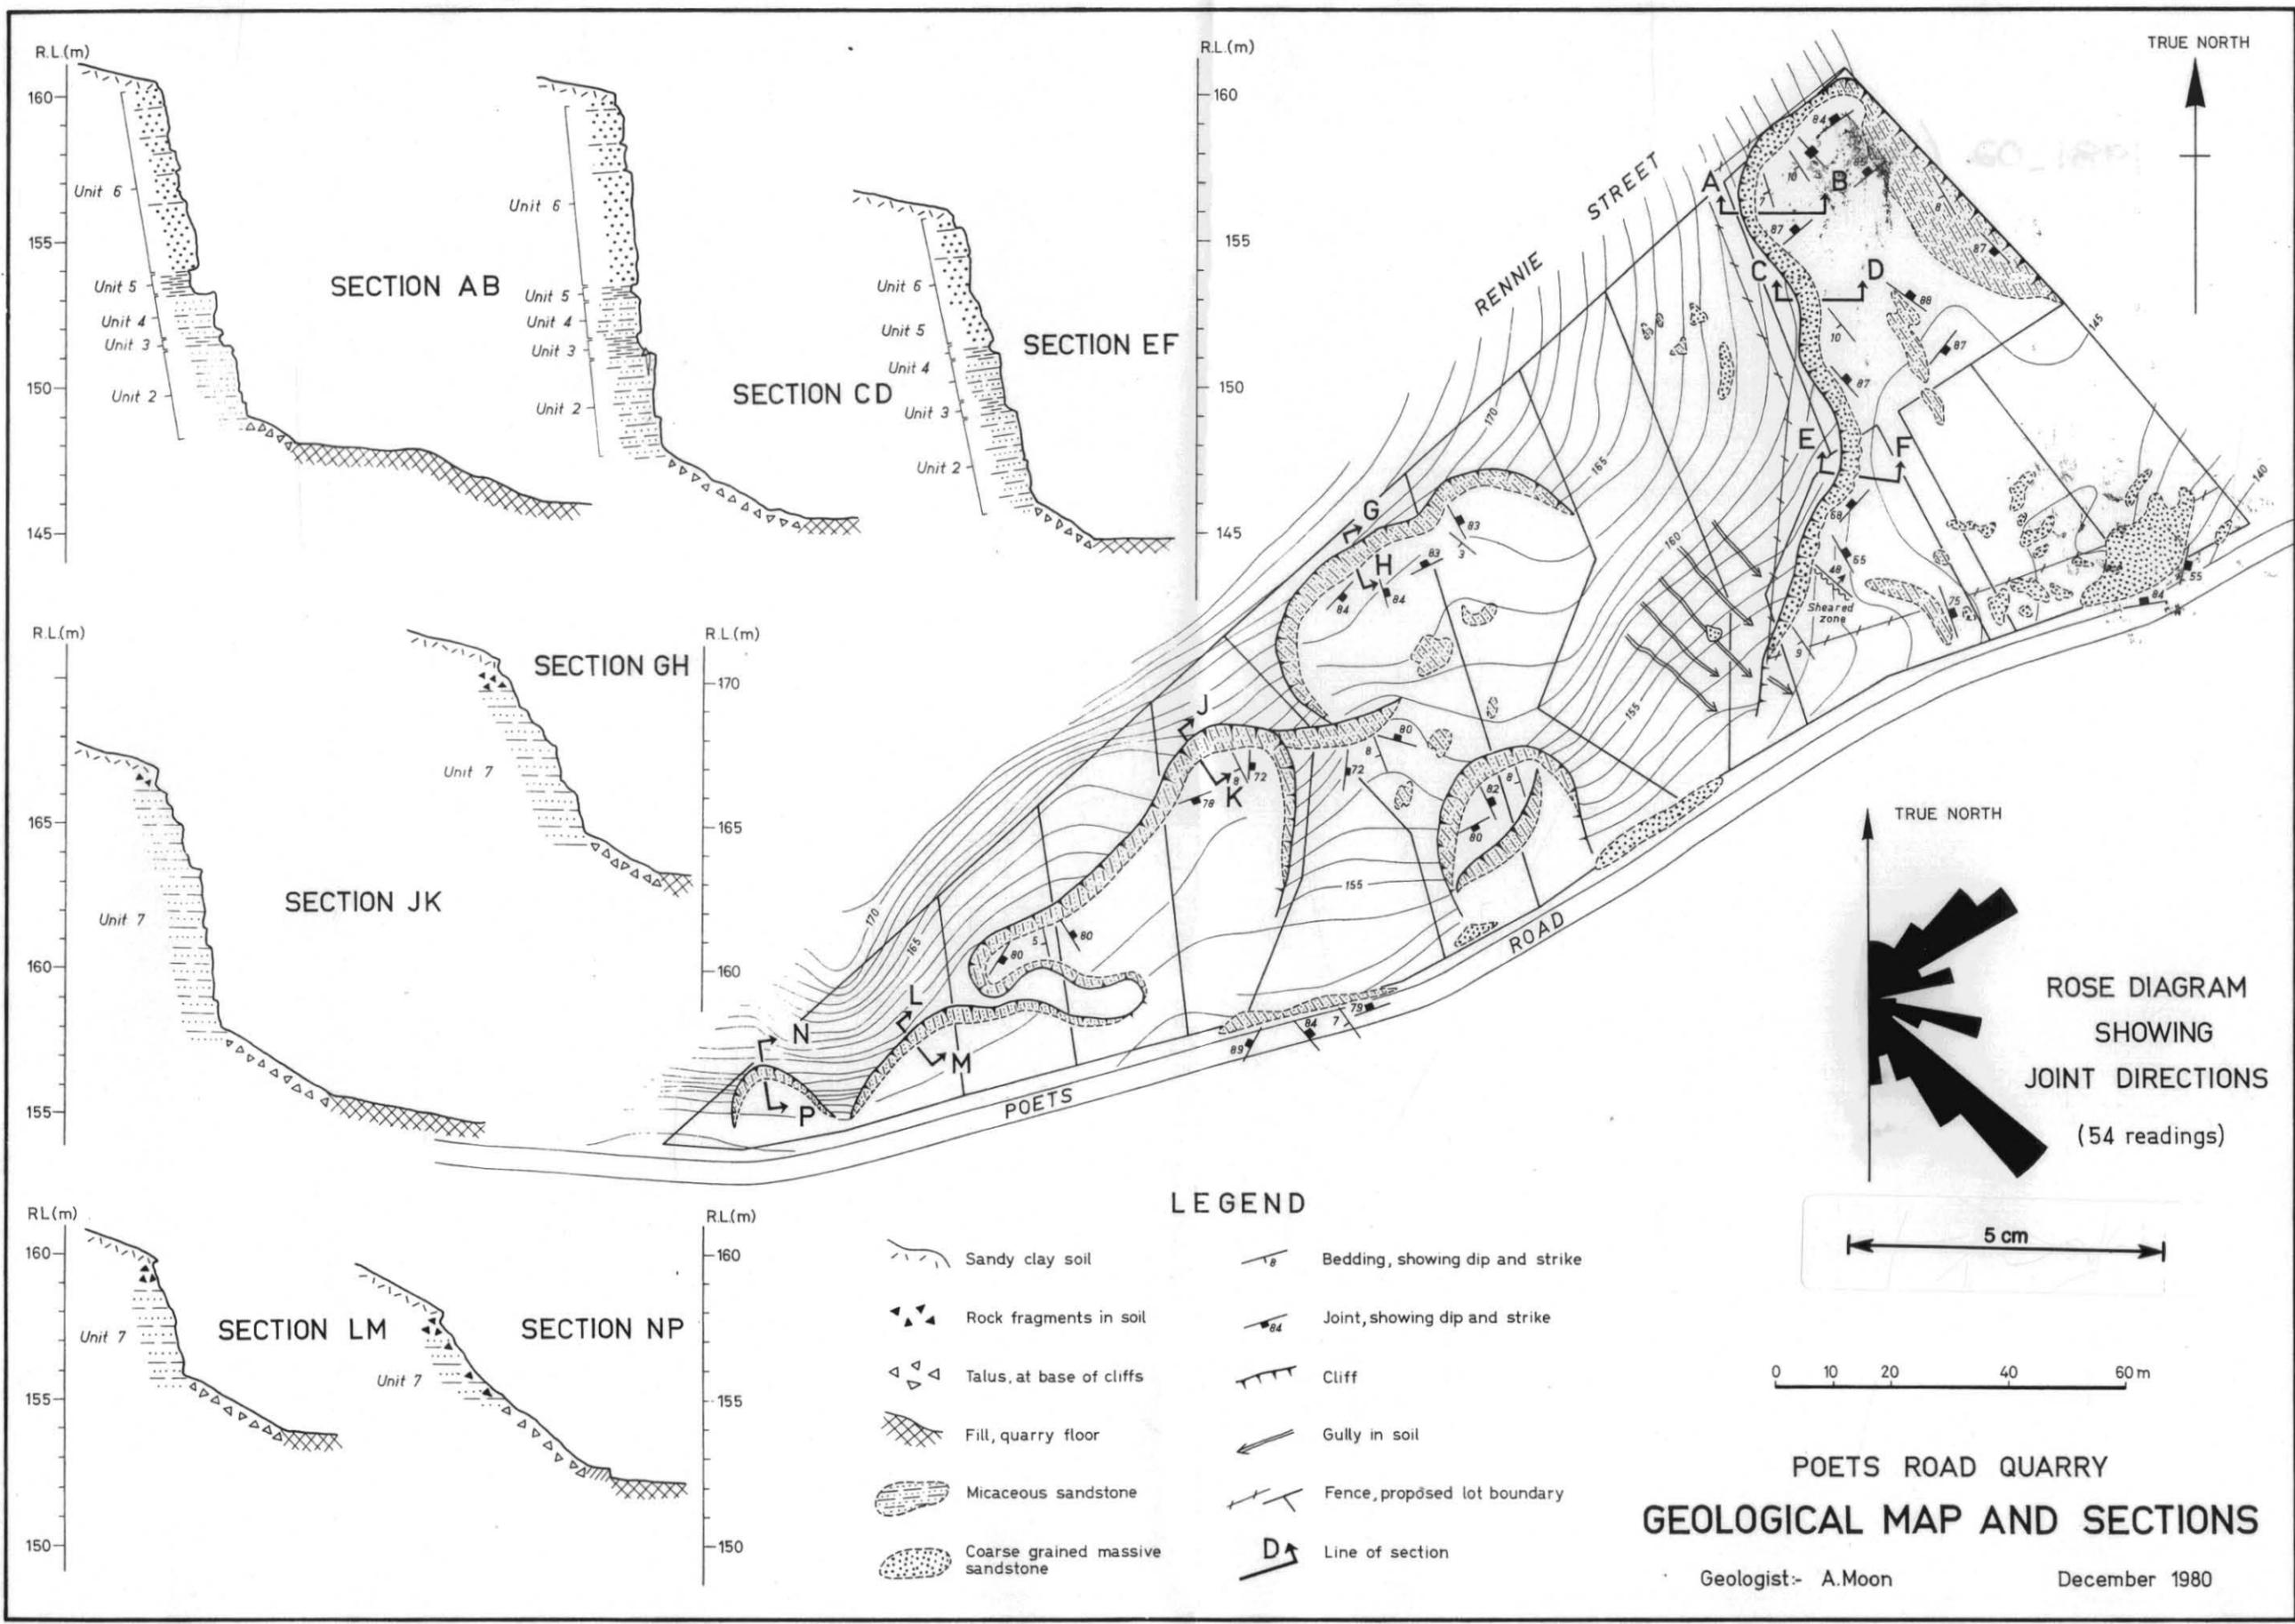
Figure 1

Apart from the joints parallel to the bedding, most joints and infill seams are near vertical. The rose diagram (fig. 1) shows the main joint directions for the project area. Although five or six steeply dipping joint sets occur, two main sets dominate, which, with the joints parallel to bedding (not shown on the rose diagram) make up the three main defect sets shown in Table 2.

<i>Set No.</i>	<i>Attitude</i>	<i>Description</i>
1	Parallel to bedding, strike 120° to 160°, dip 5° to 10° towards south-west.	Joints of large extent (greater than 10 m), usually planar but sometimes irregular, surfaces rough.
2	Strike 130° to 150°, near vertical or dipping steeply north-east.	Joints of large extent (greater than 5 m), planar with rough surfaces.
3	Strike 040° to 060° near vertical.	Joints of large extent (greater than 5 m), usually planar sometimes irregular, rough surfaces.

The spacing of the defects varies. For Set 1 and 3 spacing is generally 0.3 to 1.0 m and for Set 2 generally 1 to 3 m. Locally joints are much closer.
