1981/17. Inspection of proposed dam site near Gunns Plains

W.L. Matthews

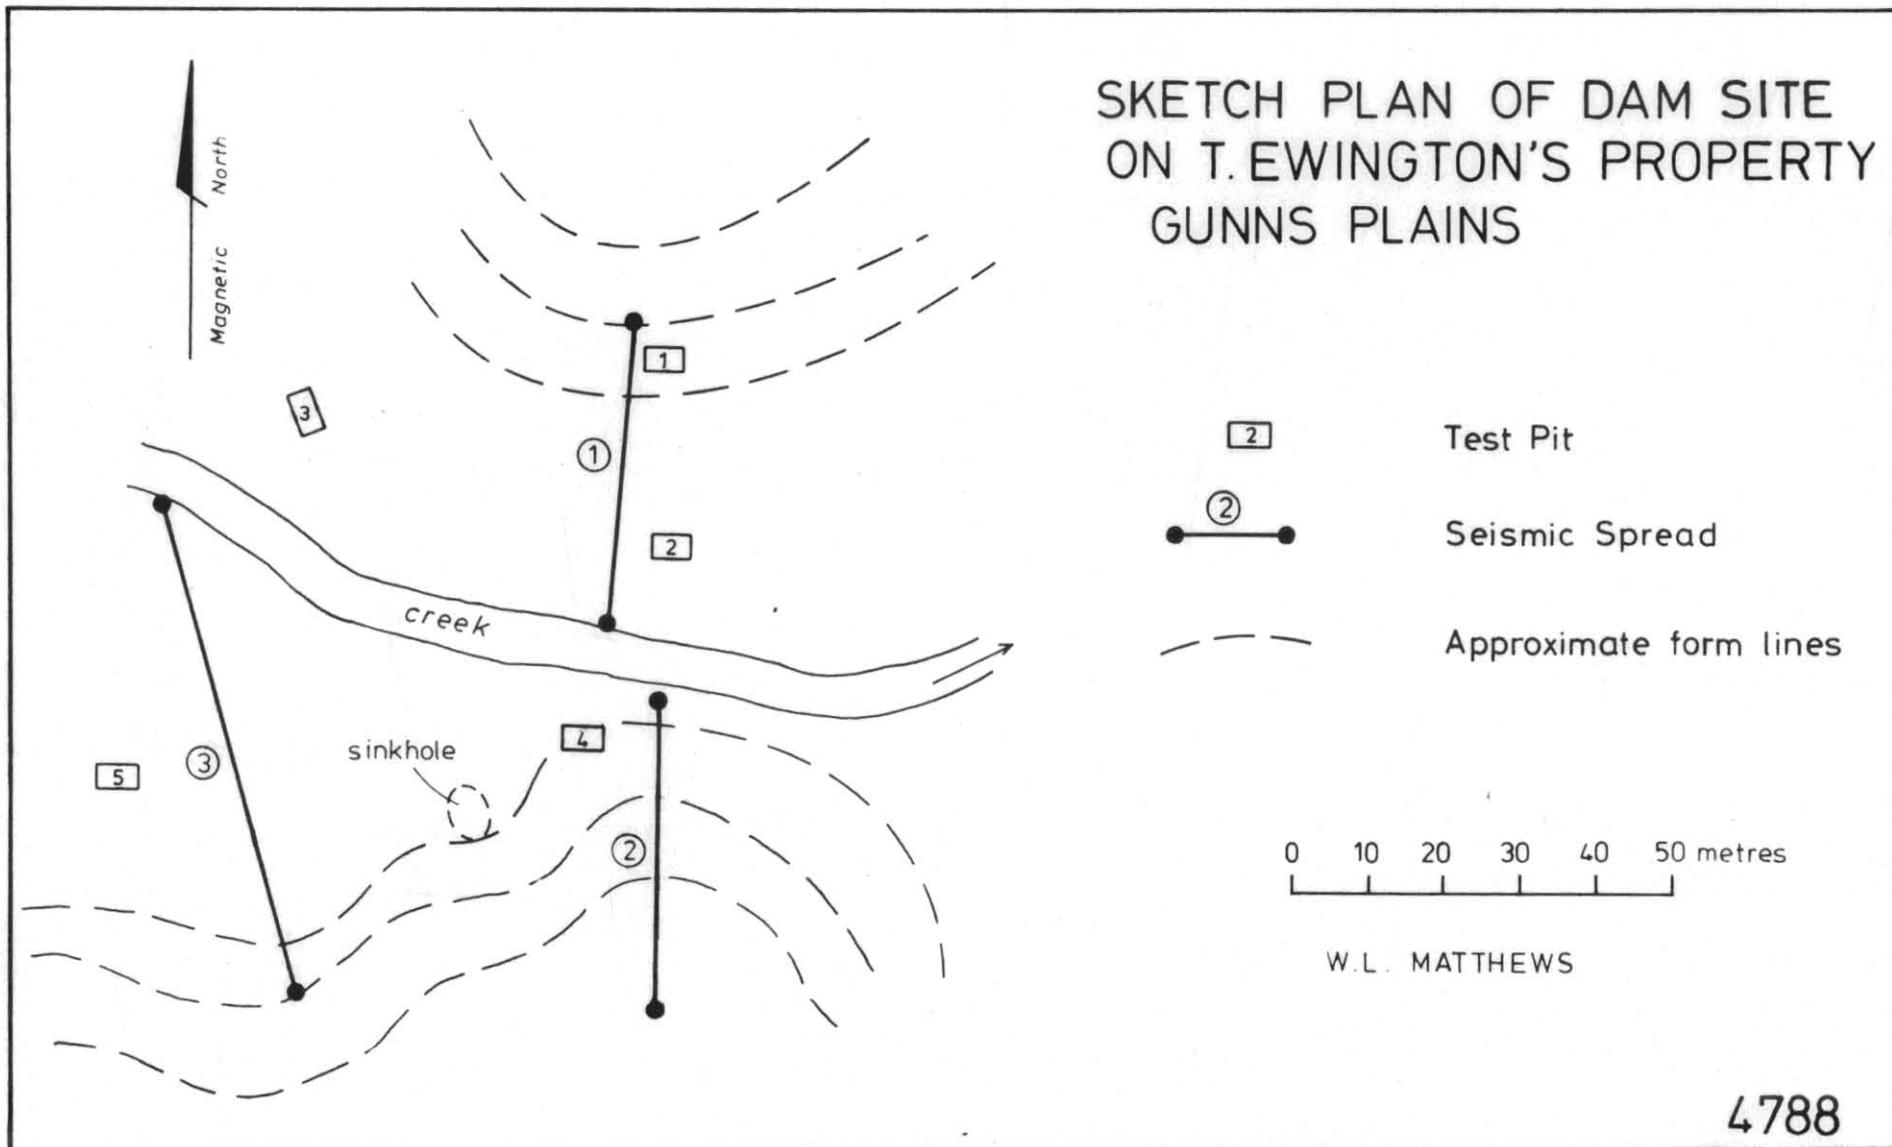
The approximate locations of the test pits are shown on Figure 1 and the logs are given in Appendix 1. Material with low permeability was encountered in all test pits. The material consisted dominantly of silty clay. Test Pits 2 and 4 contained thin bands of gravelly and sandy clay

towards the base of the holes. In each case, this coarser grained material does not appear to be very permeable because of the high percentage of fine grained material contained in it. The base of each pit was in clay or silty clay when the excavation was stopped, so that the thickness of the coarser grained material is limited, although other layers may occur at depth.

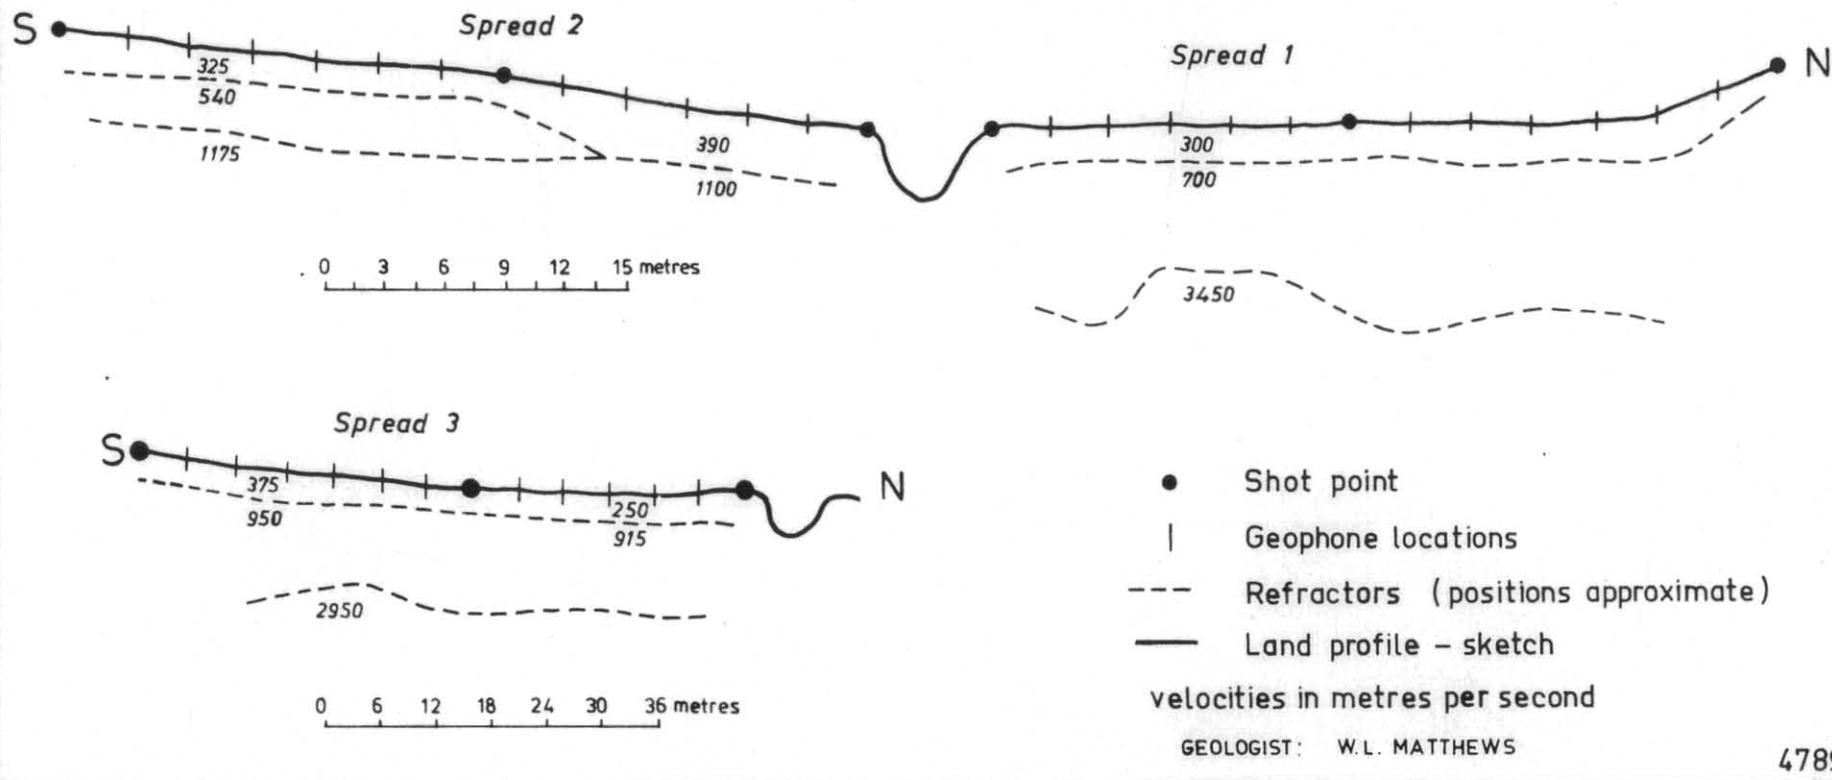
Figure 2

The near-surface material with seismic velocities of 250-390 m/sec which underlies all spreads (fig. 2) is probably soil and fractured fairly dry silty clay, as exposed in the test pits and on the sides of the creek. The material with the seismic velocities of 540-700 m/sec is probably similar, but slightly more compact and perhaps a little more moist. The 915-1175 m/sec layers are also unconsolidated material, but are quite compact and may be almost saturated with water in the higher part of the range. It should be pointed out that it is difficult to interpret any difference from seismic velocities between saturated sand or gravel and saturated clay or silty clay. Material with velocities of 2950-3450 m/sec is probably weathered or fractured rock. Limestone, in an unweathered and unfractured state, is expected to have a higher seismic velocity.

It seems unlikely that there are extensive open cavities in the rock under Spreads 1 and 3. The surface of the deeper refractor is uneven (fig. 2), but limestone, if this is the rock that this velocity represents, often tends to weather with an uneven surface. No higher velocity than 1175 m/sec is indicated under Spread 2. This is possibly what would be expected with a large extensive cavity under the area, with the seismic vibrations travelling along slow surface layers. However a cavity of this extent is very unlikely, and a more likely explanation for the absence of a higher velocity is that the unconsolidated material overlying rock is much thicker than on the north side of the creek (and further upstream on the south side where Spread 3 is sited). If material with a seismic velocity of 3000 m/sec or greater underlies the ends of Spread 2, then it is probably at least 14 m below the surface.

Large open cavities in limestone underneath the site and near to the surface are unlikely. The most likely occurrence is under seismic Spread 2, although this prospect is fairly remote and the absence of a refractor with higher velocity is probably due to the presence of a greater depth of unconsolidated material in this area.
