1981/18. A landslip on Repulse Road, north of Maydena

W.L. Matthews

*Abstract*

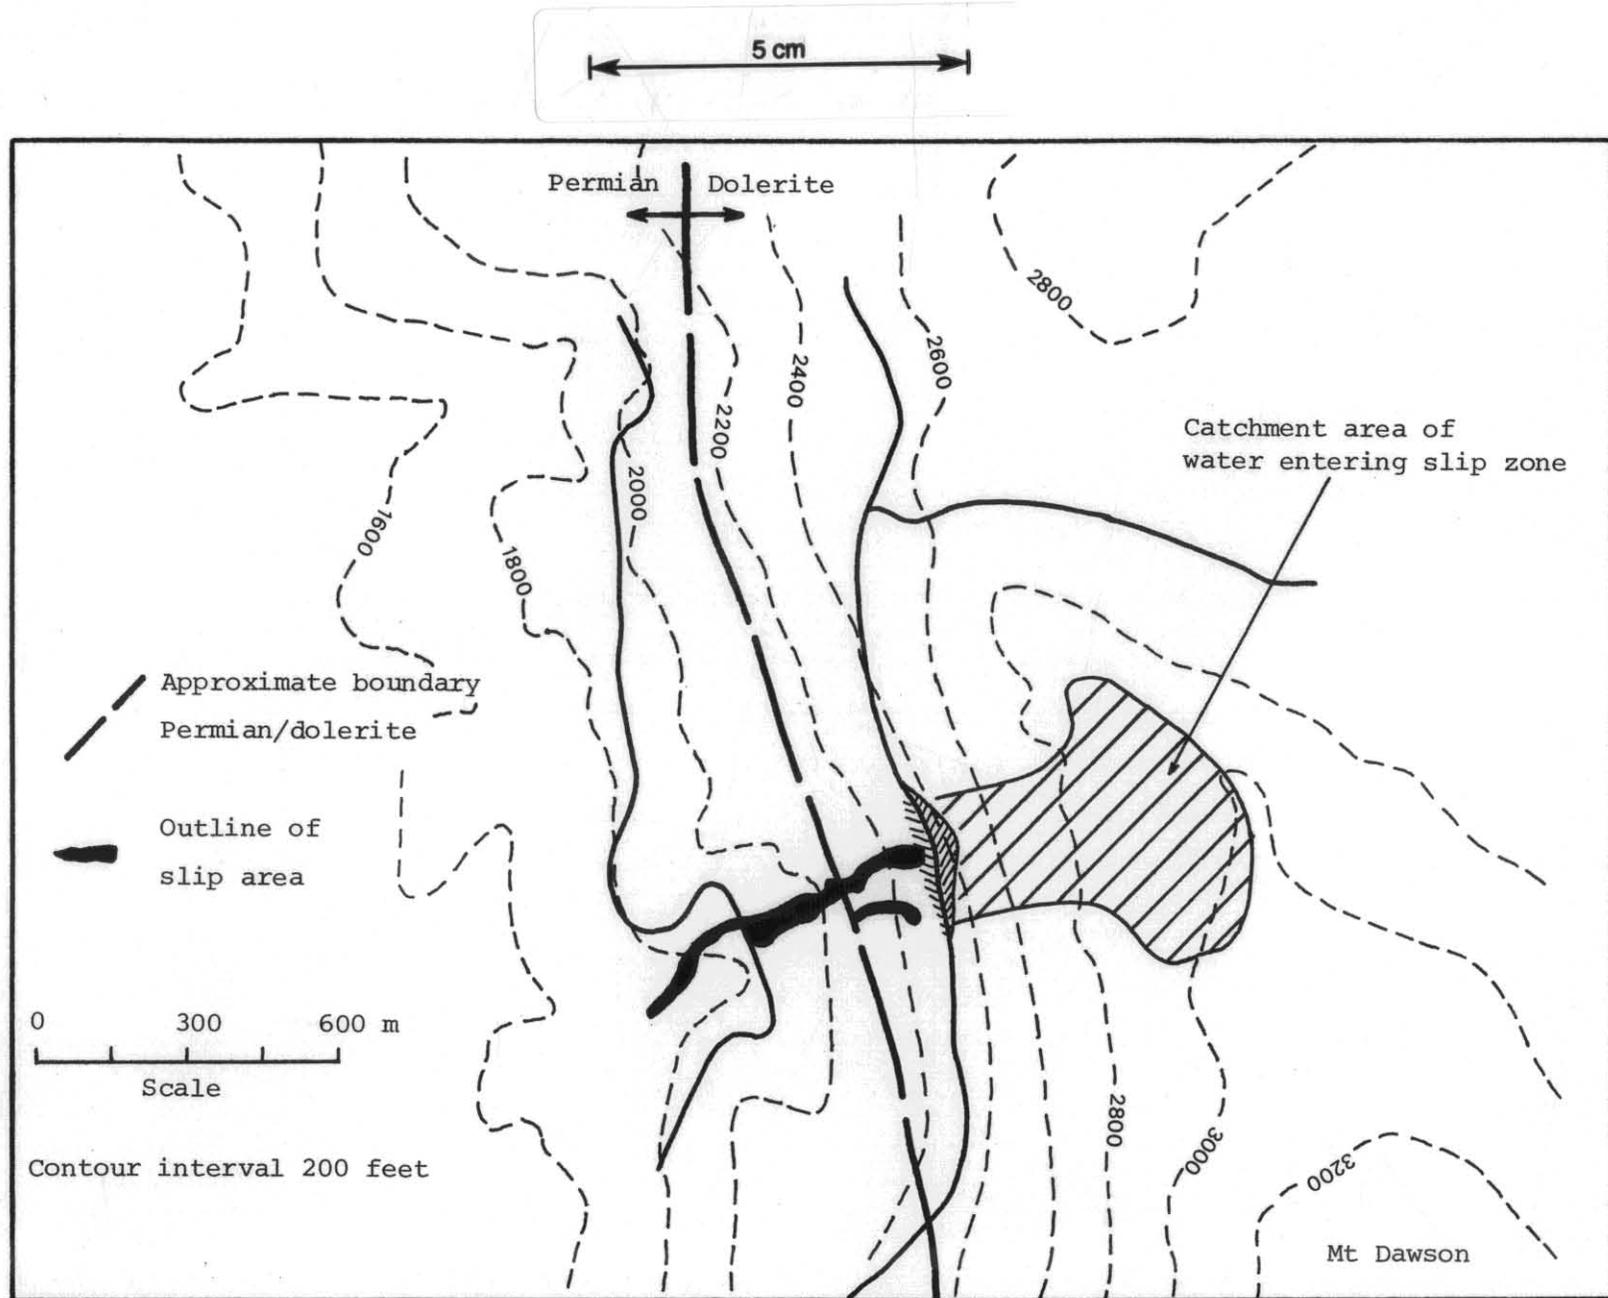
Repulse Road passes around the north-western slopes of Mt Dawson. Where the landslip has occurred (fig. 1), there is a slight re-entrant into the ridge, and the land slopes at an average angle of about 25°, although the slope below the slip area, taking the road fill into account, is steeper than this.

Figure 1. Landslips near Repulse Road, north of Maydena

The slips are long narrow zones of disturbance which, near the top, have gouged out channels several metres deep. The largest slip, which reaches to the road fill material, extends over a distance of 400-500 m down the slope, and road material (basalt boulders) can be found over much of its length. Another slip, the head of which is a little below road level, has also taken place since 1973, but at this stage has had no effect on the road. A smaller slip area between these two slips has not extended up to the road.

These slips could best be described as debris flows.

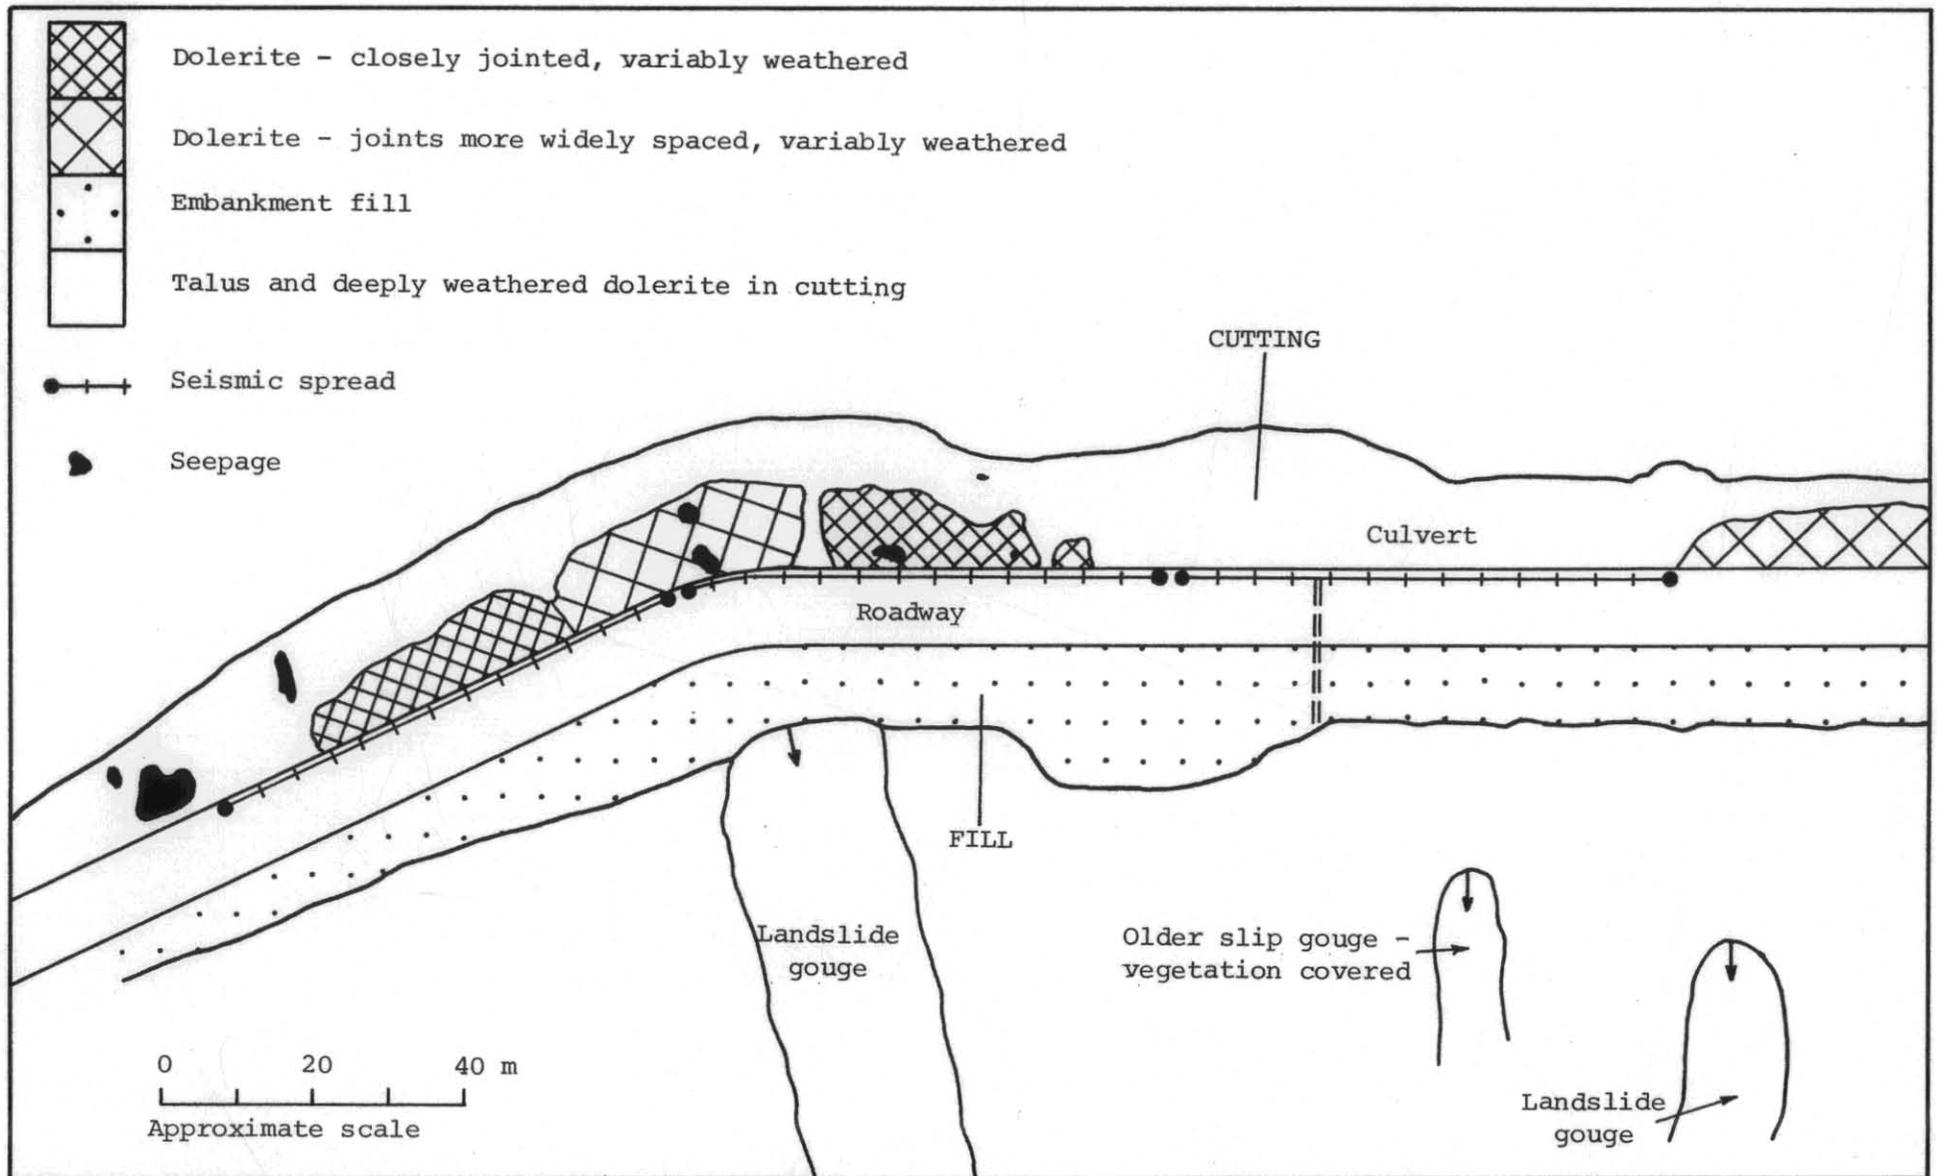
Seismic spreads were fired along the roadway (on the inside of the road) in an attempt to locate the level of less weathered rock, but this survey was somewhat less successful than expected. Three spreads were fired along the road covering the sections that have been affected by the movement (fig. 2). These spreads had a geophone spacing of five metres and only the most northern spread indicated material other than deeply weathered dolerite over long sections. Interpretation of the northern spread suggests material with an average seismic velocity of a little over 2000 m/sec at depths of 3-5 metres. If this velocity represents dolerite, it is either weathered or jointed. Dolerite such as in the out-crops upslope from the road would probably exhibit seismic velocities of 4-5000 m/sec.

The average highest velocity for the other spreads was 1100-1350 m/sec, which represents relatively unconsolidated material, although small sections of these spreads show higher velocities. If material with a velocity of 3000 m/sec underlies the southern spread, it would be at least 23 m below road level.

Figure 2. Sketch plan, area around landslip on Repulse Road

If relatively solid rock occurred just below road level, methods of stabilisation may have been more easily devised. It seems likely that the only realistic means of attempting to maintain stability of the area is to undertake some drainage measures and promote vegetation regrowth. An additional measure may be to move the road further into the slope and have a greater proportion of the road underlain by *in situ* dolerite. Despite

the seismic results, a comparatively large proportion of the road cutting has exposed variably weathered dolerite. Moving the roadway a little into the slope would require a higher cutting and a number of benches may be necessary.

Drainage measures should aim at preventing water from seeping underground and these include:

(a) to intercept water seeping from a flatter area above the slip before it reaches the vicinity of the road. Two small streams run towards the slip area (disappearing before reaching it) even in the summer. In wet periods the flow of these streams could be expected to increase in volume markedly. A drain would have to be installed uphill from the cutting top to intercept this water before it disappears underground.

(b) A drain around the top of the cutting (or a bench near the top) would intercept surface flow between the above drain and the cutting top before it flows down the cutting face.

(c) A sealed table drain along the inside of the road would remove rainwater which falls on the cutting itself and water from further up the road.

Discharge areas for water from the above drains should be selected with care. Discharge on land with a high slope angle and thick talus just below the road are likely to cause further problems. The present culvert in the slip area could aggravate the situation.
