1981/19. Proposed landslip zoning of Wulf's farm, Browns Hill, Underwood

W.R. Moore

Survey of Wulf's slip, Underwood

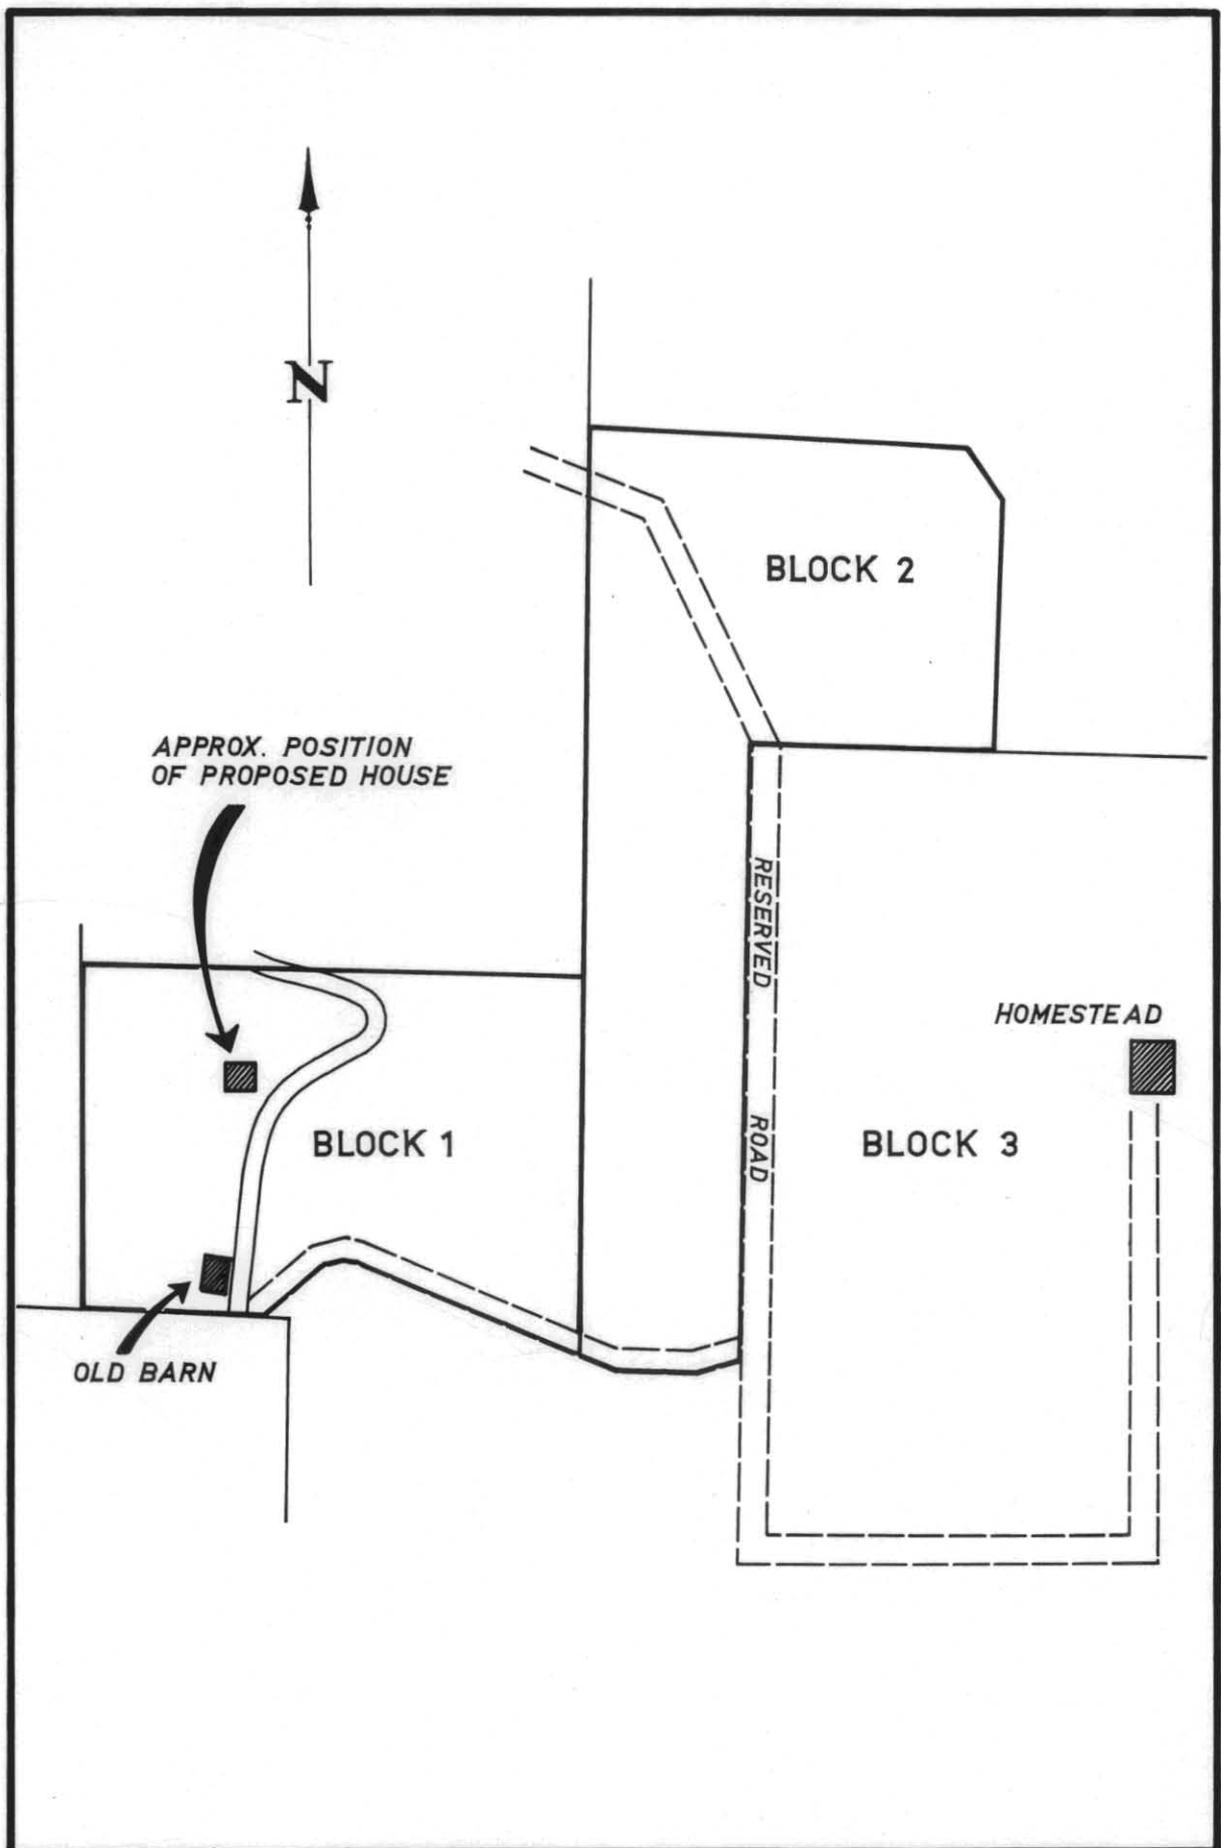
Figure 1. Proposed subdivision of land, Wulf's farm, Browns Hill Road, Underwood

The subdivision, as proposed by Wulf, is to split the existing farm into three blocks with the boundaries as proposed by the Tamar Regional Master Planning Authority (fig. 1). It is planned that Block 1 be sold immediately and a house built on the proposed site (fig. 1) for M.G. Pinner of Karoola. Block 2 is to be sold as a rural block with access along the road reserve. Block 3, the homestead block, is to remain as a rural block with no further subdivision planned in the immediate future.

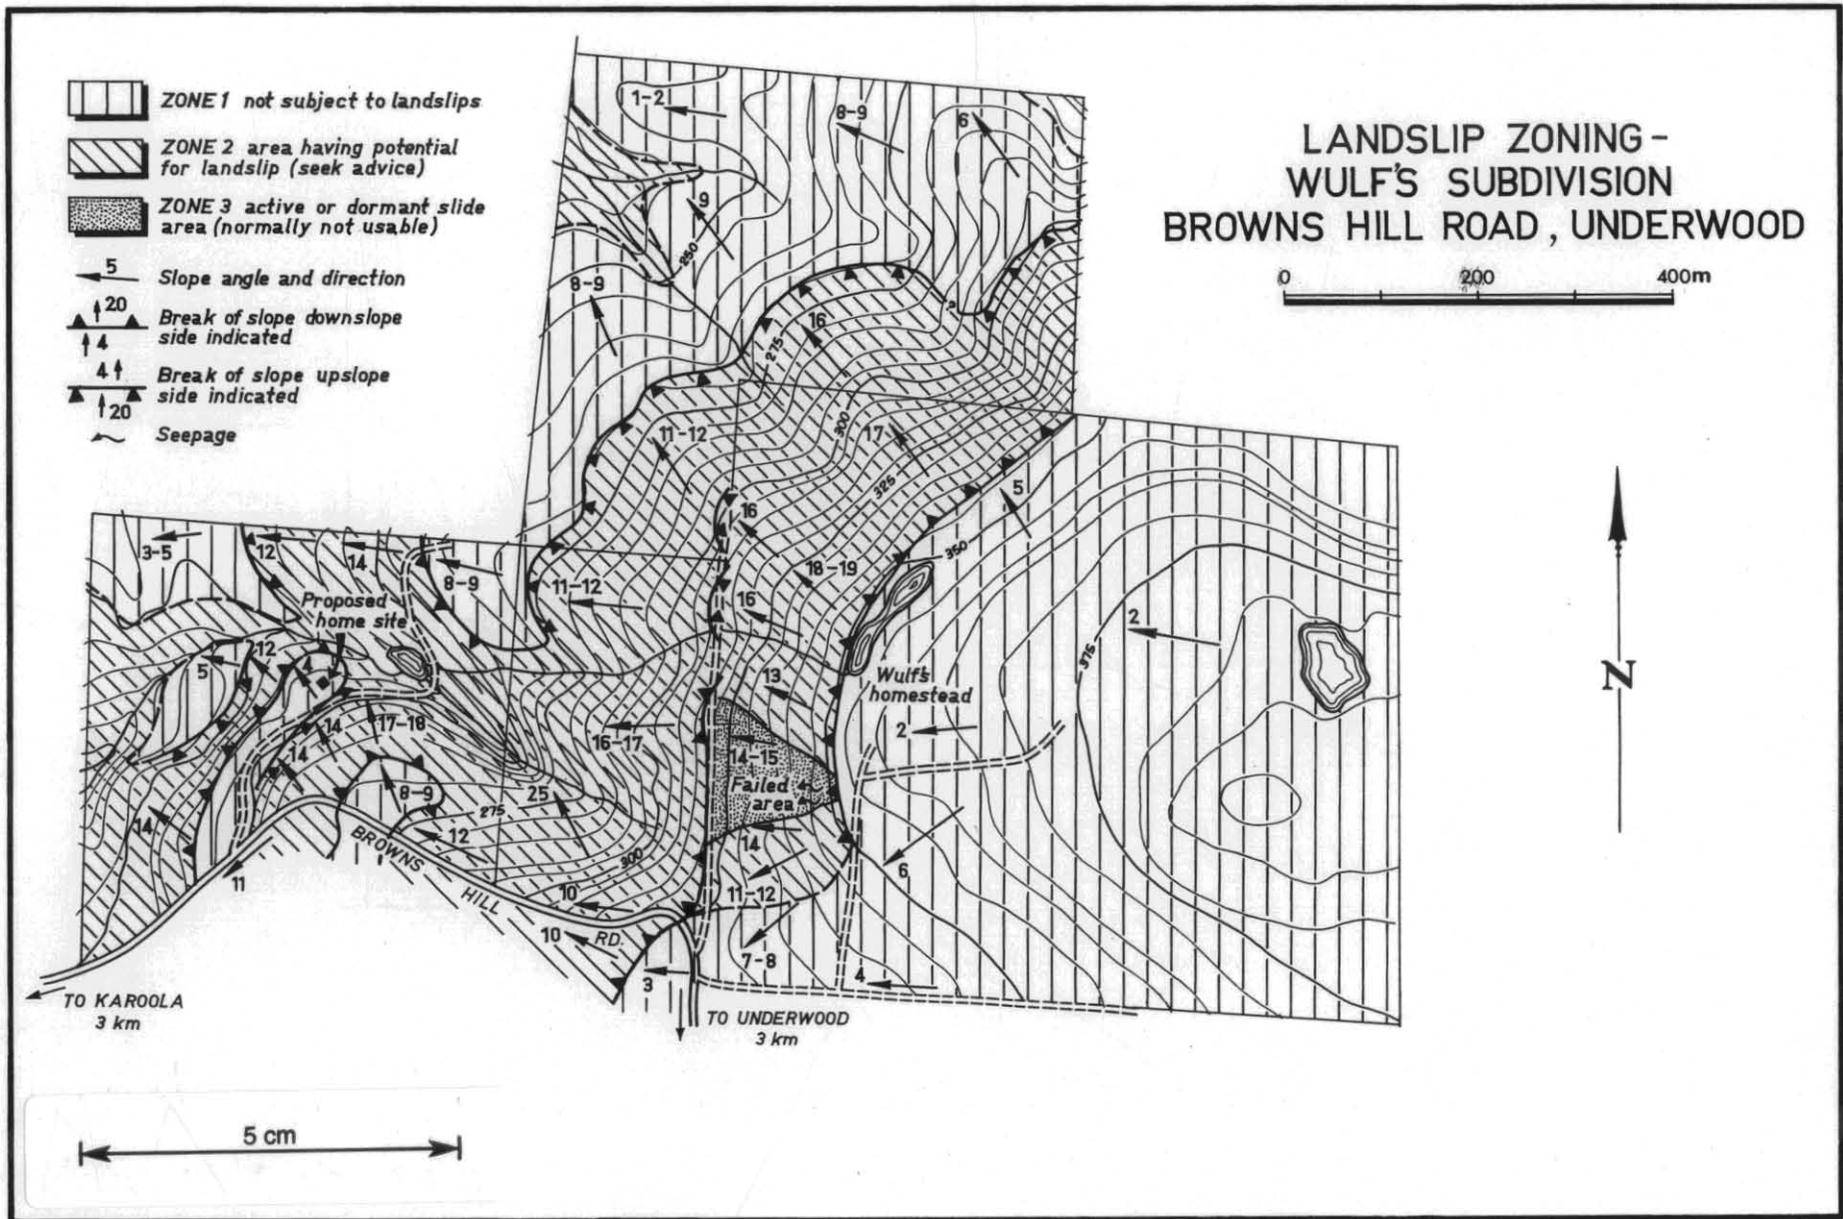
Figure 2.

Because the benches are less well developed south of the stream to the Browns Hill Road, the geology and the alternation of slope and bench is obviously more complex. There is a possibility that these small benches were produced in this area by an old landslip. It is on the middle of one of these benches, the site of an old homestead and barn, that Mr Pinner wishes to build his home. The site is shown on Figures 1 and 2.

To try and prove that this bench was structural a hole was augered to 7.3 m depth. Because little to no core was recovered when the hard rock was encountered, the drilling results were inconclusive. In the top three metres sandy clay soil and clay subsoil were present. This was overlain by a weathered layer of clayey sand. At 6.8 m the rock became harder and the drill could not penetrate beyond 7.3 m depth. From the few rock fragments recovered, the bottom rock layer between 7.0 - 7.3 m is thought to be a hard grey sandstone interbedded with grey mudstone, which is probably the top of the bench rock surface. No water was present in the hole and top layers were only slightly moist.

From this subsurface evidence it appears that no stability problem is likely on the bench as the result of building a house. A more likely problem is that failure may occur on the slope behind the house. This steep slope has a slope angle of 14°, which increases to 17 - 18° towards the stream; the slope is short with another bench above it. To reduce the risk to the house if a failure should occur on this slope, the house should be located on the north side of the track away from the bank. No excavation of the toe of this slope is proposed now or in the future for any future building etc. No further subdivision should be permitted on the other two benches, particularly the small one above the proposed house site. Any extra water from this higher bench would seep down the slope, and as the slope is within the critical range for landslips to occur, this can be avoided by allowing no further subdivision of Block 1 between the road and the stream. Any future subdivision of this block should be confined to the more extensive terrace on the north side of the stream.

The septic tank of the proposed house should be located on the same bench as the house and towards the road entrance, but the overflow should be piped down the slope in front of the house to the lower bench. The stormwater should be kept from draining on to this slope and should enter the stream at the lower bench level. Any swimming pool should not be located in front of the house because any leakage from it would flow on

to the slope. The removal of trees on the slope behind the house should be kept to the minimum. With these precautions, the risk of failure on the slope behind and in front of the house can be reduced to an acceptable level.

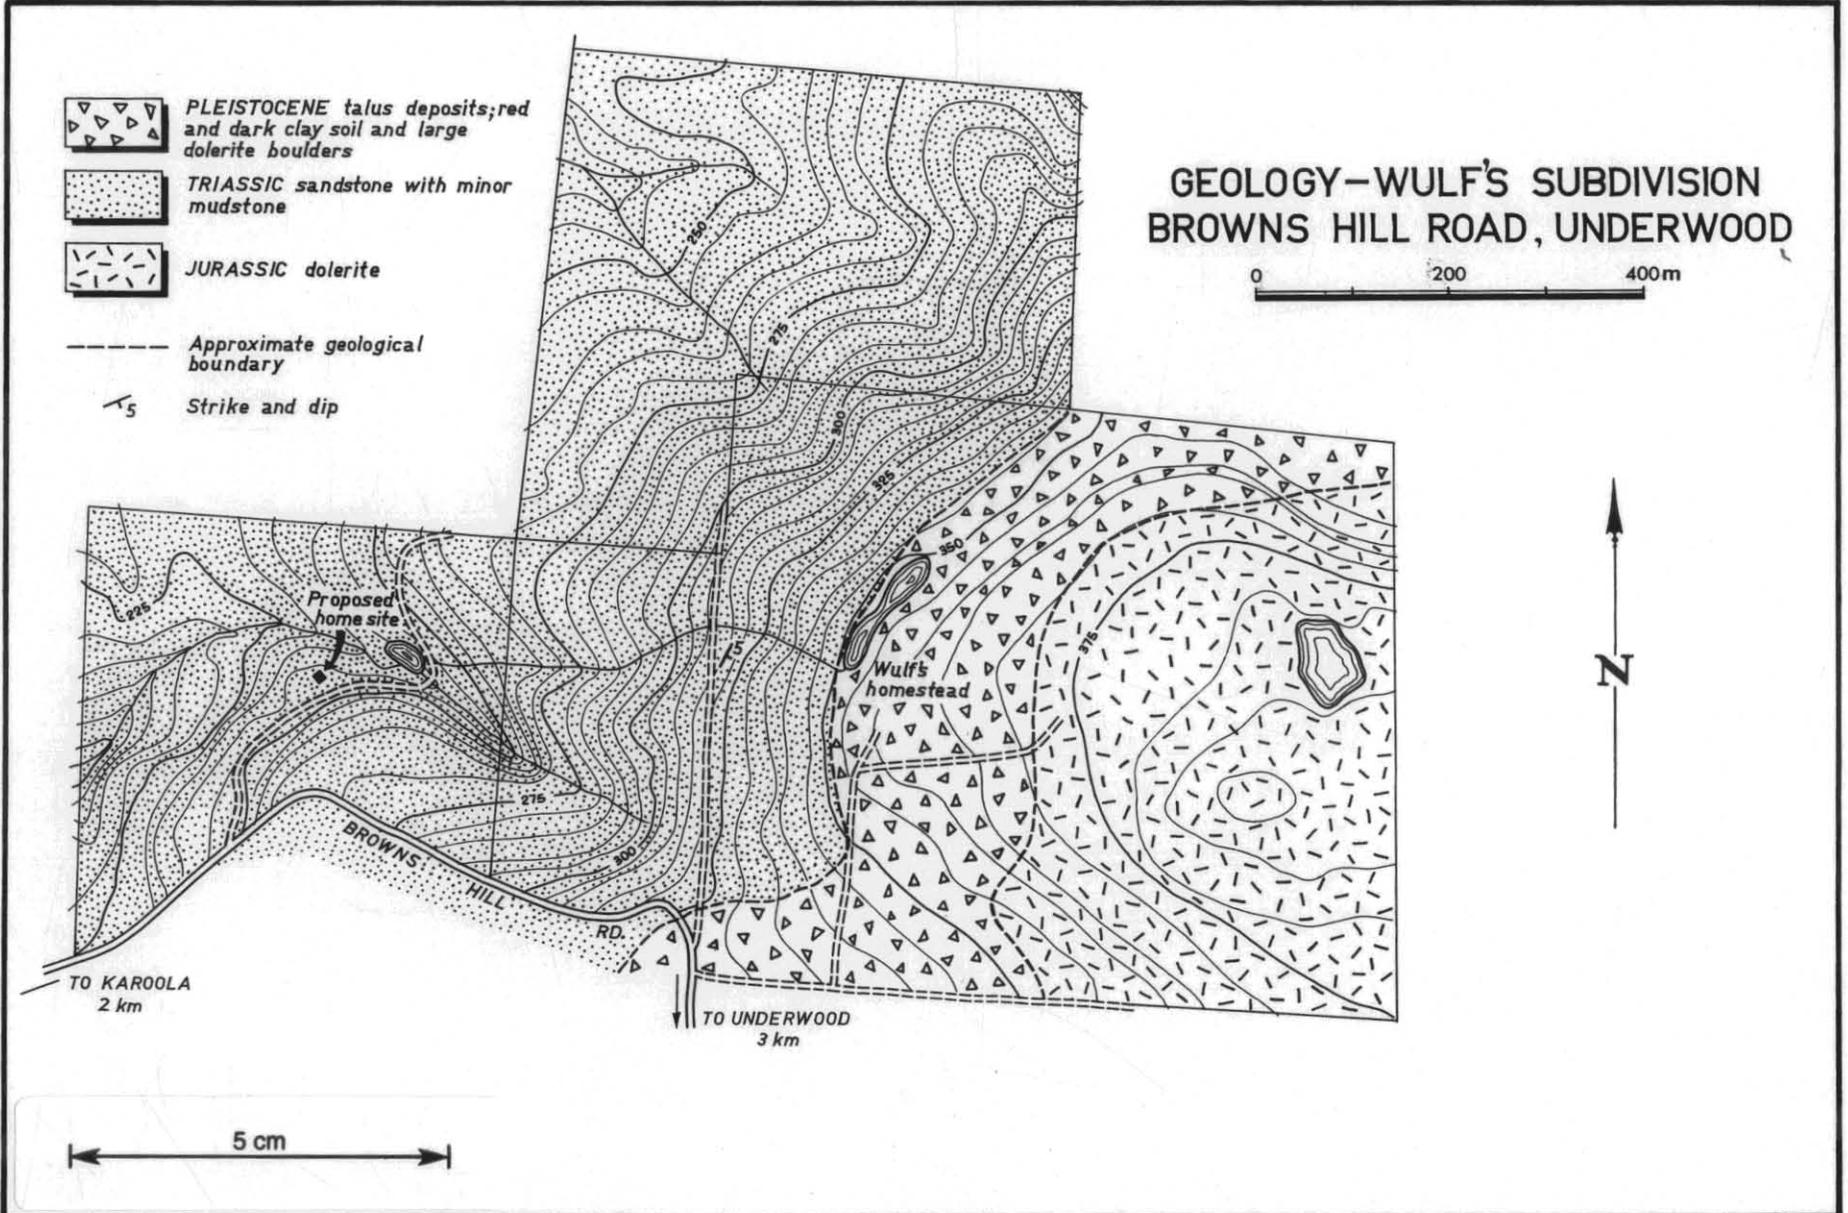
Figure 3.

Browns Hill is a fault-tilted block capped by dolerite, with the tilting dipping towards south-east (fig. 3). The north-east uplift is highest at where Wulf's farm is situated. Here the lower bench of dolerite crops out on the higher flat section of the homestead block. A low sloping area of red and brown clay soil with very large dolerite boulders overlies the uppermost Triassic sandstone bench. These dolerite boulders, with their red and brown soils, cover the western half of Block 3. No slope stability problems are likely to be encountered on the dolerite and dolerite talus areas.

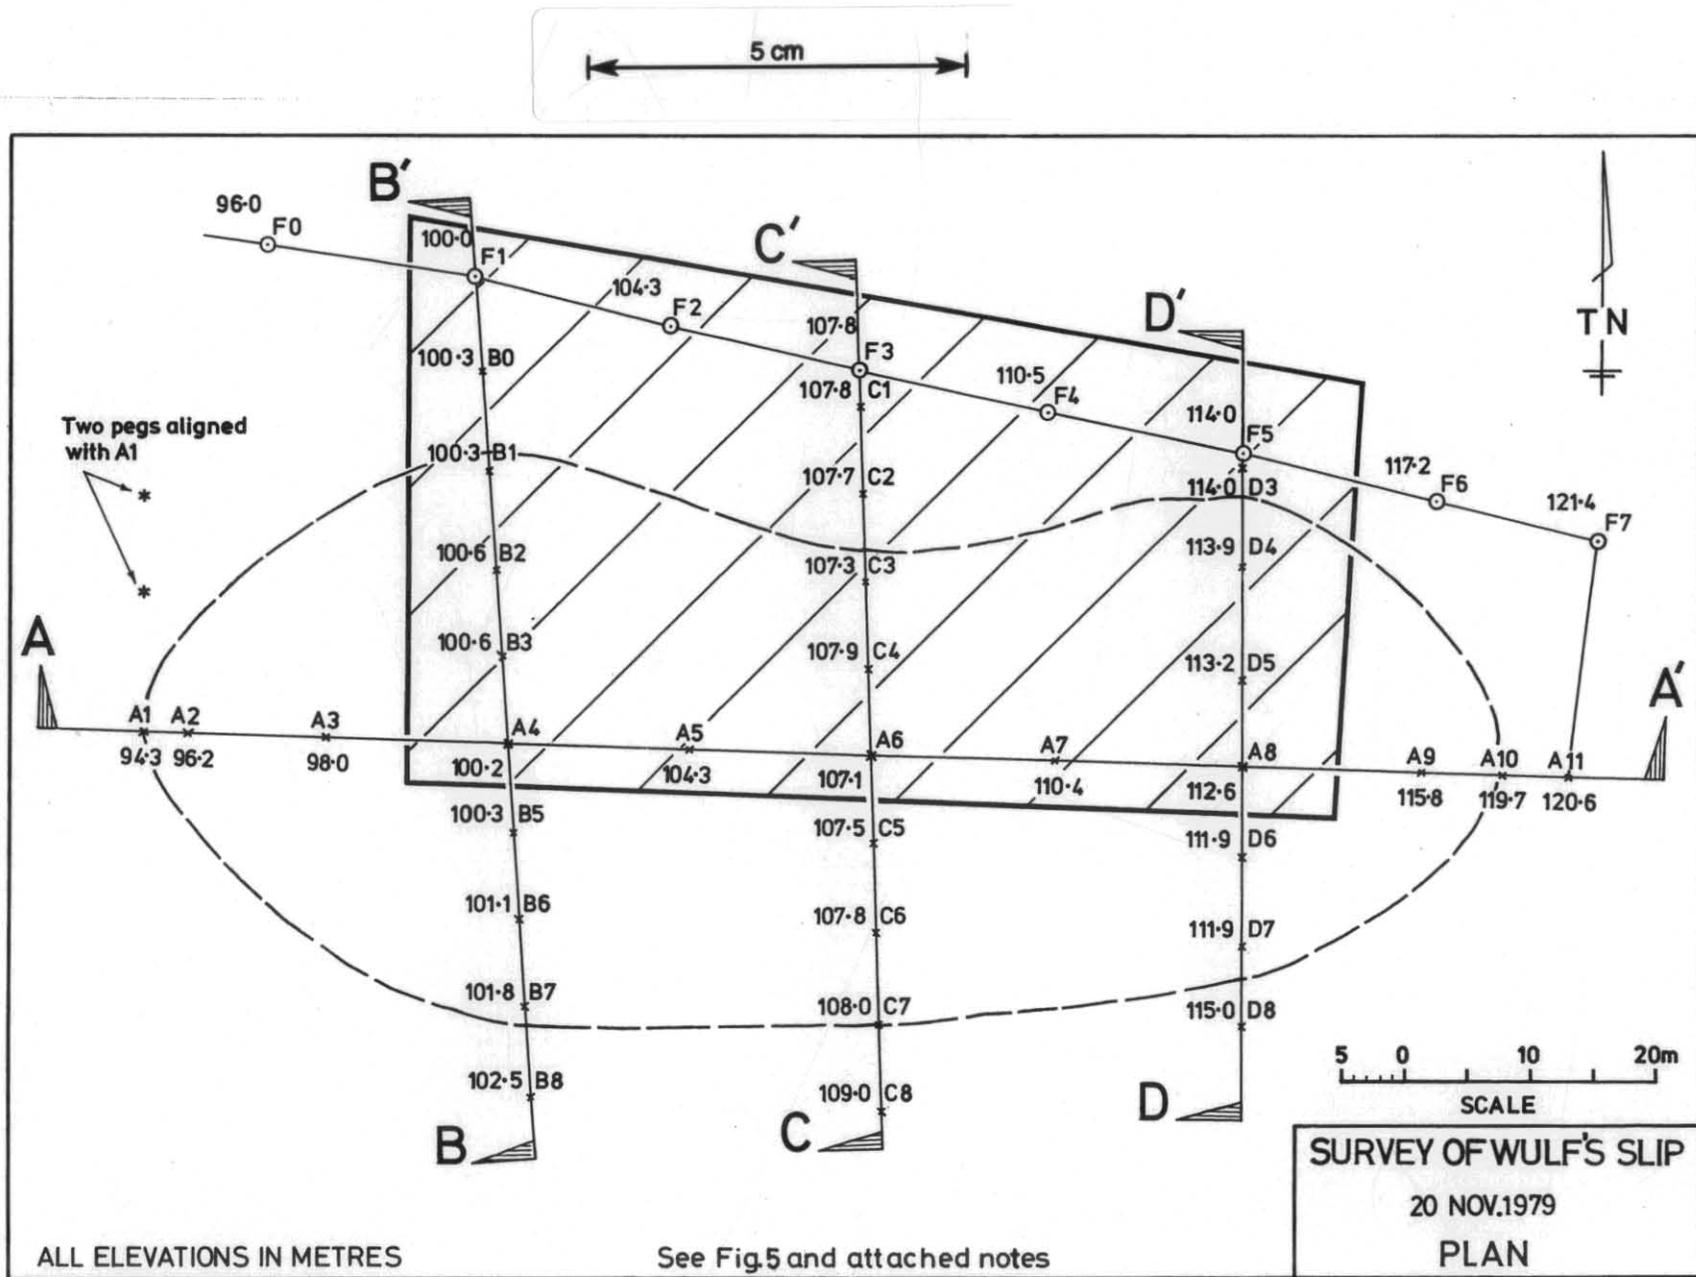
Figure 4.

- (4) The two pegs aligned with A1 may be used to sight the original position of A1 which has probably been covered by the toe of the landslip.
- (5) The outline of the landslip is approximate only; where it crosses the survey lines it is accurate to ± 1.0 m. Peg A10 was 0.3 m from the headscarp at the time of survey.

- (8) The approximate maximum error in the survey within the shaded area on Figure 4 is
RL ± 0.1 m
position ± 0.5 m

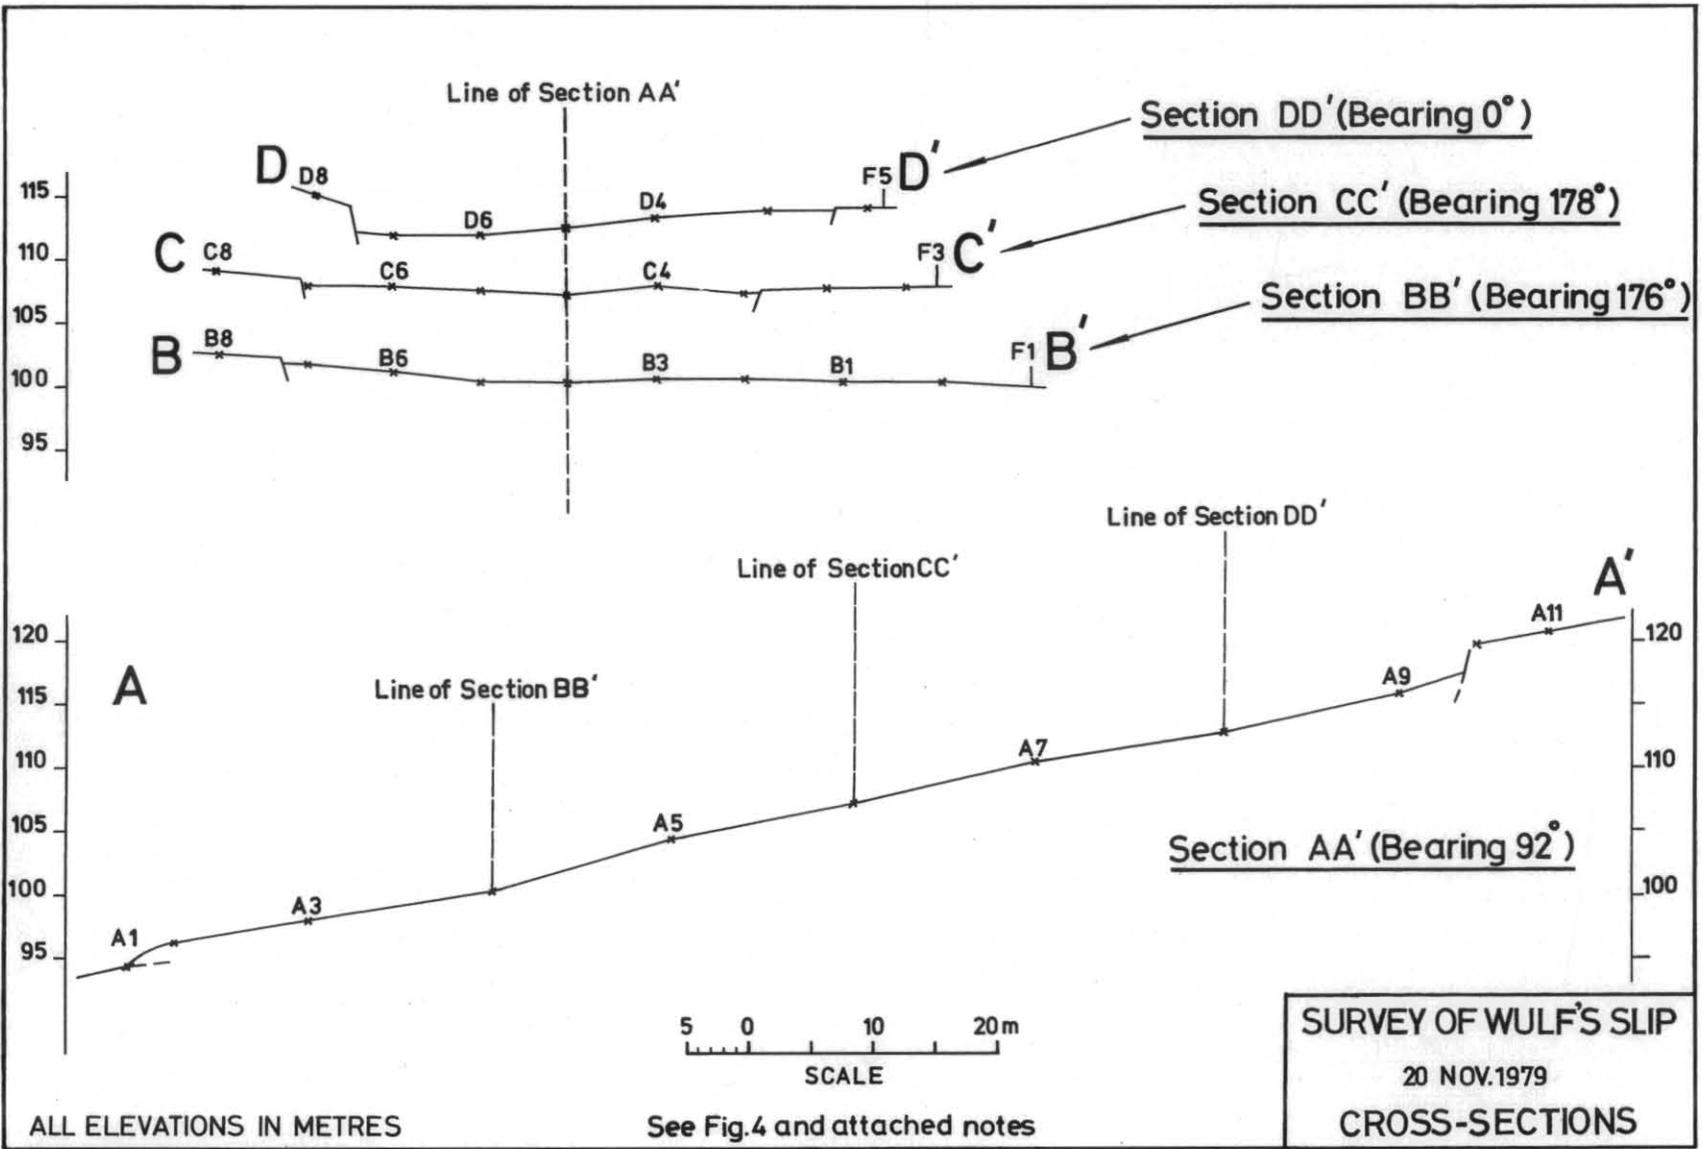
Figure 5.

- (6) The reduced levels (RL's) on Figures 4 and 5 are based on an arbitrary site datum. The base of fence post F1 has been given the value of RL 100.0.
