1981/52. Slope stability of Lot 1, R. & C.S. Adams subdivision,
Windermere.

W.R. Moore

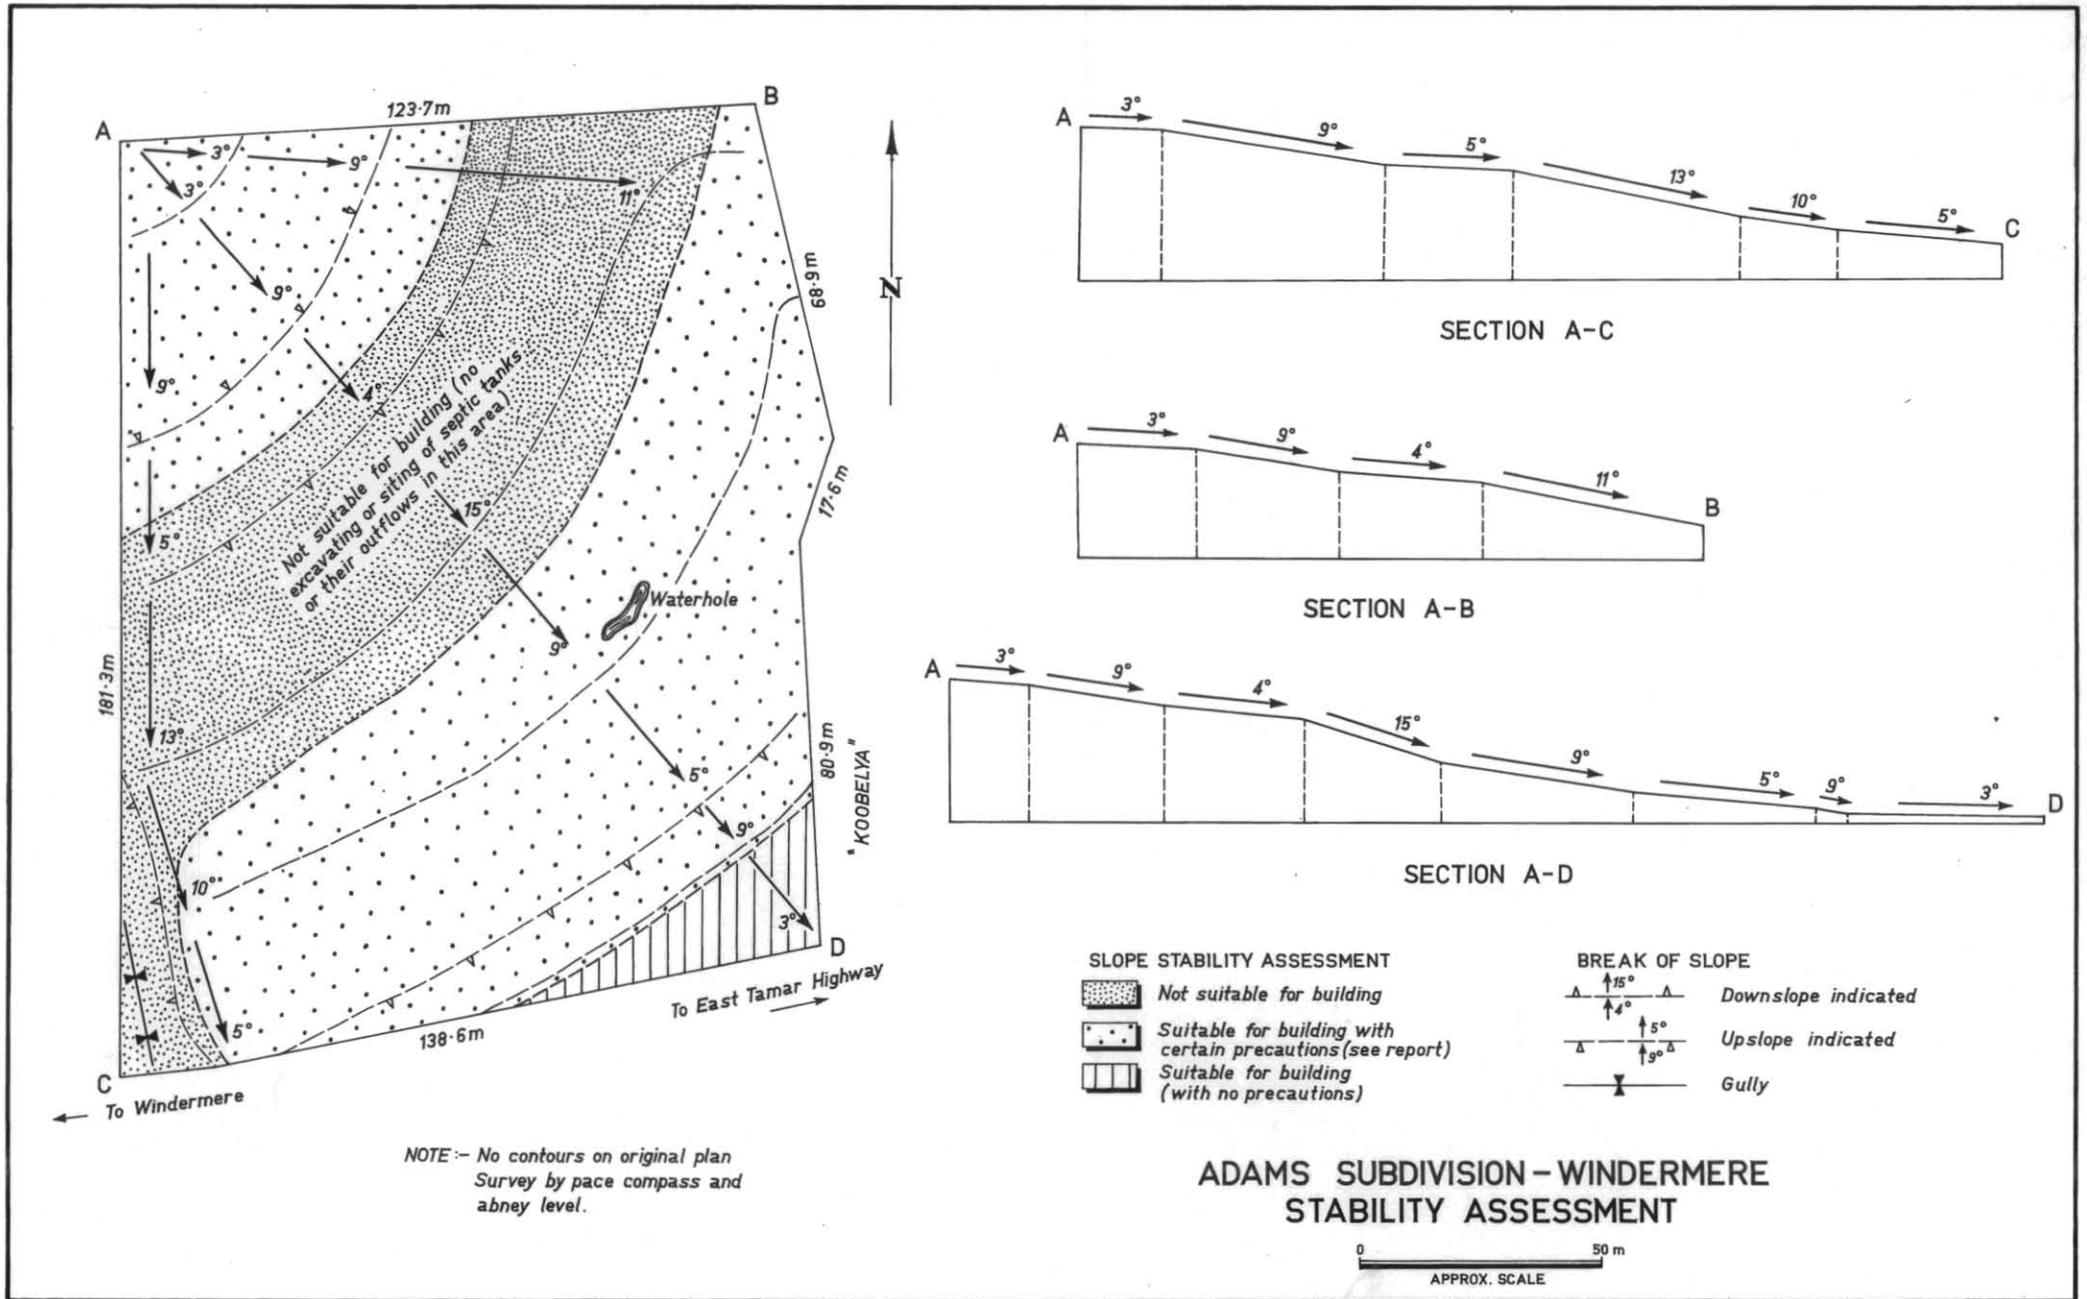
Fig.1

The block has a complex topography, with slopes ranging from 3° to 15° (fig. 1). The block is part of the terminal slope of a low ridge that parallels the River Tamar. A narrow, dry, shallow valley is present along the western boundary of the block. The eastern boundary of the block coincides approximately with the valley of a small stream that flows east on the neighbouring block. The north-west corner of Lot 1 is a small section of the ridge crest, with a slope of 3° towards the River Tamar and towards the eastern stream valley. This ridge slope falls by a concave slope of 9° to a narrow bench of 4-5° slope. This bench ends abruptly, with a noticeable break in slope, and the slope steepens to 13-15°. This steep slope flattens gradually to form a long slope of 9°.

The downslope direction swings in an arc from a north-south trend to an almost east-west trend (fig. 1). The ridge crest, the upper bench, and the intervening slope can be traced around the block, as shown in the three sections of Figure 1. In contrast, the steep slope of 13-15°, and its foot slope of 9° merge to form a continuous valley slope of 11° on some parts of the block. The lower terrace, although modified for a farm track, is well marked.

The presence of an old landslip and plastic clay make all of this block, except for the small area around the river bank and terrace, a potential landslide area. With increasing slope angles this slope sensitivity increases, and for slopes in excess of 9° the risk of failure is too great to warrant building.

Therefore on this block, the prominent steep slope of 11° to 15° (fig. 1) is considered unsuitable for building, and the area where future slope failure would most likely occur. To minimise the risk of failure, no extra water should be drained onto this slope. All stormwater drains, septic tanks, and their overflow drains, should be kept off this slope.

A further precaution is not to load this slope with extra weight. Therefore on the upper bench, a house should be situated at a minimum of ten metres from the bench edge. Equally important is that the foot of this 11-13° slope not be lightened by excavating material from its base. With this in mind, a precautionary border zone of some 15 m of the 9° slope is included in the non-building zone (fig. 1).

- (1) The block be used for only one house.
- (2) No building be undertaken on the steep slope of 11-15°.
- (3) No building should be undertaken in the two bordering areas to this slope. In the upper bench this border zone should be ten metres wide, and at the foot for 15 m down the 9° slope. No excavating should occur in this area, nor should septic tanks or swimming pools be located here.

- (4) If a house is sited on the upper level the risk of a potential failure is accepted. The house should be set ten metres back from the edge of the break in slope. All water and sewage etc. should be piped down this slope to the lower levels, and the access road should climb to the bench by way of the eastern and northern boundaries.

- (5) If the house is positioned on the lower section of the block, a location preferred for slope stability, then care should be taken that septic tank overflow does not reach the road.
