1982/17. Slope stability at West's block, Cluan Tier

D.J. Sloane

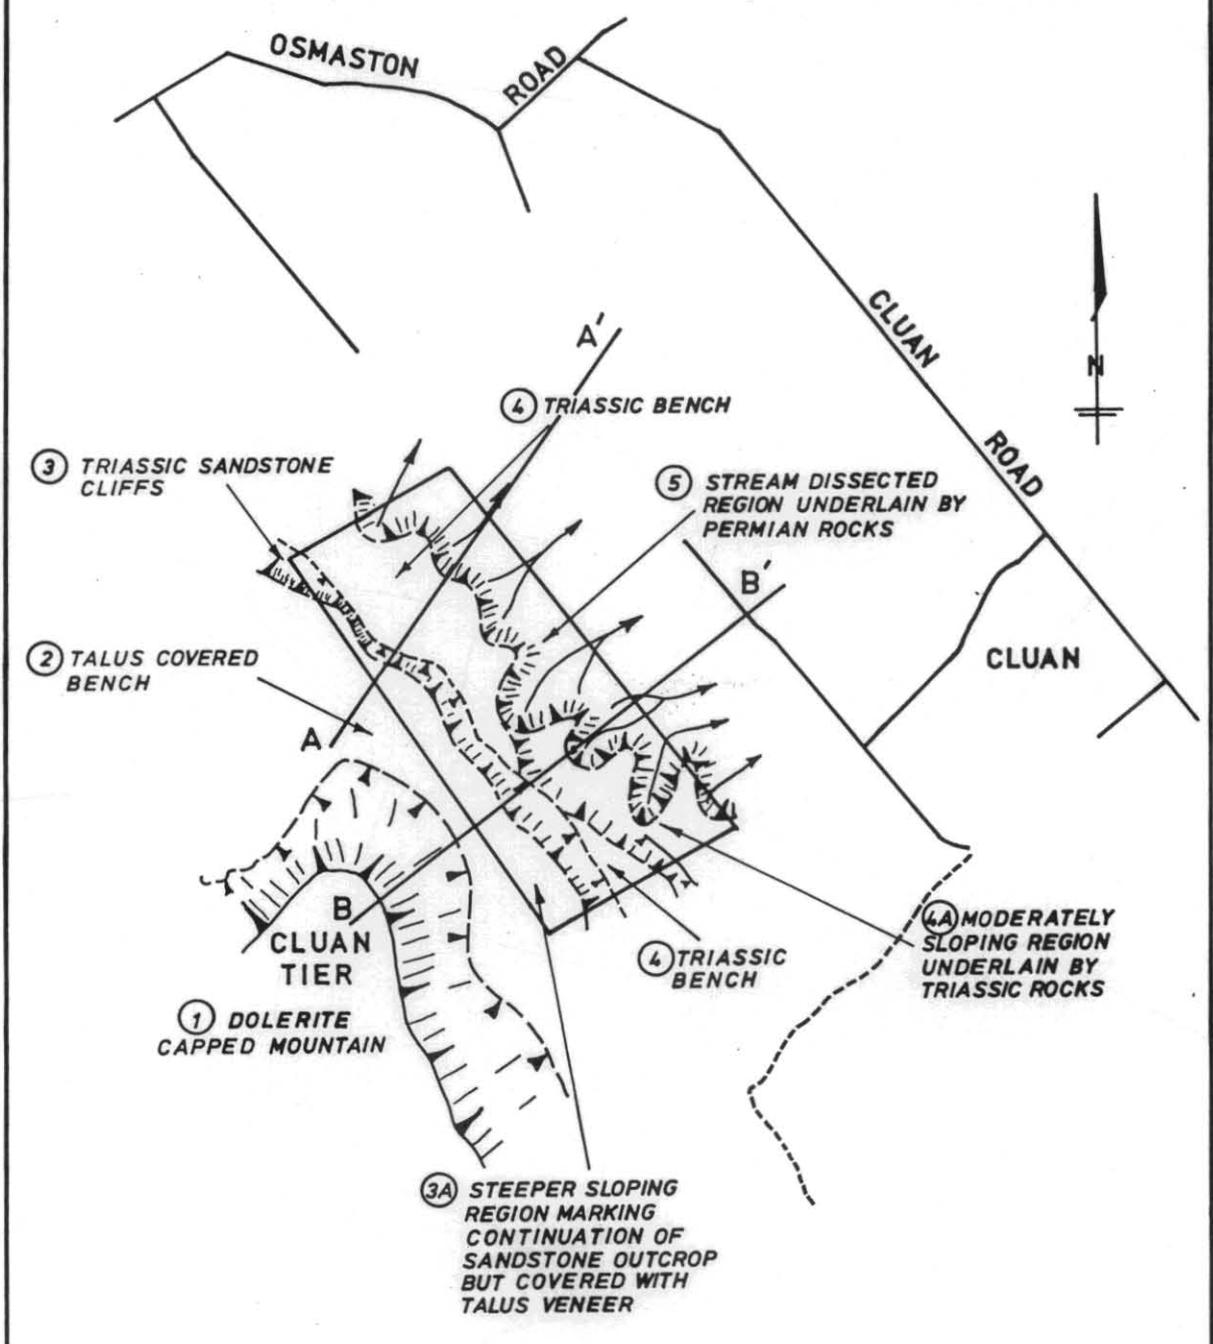
Fig. 1

The morphology of the area is shown in Figure 1 and is based on an inspection of aerial photographs. The morphology can be subdivided into 5 distinct units, described below and arranged in order of descending altitude.

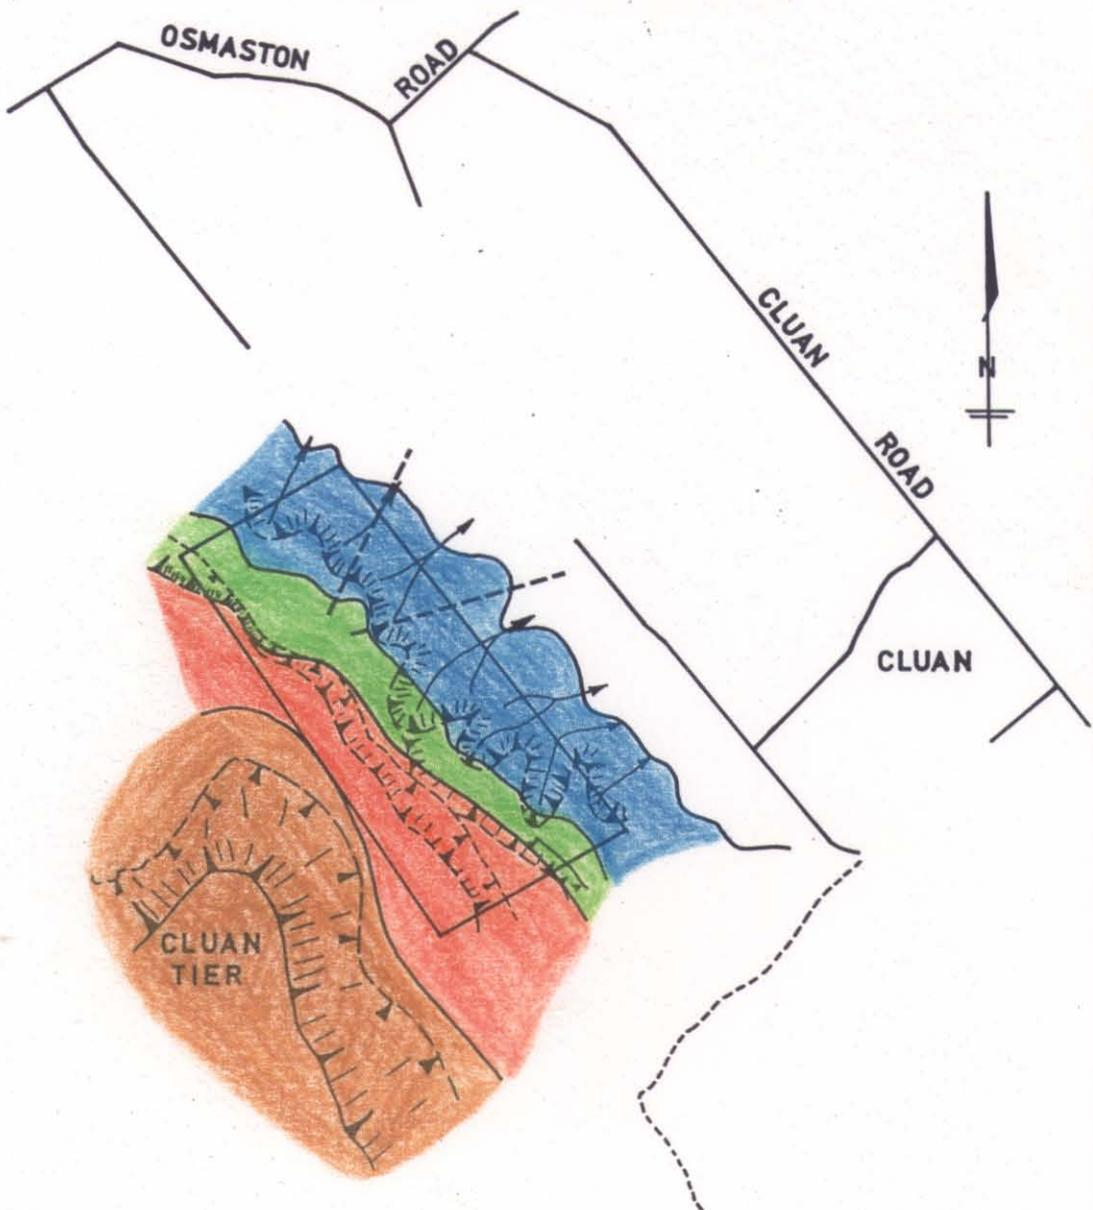
Fig. 2

The topography of the region closely reflects the underlying geology (figs. 2, 3). Morphologic unit 1 is underlain by *in situ* Jurassic dolerite, a remnant of an intrusive sill which has subsequently been exhumed by erosion and now caps the Cluan Tier peak. Underlying the dolerite is sandstone of Triassic age. The sedimentary rock can be clearly seen exposed in cliffs near the western corner of the area. This resistant band of sandstone undoubtedly underlies steeper slopes to the south-east in Unit 3A. It is considered that the talus covered bench (Unit 2) is a structural feature related to the top of the Triassic sandstone which has horizontal to subhorizontal bedding. Triassic sandstone and siltstone also underlies the topographic bench (Unit 4) and steeper slopes (Unit 4A). The Triassic sediments can be readily identified in the field as they are composed largely of medium sand-sized quartz grains. Where exposed the sandstone is often friable and has weathered to a clayey sand. The main West's Block access road passes below the Triassic sandstone cliffs (Unit 3) and traverses the Triassic bench (Unit 4). Triassic rocks are exposed in several road cuttings in this area.
