1982/22. Slope stability investigation of H.M. Archer's proposed subdivision at Windermere

W.R. Moore

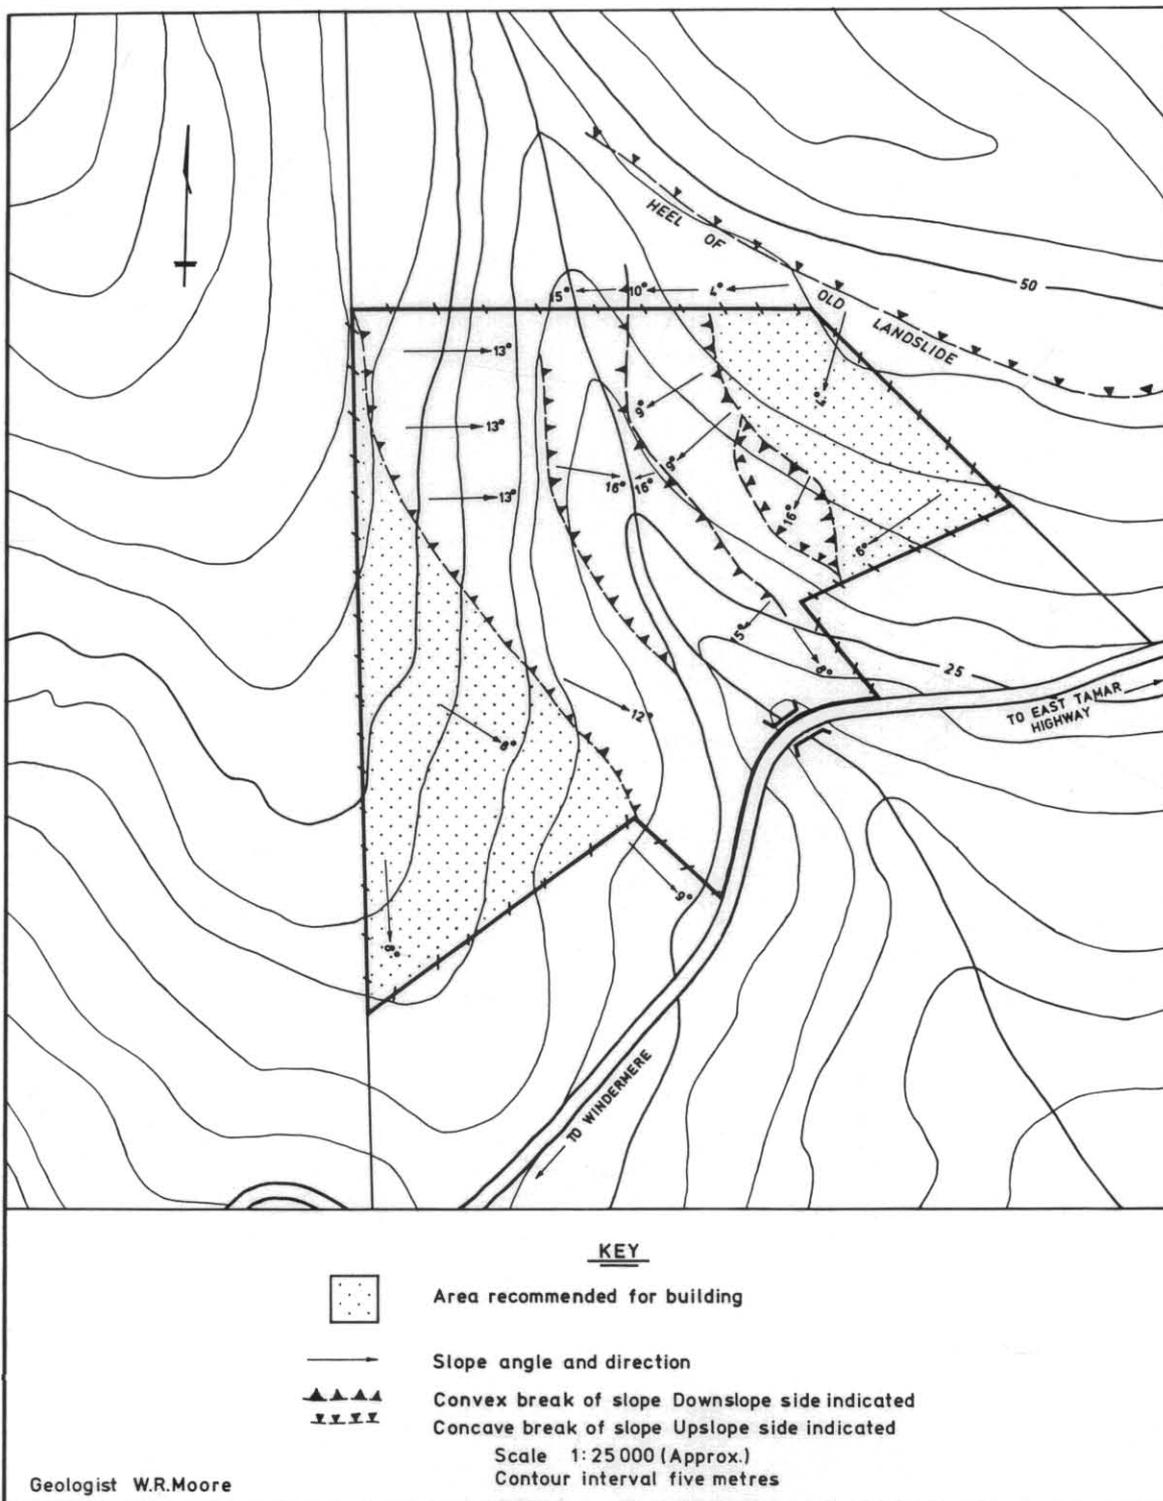
Figure 1. Slope map of proposed subdivision, Windermere.

The area covered by the subdivision comprises the two slopes bordering a small stream valley between two south-trending ridges (fig. 1). The valley is narrow, with the stream possessing little to no flood plain on the valley floor. Short steep slopes of 15-16° border the incised stream. These slopes flatten with a noticeable change in slope to long slopes of 12-13° on the western side of the stream and 8-9° on the eastern side (fig. 1).

On the eastern side of the stream the slopes are more complex because of the presence of a very old landslide, the heel of which is marked by a low bank outside the subdivision's boundary. This landslide is thought to have formed the relatively flat area with a low slope of 4°, and the 8-9° slope lower down the western side of the valley.

The most stable area in the western section is the spur ridge and its flanks, which have slopes of 8-9°. The slope steepens below this area, with slope angles up to 13°. Although there is no direct evidence of prior landslide movement, the potential for slope failure must be high, with slopes up to 13° underlain by clay. Previous slope movements are postulated in the area to explain the presence of dolerite and ironstone boulders on the ground surface; these may have been transported by old gravity slides from the Doctors Rise area to the north where dolerite and ironstone crop out. This explanation has been used elsewhere in the Tamar Valley to explain the presence of dolerite and ironstone boulders, but recycling from Tertiary gravel beds appears an equally likely explanation for their origin.

The most stable area on the western side of the stream is the west flank of the ridge, with slopes of 8°. This area remains a Zone III landslide zone area, but there appears to be enough suitable land for two building blocks on this area. The remainder of the western section of the subdivision is considered too steep to build on, with slopes of 12-13° steepening to 16° near the stream.

- (2) No future further subdivision of these blocks be permitted beyond the proposed three.
- (3) On each block one house be sited in the area outlined on Figure 1.

- (6) The position of the house on the eastern block be in the northern area of the block on the 4° slope area. The weight of the house and all water soakage should be kept to a minimum on this site, with only above ground pools recommended. As many trees as possible should be planted on the lower slopes of 8-9° and 15-16°.
