1982/24. Slope stability investigation of land near Second River,  
North Lilydale.

W.R. Moore

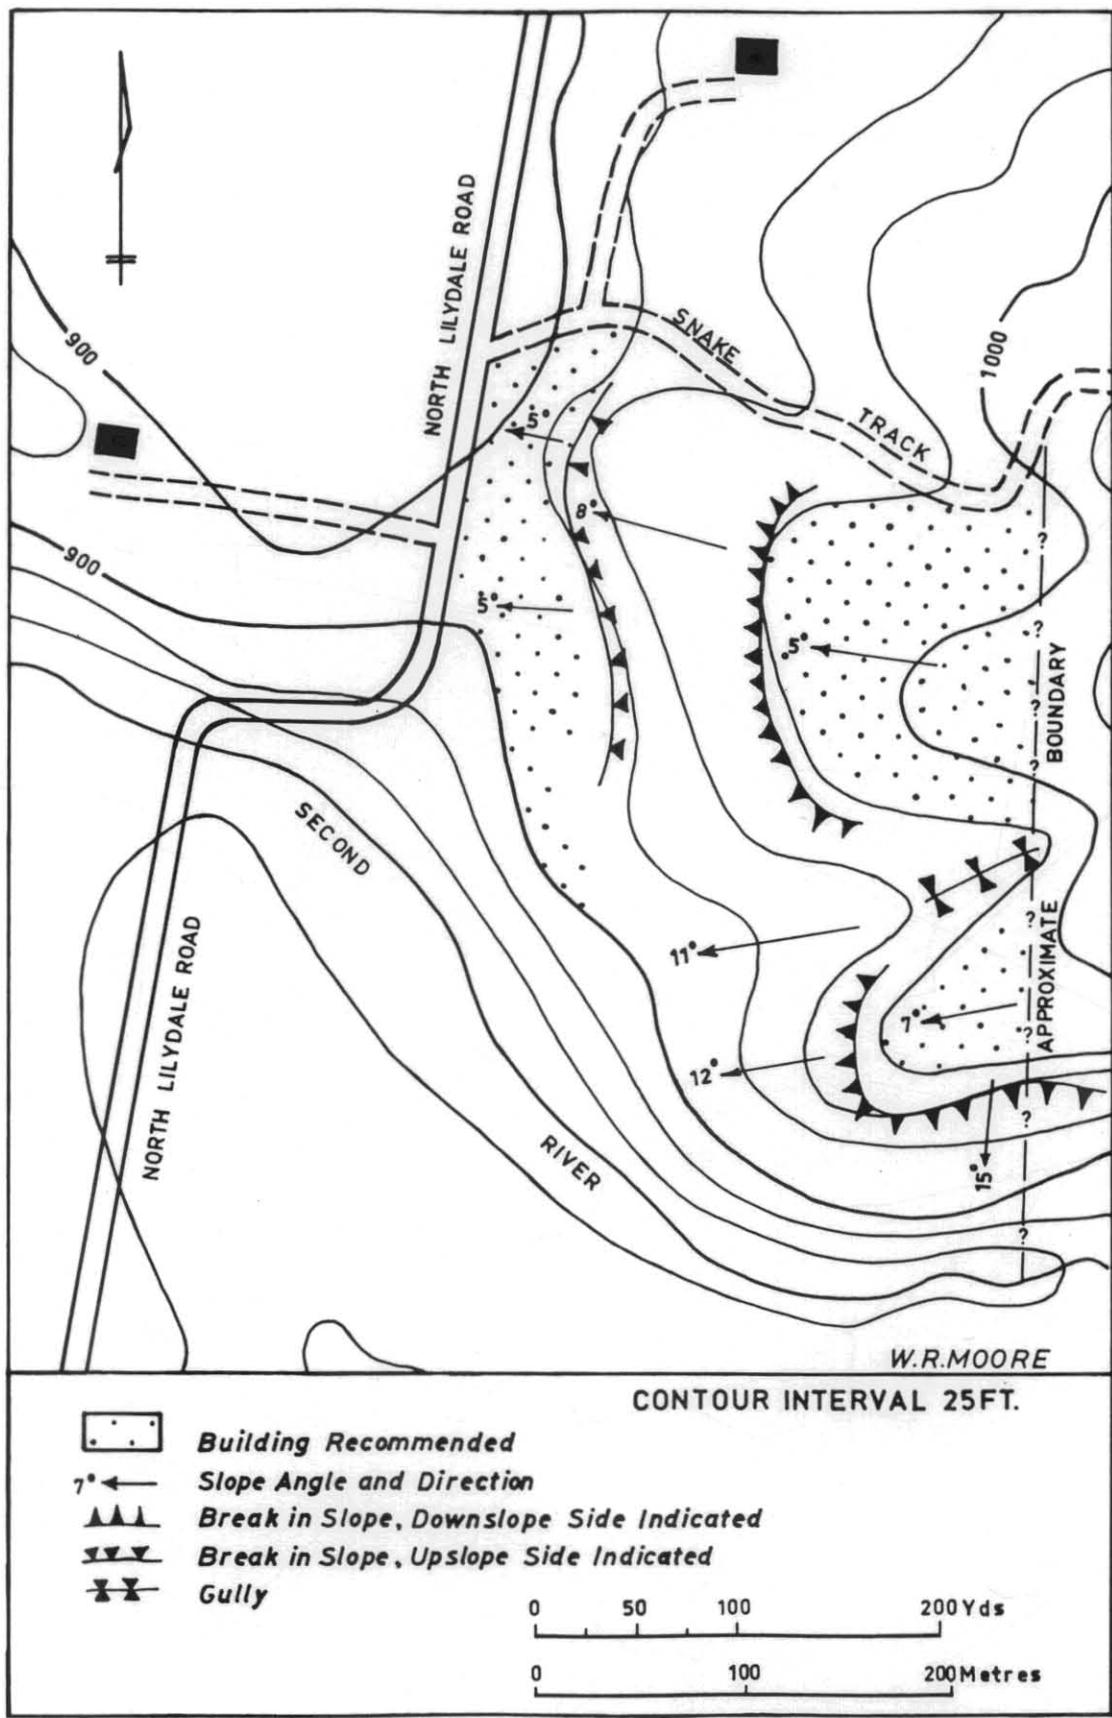
Figure 1. Slope stability investigation, North Lilydale.

The most stable areas on the block are the low sloping ground on the top of the two spurs and the narrow strip fronting onto North Lilydale Road; this is the upper section of a wide flat that extends west of the road. There appears to be little to no risk of slope failure in these three areas and building could be recommended.

There are some very steep slopes on the south-west corner of the block, with the southern slope of the spur in this area steepening rapidly to 15°. Even though this slope is short, it is too steep for building to be contemplated. The long 11°-12° WSW-trending slope on the same spur is considered to be marginally stable, and before any building could be recommended on this slope, the thickness of the clay above the rock and its properties would have to be investigated. If the clay horizon was found to be thin, a building could have its foundations bed to the rock and the additional risk of slope failure by building would be minimal. Before recommending building on this slope, a thorough subsurface investigation would be required.

Three areas of this large block are considered to be stable and suitable for building on the limited surface examination undertaken. These three areas are shown as areas on which building is recommended on Figure 1.

- (1) The house be sited on the low sloping area of the northern spur, near the middle of the area recommended.
- (2) The septic tank be placed on this spur and the overflow piped to the gully floor to the south.
- (3) If any future subdivision requires further building outside the areas recommended, a subsurface investigation would be required.
