1982/28. House cracking at Carinya Street, Blackmans Bay

D.J. Sloane

A house at Blackmans Bay has developed several brickwork cracks over the past five years. One crack in particular has developed along a vertical construction joint in the south wall brickwork. The crack is closed at ground level but gradually increases in separation to about 20 mm at roof level above the first floor.

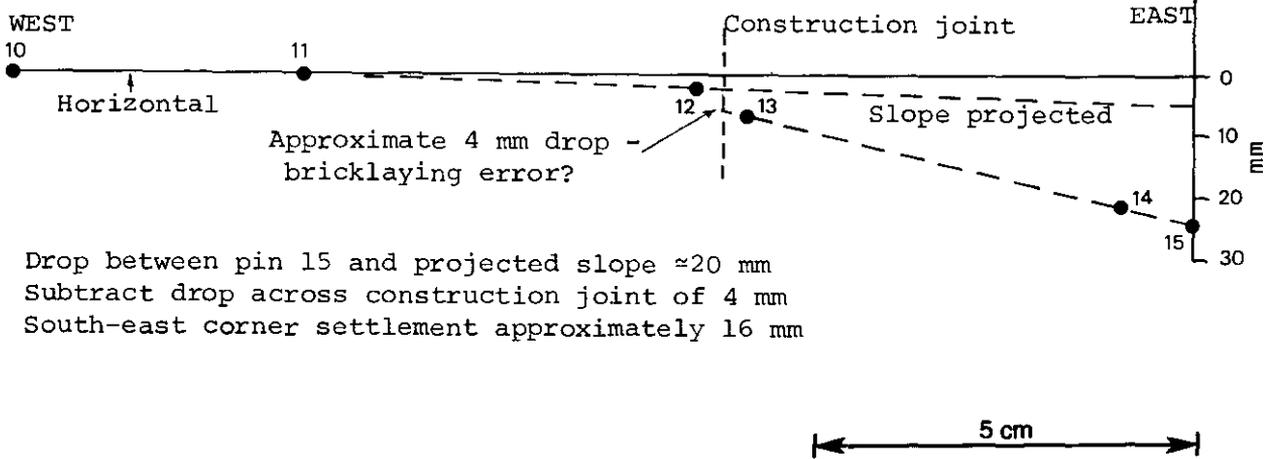
(a) South wall - first floor survey line

Drop between pin 15 and projected slope ≈ 20 mm
 Subtract drop across construction joint of 4 mm
 South-east corner settlement approximately 16 mm

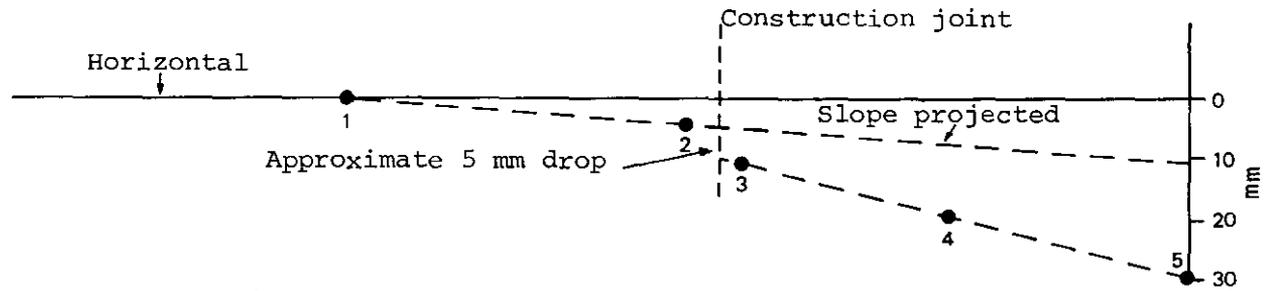
(b) South wall - ground floor survey line

Drop between pin 5 and projected brickwork slope ≈ 20 mm
 Subtract drop across construction joint of 5 mm
 South-east corner settlement approximately 15 mm

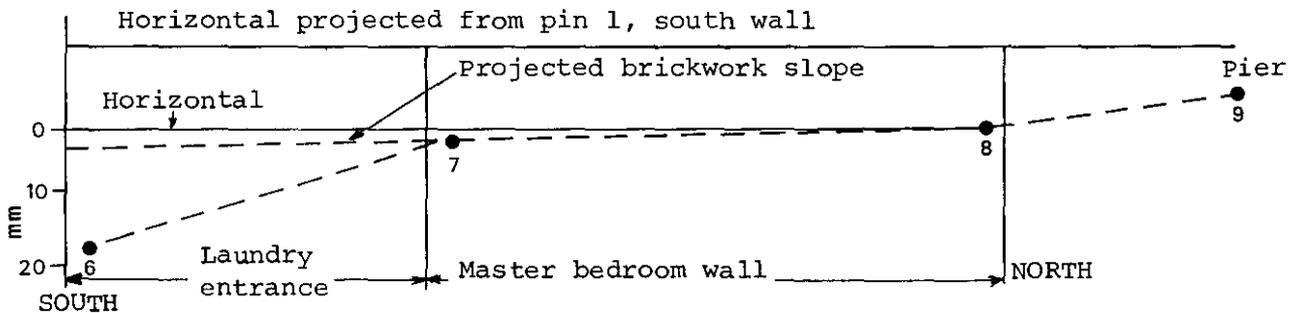
(c) East wall - ground floor survey line

Approximate drop of south-east corner (pin 6) from horizontal drawn along main section of east wall ≈ 16 mm.

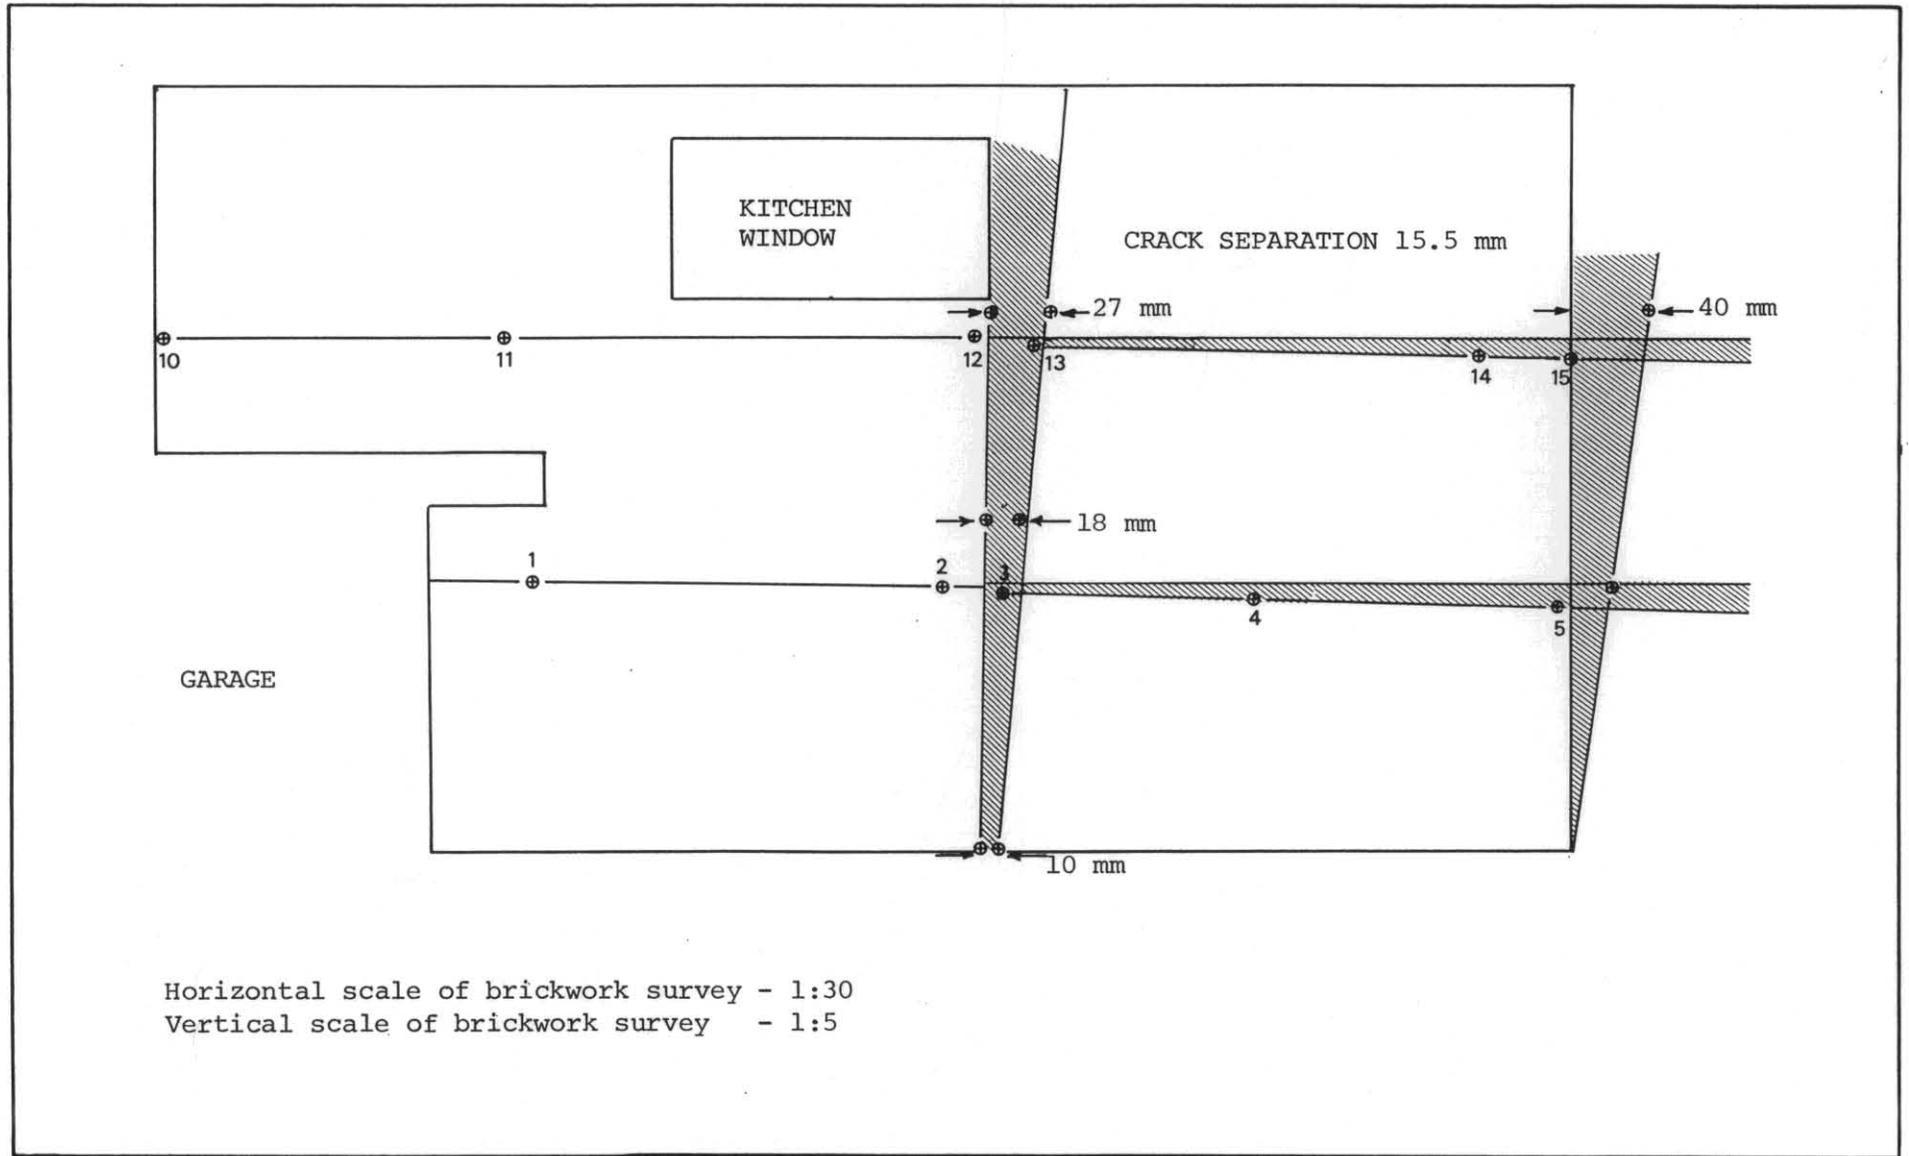
Figure 3. Diagrammatic representation of vertical and horizontal brickwork survey, south wall section.

main construction joint crack and also the south-eastern corner. The results are shown on Figure 3. Both sides of the main construction joint are off-vertical by varying amounts with displacement to the east. Measurements taken below the kitchen window (pins 12 and 13) indicate that the western side of the joint is about 7 mm off-vertical, with the eastern side about 25 mm off-vertical. Part of these measurements may be attributed to bricklaying error, but the magnitude of the measurements indicates that the wall on the eastern side has rotated to the east compared with the western section. The south-eastern corner of the building is about 40 mm off-vertical where measured at the first floor survey line, with displacement to the east. Part of this displacement is undoubtedly bricklaying error as the eastern part of the wall has remained intact, but there is a discrepancy of 15 mm in measurements taken at the construction joint to those taken at the south-east corner.

In summary, the main south wall construction joint shows a separation of 15.5 mm where accurately measured below the kitchen window, approximately 3.5 m from ground level. The gap reduces in width to closure at ground floor slab level. From this level, a brickwork crack propagates to the west, across to the WC drain pipe and down to foundation level (fig. 4). Foundation failure is likely to have occurred at this point. The construction joint appears to open and close seasonally by about 3 mm, closing during winter and opening during summer. The sides of this joint are not vertical and measurements indicate that the eastern side wall has rotated compared with the western side, the hinge point being located at foundation level close to the WC drain pipe.

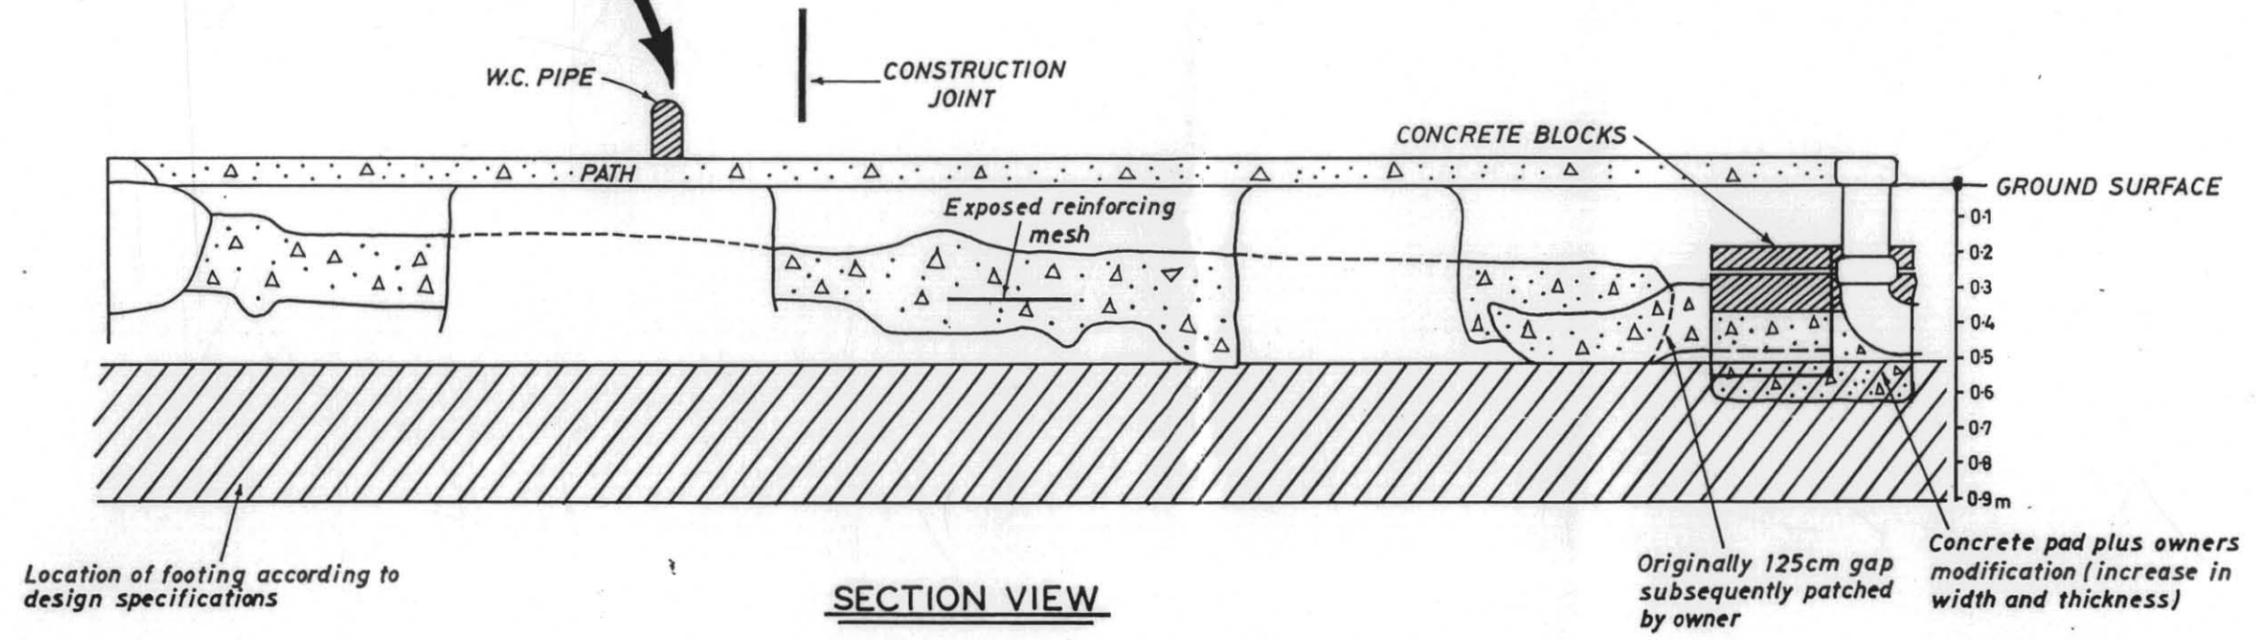
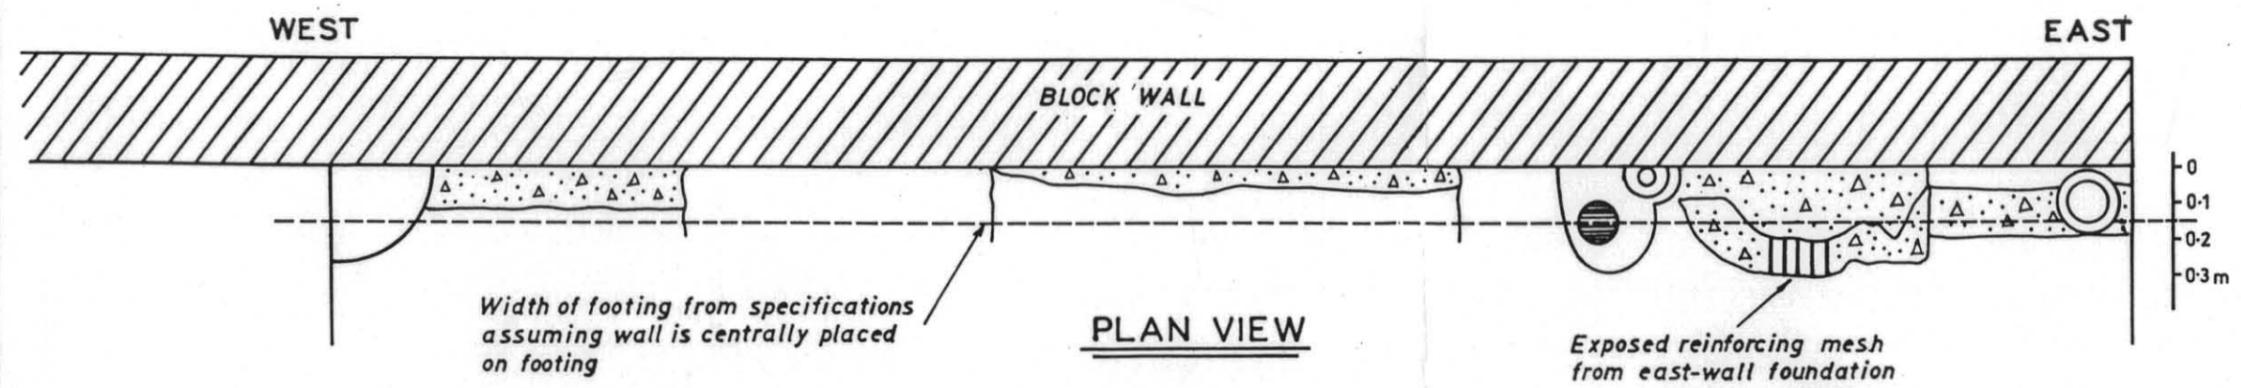
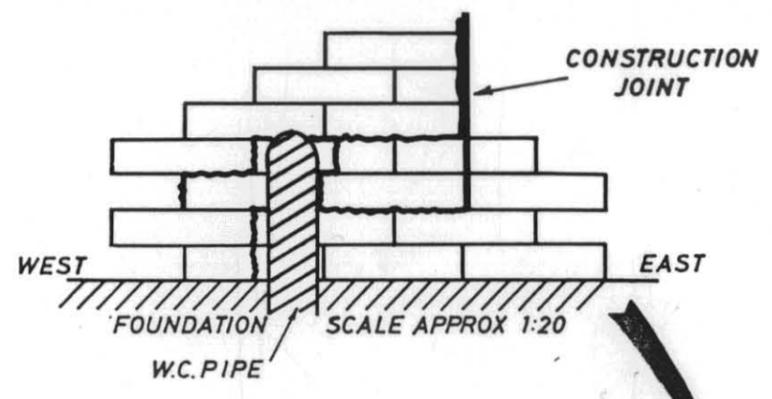
FIGURE 4.

The owner of the house has exposed a large part of the south wall foundations. These have been carefully measured and are shown in Figure 4. The house plans (fig. 1) indicate that the footings along this wall should be type 'A' - 2'0" (0.6 m) wide by 15" (0.38 m) deep with No. 6 trench mesh top and bottom. The foundations vary in thickness from 0.14 m to 0.33 m, with a large proportion being approximately 0.2 m thick. If it is assumed that the concrete block walls are centrally placed on the foundation, then the foundation should project 6" (0.15 m) out from the base of the wall.

Most of the foundation does not project this far and in the area of the WC drain pipe there is no projection at all. Some of the foundation has been removed in order to place the drain pipes, and initial footing damage may have been caused in this area, especially as the main construction joint crack propagates across to foundation level at this point. The foundation is also thinnest at this point. Reinforcing is exposed and rusting in the central part of the wall and also at the intersection of the east wall foundation. Only a lower layer of trench mesh can be seen and using a small pipe and wire detector only this layer can be detected. A concrete saw cut is needed to confirm that only one layer is present. The foundation under the south-eastern corner has been constructed of concrete block, with a small pad of concrete below. At the junction of the concrete block part of the foundation to the *in situ* poured reinforced concrete section, a gap approximately 120 mm in width had been left with trench mesh also exposed. This gap has subsequently been filled by the owner who has also increased the width of the footing.

The plans also specify that the footings should be at a minimum depth of 3'0" (0.9 m) if they are on clay, and the footings are shown at this depth on the plans. The footings are in fact only at about half this depth.

The foundations of the south wall have not been built to design specifications and are inadequate compared with current standards. They are not as wide, about one half as thick and about one half as deep as specified. It also appears that the top layer of trench mesh has been omitted. The footings are not continuous along the southern wall with the last 0.75 m of the eastern corner largely composed of concrete blocks. Reinforcing is exposed and rusting in some areas. The foundation construction is undoubtedly related to house damage observed.

It is suggested that a structural engineer be consulted as to the best remedial methods to restore the stability of the south wall. It is likely that the least expensive solution is underpinning the south wall foundation. From the investigation, the most suitable founding materials occur at a depth of about 1.7 m, at which depth seasonal moisture variations would be small. Once the wall is underpinned and stabilised other associated cracks etc. can be cosmetically repaired. All earthenware drainage pipes should be checked for leakage or possibly replaced by flexible PVC pipes. An area of paving should be placed along the south and eastern walls to prevent ingress of water adjacent to the foundations. Further monitoring of the construction joint and horizontal survey lines should continue. Seasonal moisture profiles should also be determined.

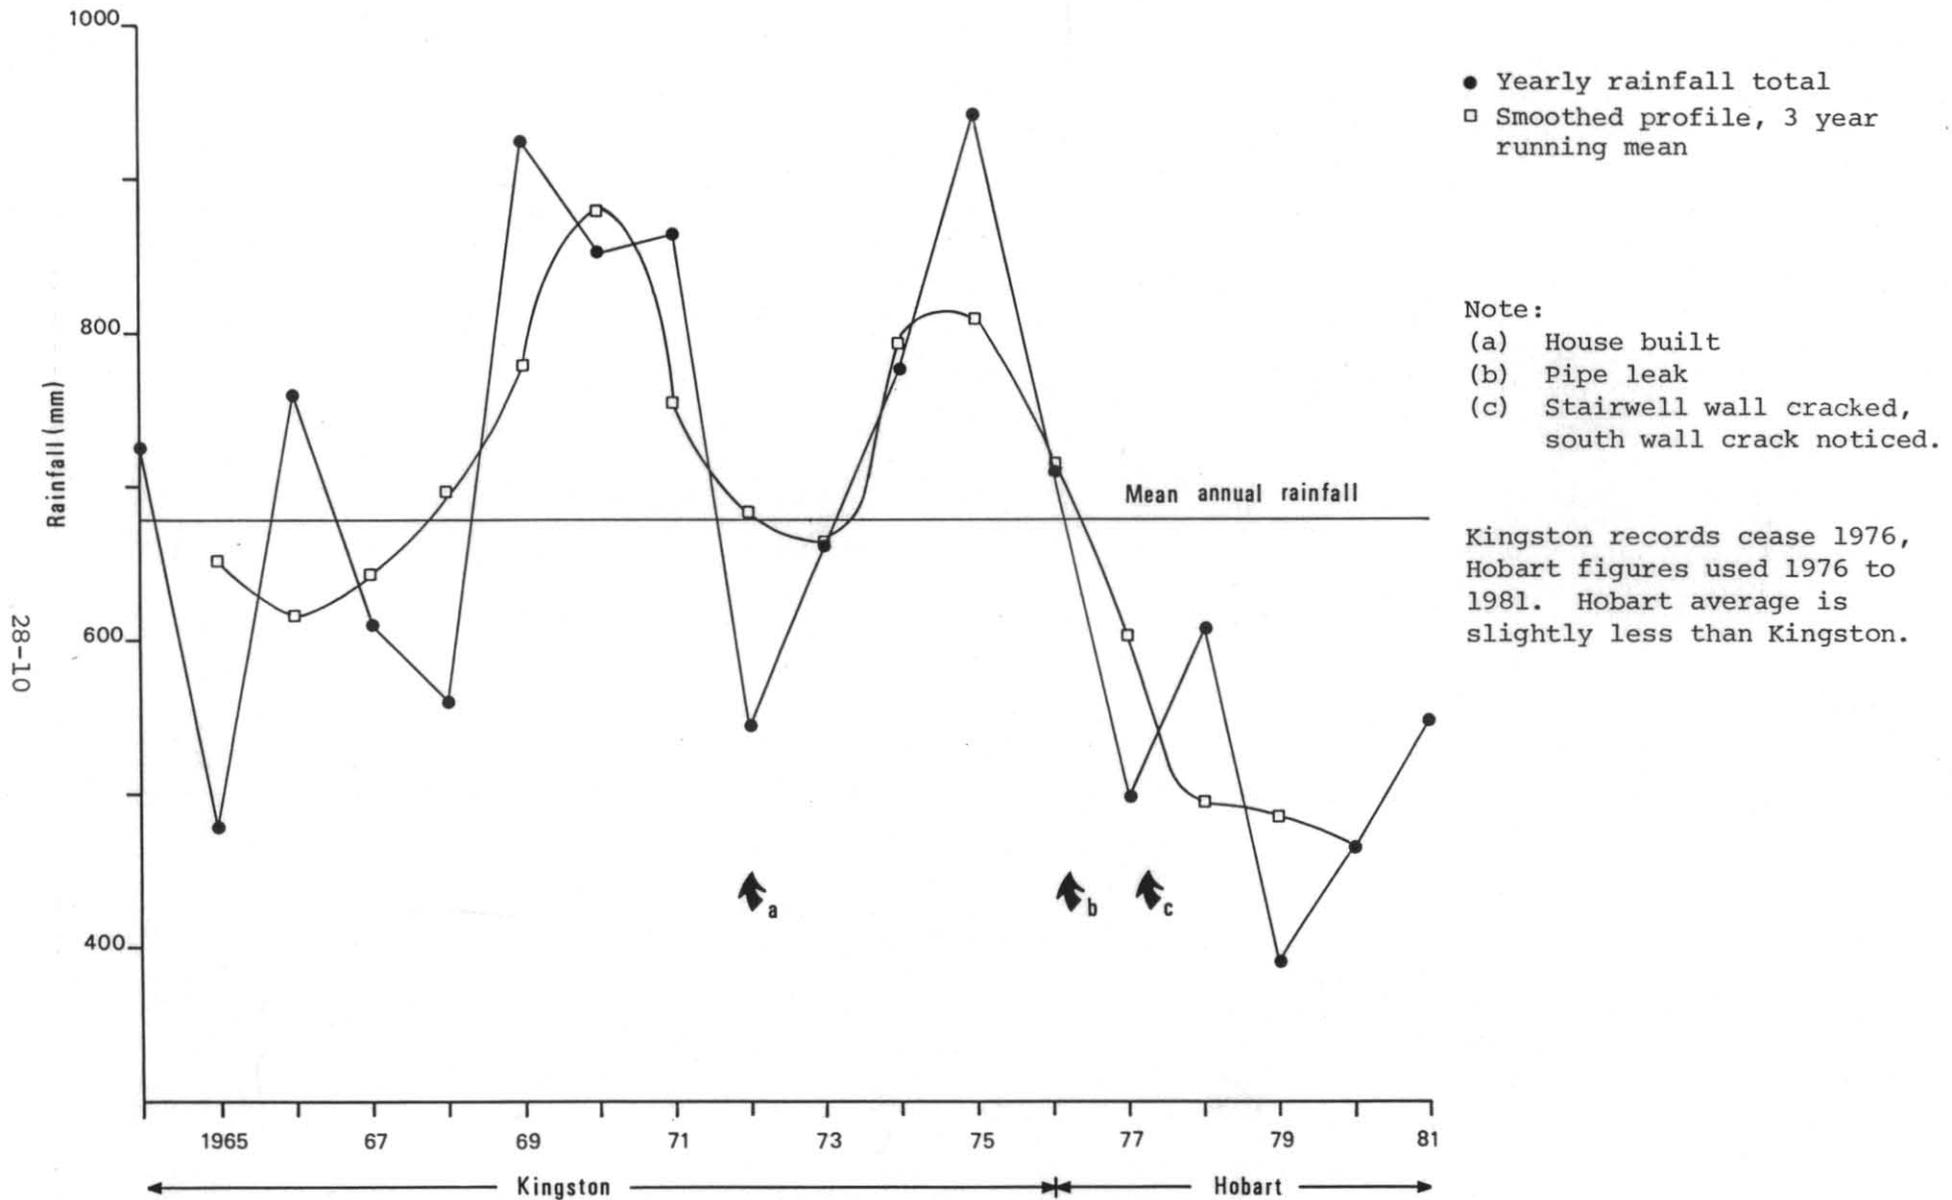
Figure 5. Graph of annual rainfall, Kingston - 1964 to 1981.

Dry conditions have prevailed over most of Tasmania, especially the south-east, for the past six years. Rainfall figures for Hobart show that the past three or four years have been about 150 mm below the average of around 670 mm (fig. 5). Figure 5 also shows a smoothed curve generated by running means over a three year period which indicates broad rainfall trends clearly. This dry period has resulted in numerous requests for investigations of cracked buildings by this Department and others. These problems are undoubtedly related to dry conditions and their effect on expansive soils. These climatic conditions are probably a major factor in the house cracking at this site as most problems were initially noticed in the summer of 1977, at the beginning of the dry spell, despite the fact that the pipe leak under the slab occurred at the beginning of 1976.
