1982/32. Rock slope stability at the Giblin Street quarry

R.C. Donaldson
A.T. Moon

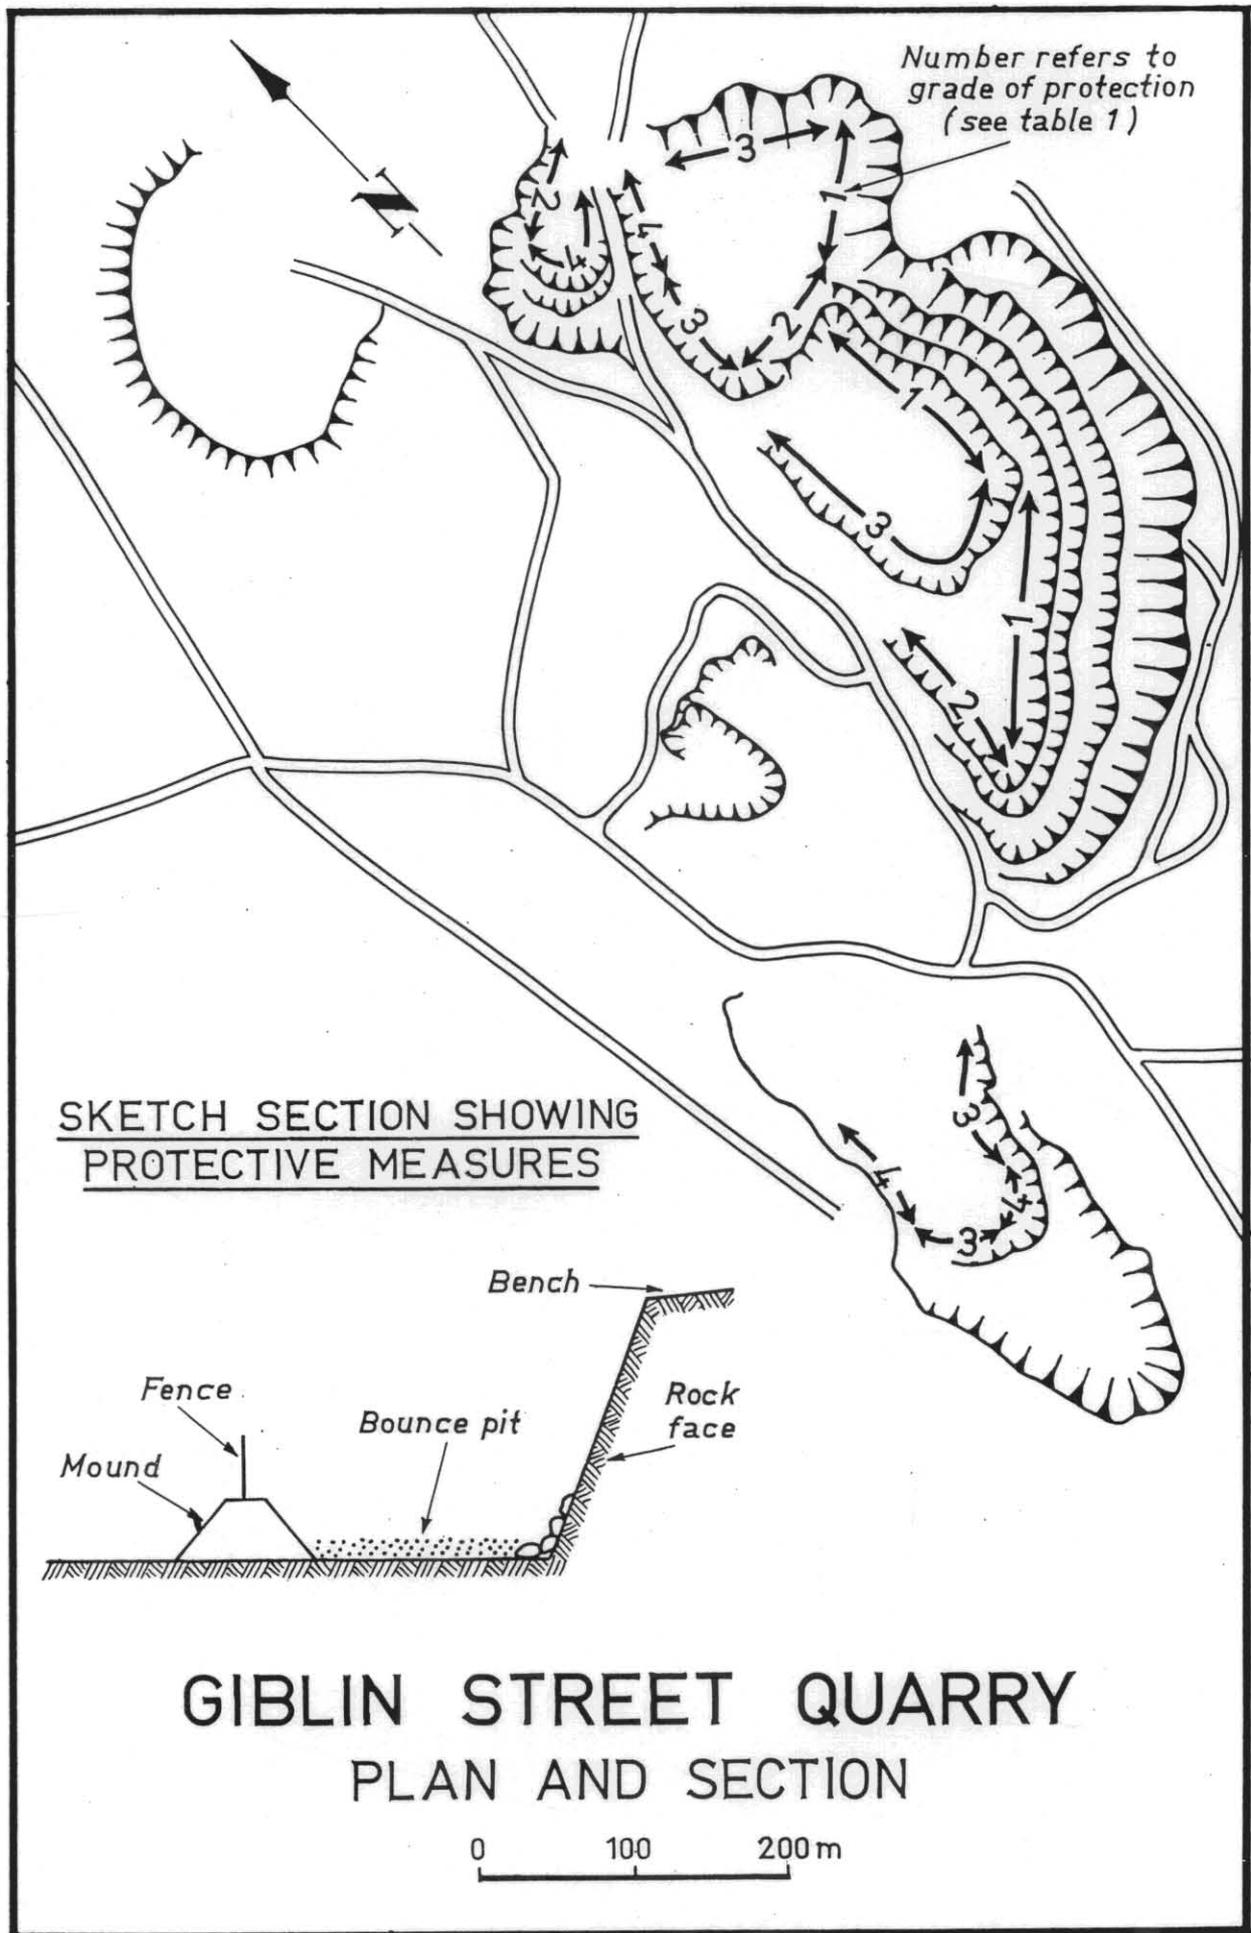
Three grades of protective measures are given in Table 1, based on the height of the protective mound and the distance of the mound from the face. The fourth grade refers to rock faces which do not require a protective mound. The grade of protection required for different parts of the quarry is shown on Figure 1. This preliminary assessment is provided for planning purposes to indicate our opinion of the type of protective measures required. The final choice and details of protective measures will depend on the specific development proposed.

It is recommended that a structure comprising a bounce pit and a rock and earth mound be placed along the base of the major faces. This method should prove to be relatively inexpensive (due to the availability of materials on site), simple to construct, and easy to maintain.

It is envisaged that the bounce pit should contain between 0.3 m and 0.5 m of sand, gravel, loose soil, or any energy absorbing material. The protective mound could be constructed from the boulder size material present in the quarry and covered with soil. A typical section of the protective measures proposed is detailed in Figure 1.

A fence on top of the mound would be necessary to prevent public access to the bounce pit and provide a final line of defence against small rock fragments.
