1982/33. Preliminary site investigation of a proposed reservoir at Heybridge, north-west Tasmania

R.C. Donaldson  
W.R. Moore

The North West Regional Water Authority requested the Department of Mines to advise on the geological suitability of a proposed reservoir site at Heybridge, north-west Tasmania [DQ157517]. Initially, the Authority indicated two sites that were under consideration, but required that only one of these be investigated.

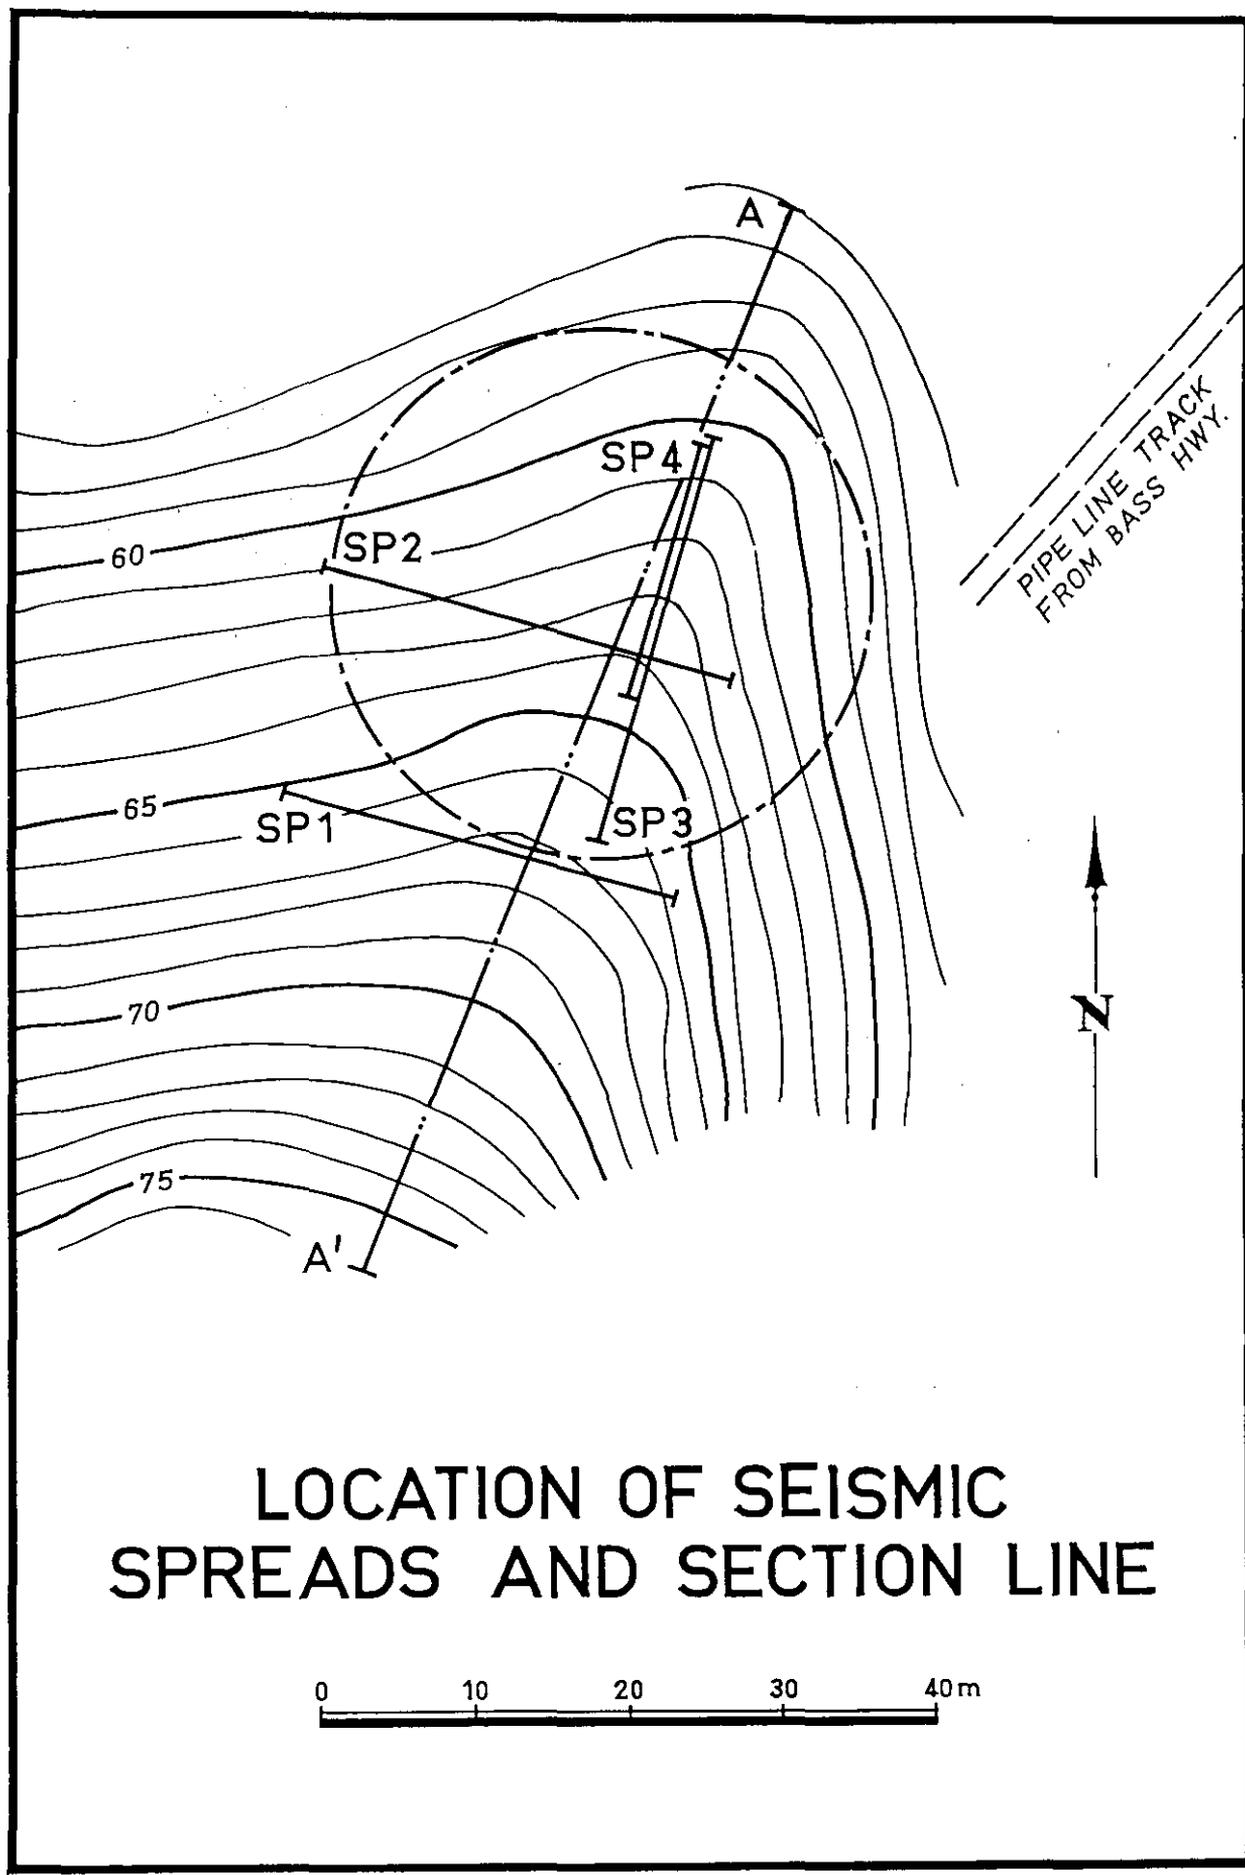
Figure 2

Four seismic spreads were fired using a twelve-channel Nimbus seismograph. The spreads were fired from both ends using gelignite and seismic boosters with electric detonators. Geophone spacing was nominally set at 2.5 m but reduced to a combination of 1.0 m and 2.0 m intervals for the weathering spread. The location of the spreads is shown on Figure 2.

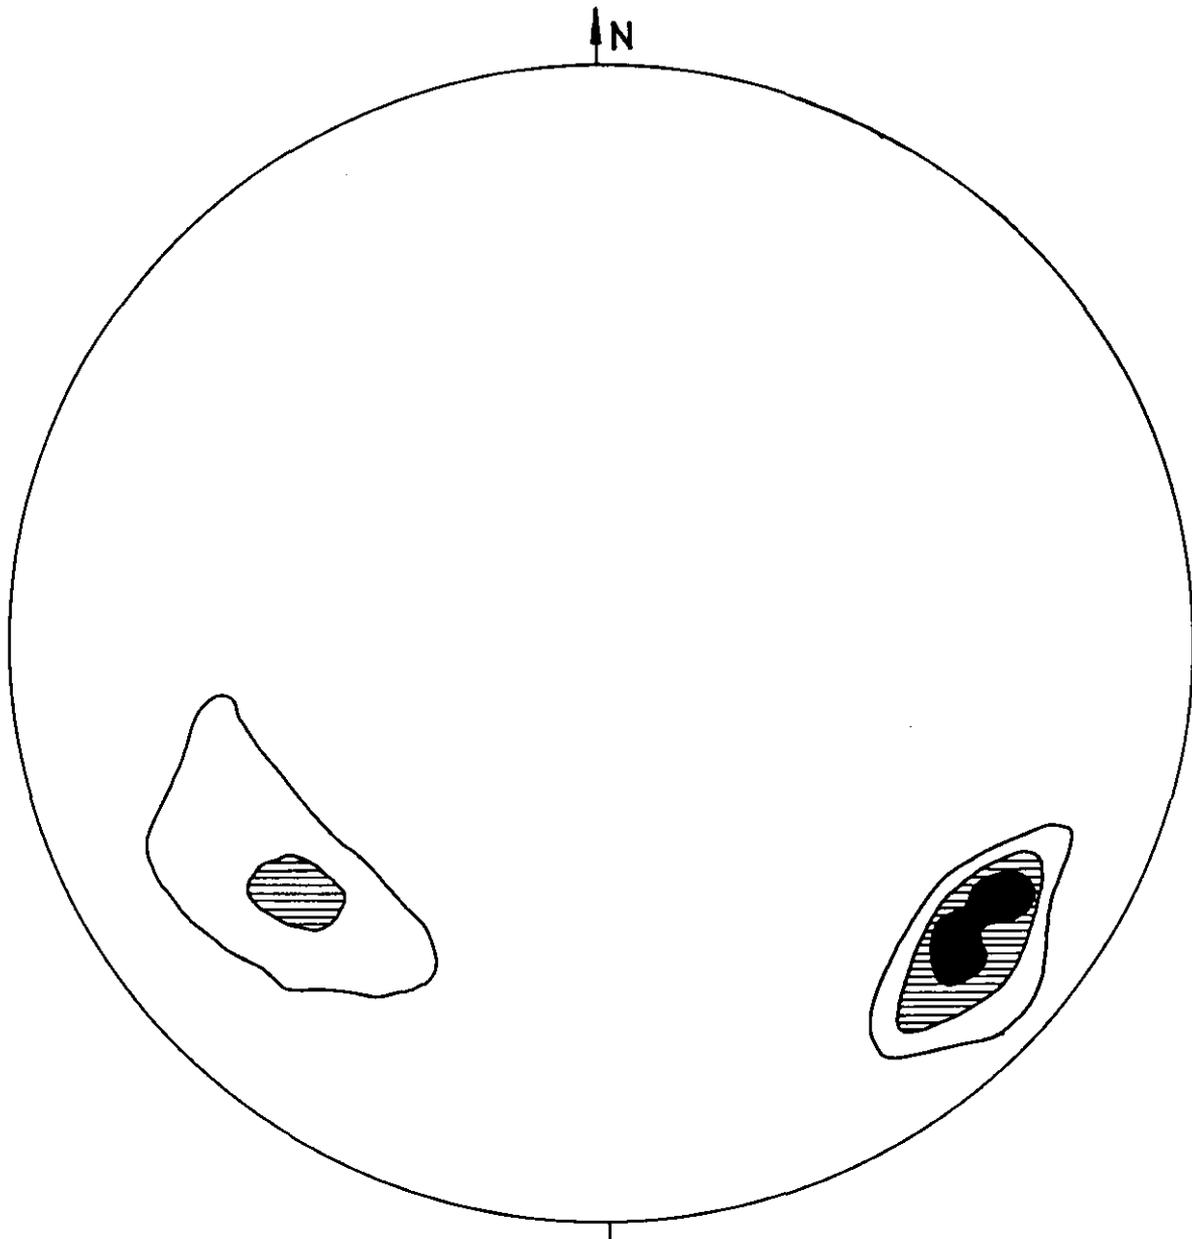
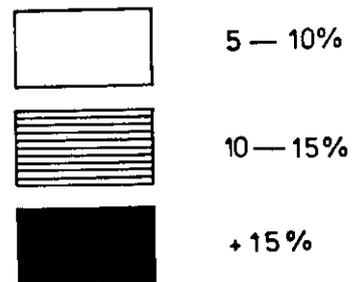
FIGURE 3.

A strong concentration of bedding plane (+ 15%) poles are present on the polar equal area stereonet plot (fig. 3). Bedding planes dip steeply in a NW to NNW direction with bedding dip direction ranging between 323° and 293° (M) with a strong concentration of bedding dip direction between 300° and 315° (M). The dips of the bedding planes range from 65° to 78° with a marked concentration between 65° and 75°.

Joint planes measured also show a strong concentration with high dips and dip directions in the NE and ENE directions. Compared with the bedding planes, the joint planes cover a wide range of both dip and dip direction, with dips ranging between 55° and 70° and dip directions between 028° and 080° (M). A concentration of joint poles of 10 - 15% is present with a joint dip direction range of 045° to 055° (M) and a dip range of 55° to 60°.

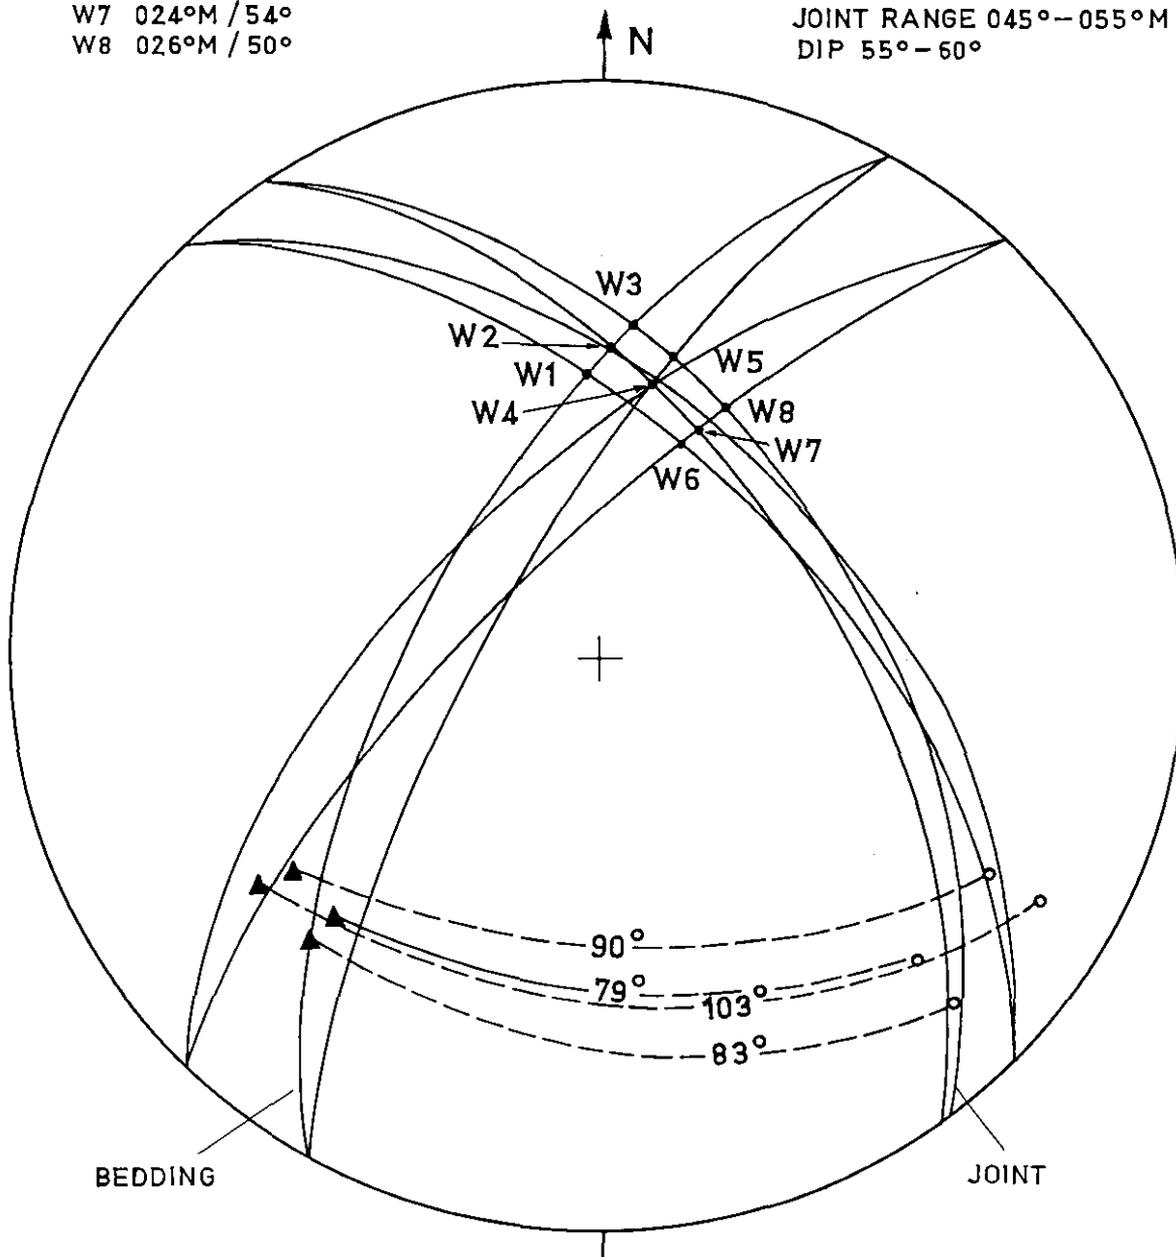
FIG.4

These two widely spaced concentrations of the discontinuities, the major joints and the bedding, make for potential wedge failures. The dip direction and dip concentration planes of both the bedding and joints are plotted as great circles on an equatorial equal area stereonet (fig. 4) and the intersection of these two sets of great circles indicates the range of potential wedge failures. The direction of the intersecting line and the plunge of these two planes are measured and listed (fig. 4).

It is along the line of intersection of the two planes or its direction of movement that the potential wedge will slide, given that the plunge of this line of intersection is less than that of the face angle of the cutting or any proposed rock face. With the intersection

plunge angle being less than the face angle, the wedge will daylight and fail given that this plunge angle is greater than the friction angle of the rock in question (Hoek and Bray, 1977). The friction angle for the Burnie Formation quartzite and argillite is between 32° and 35°. With a designed face angle less than the plunges of these lines of intersections the potential for wedge failure is eliminated.

The potential wedge failures predicted from the statistical analysis of the measured section (figs. 3, 4) fit very closely to the great circle plots of the observed wedge failures on the cutting face. All the plunges of the lines of intersections are less than the face angles of the Bass Highway cutting, hence the failures (fig. 5). For simplicity only one strike direction of the face was plotted, that of the eastern end, as it approximates closely the likely direction of the face at the proposed reservoir site. The higher face angle of the road cutting is achieved without any noticeable increase in the number of wedge failures at the west end of the cutting because of the swing in the face towards the west-south-west. This swing in face direction would eliminate the low angle plunging wedges numbered W<sub>2</sub> and W<sub>4</sub> of Figure 5. These two wedges would not daylight on the face at this direction.

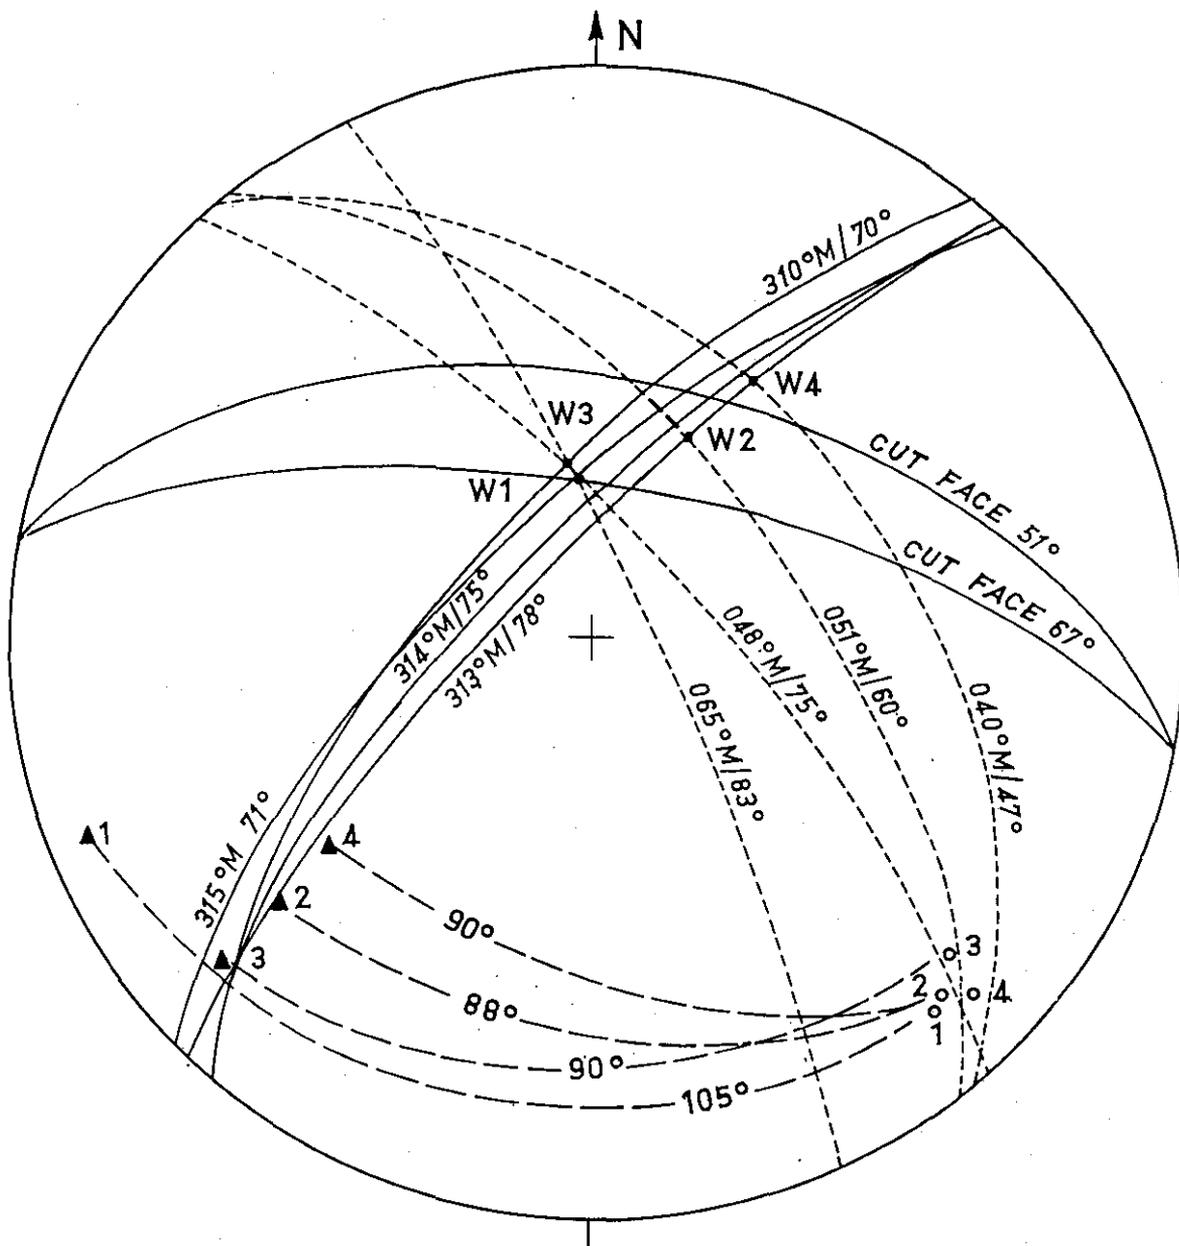
FIG. 5

Given that the face direction approximates the east-west direction of the road cutting, potential wedge failures are possible on faces cut as low as 42°. Wedge failures present on the existing road cutting indicate from the plunge of their lines of intersections that the face would have to be cut at an angle of 45° for these failures to be eliminated.

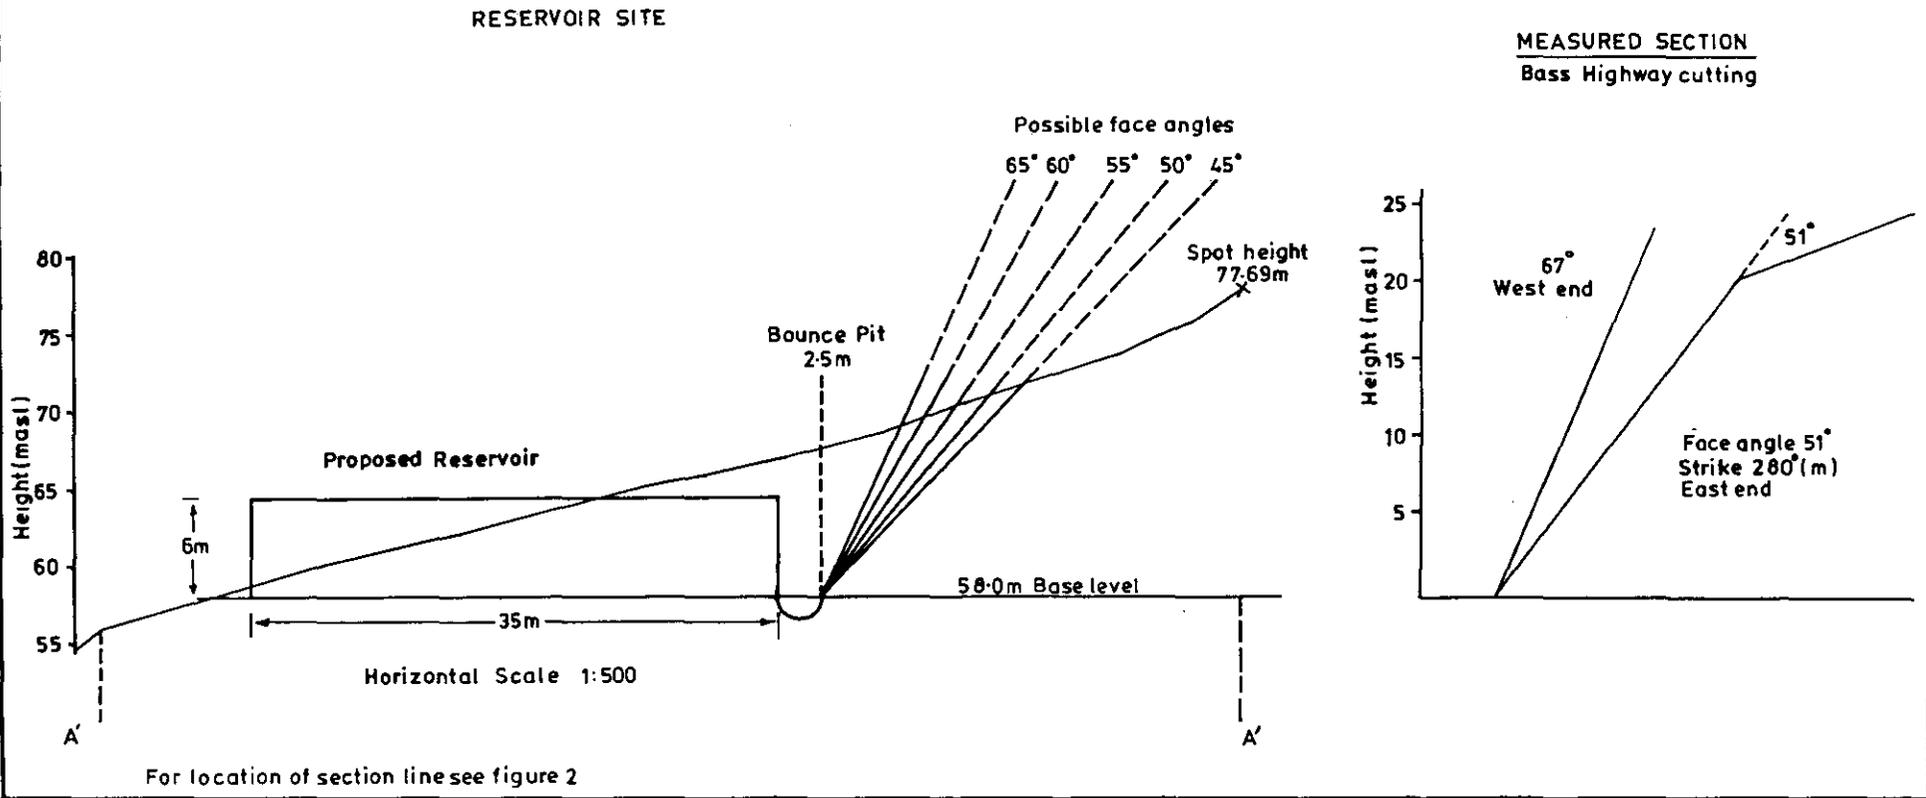
Figure 6

From the cross-section line A' - A' drawn from the contour map (fig. 2), the amount of material required to be excavated to lower the face from a 65° to a 45° angle will be increased by approximately 20%. Therefore the cost advantage by increasing the slope angle is considerable, but this must be counter-balanced by the increase in the potential risk.
