UR1982-38

1982/38. Slope stability investigation of a proposed subdivision at Windermere

W.R. Moore

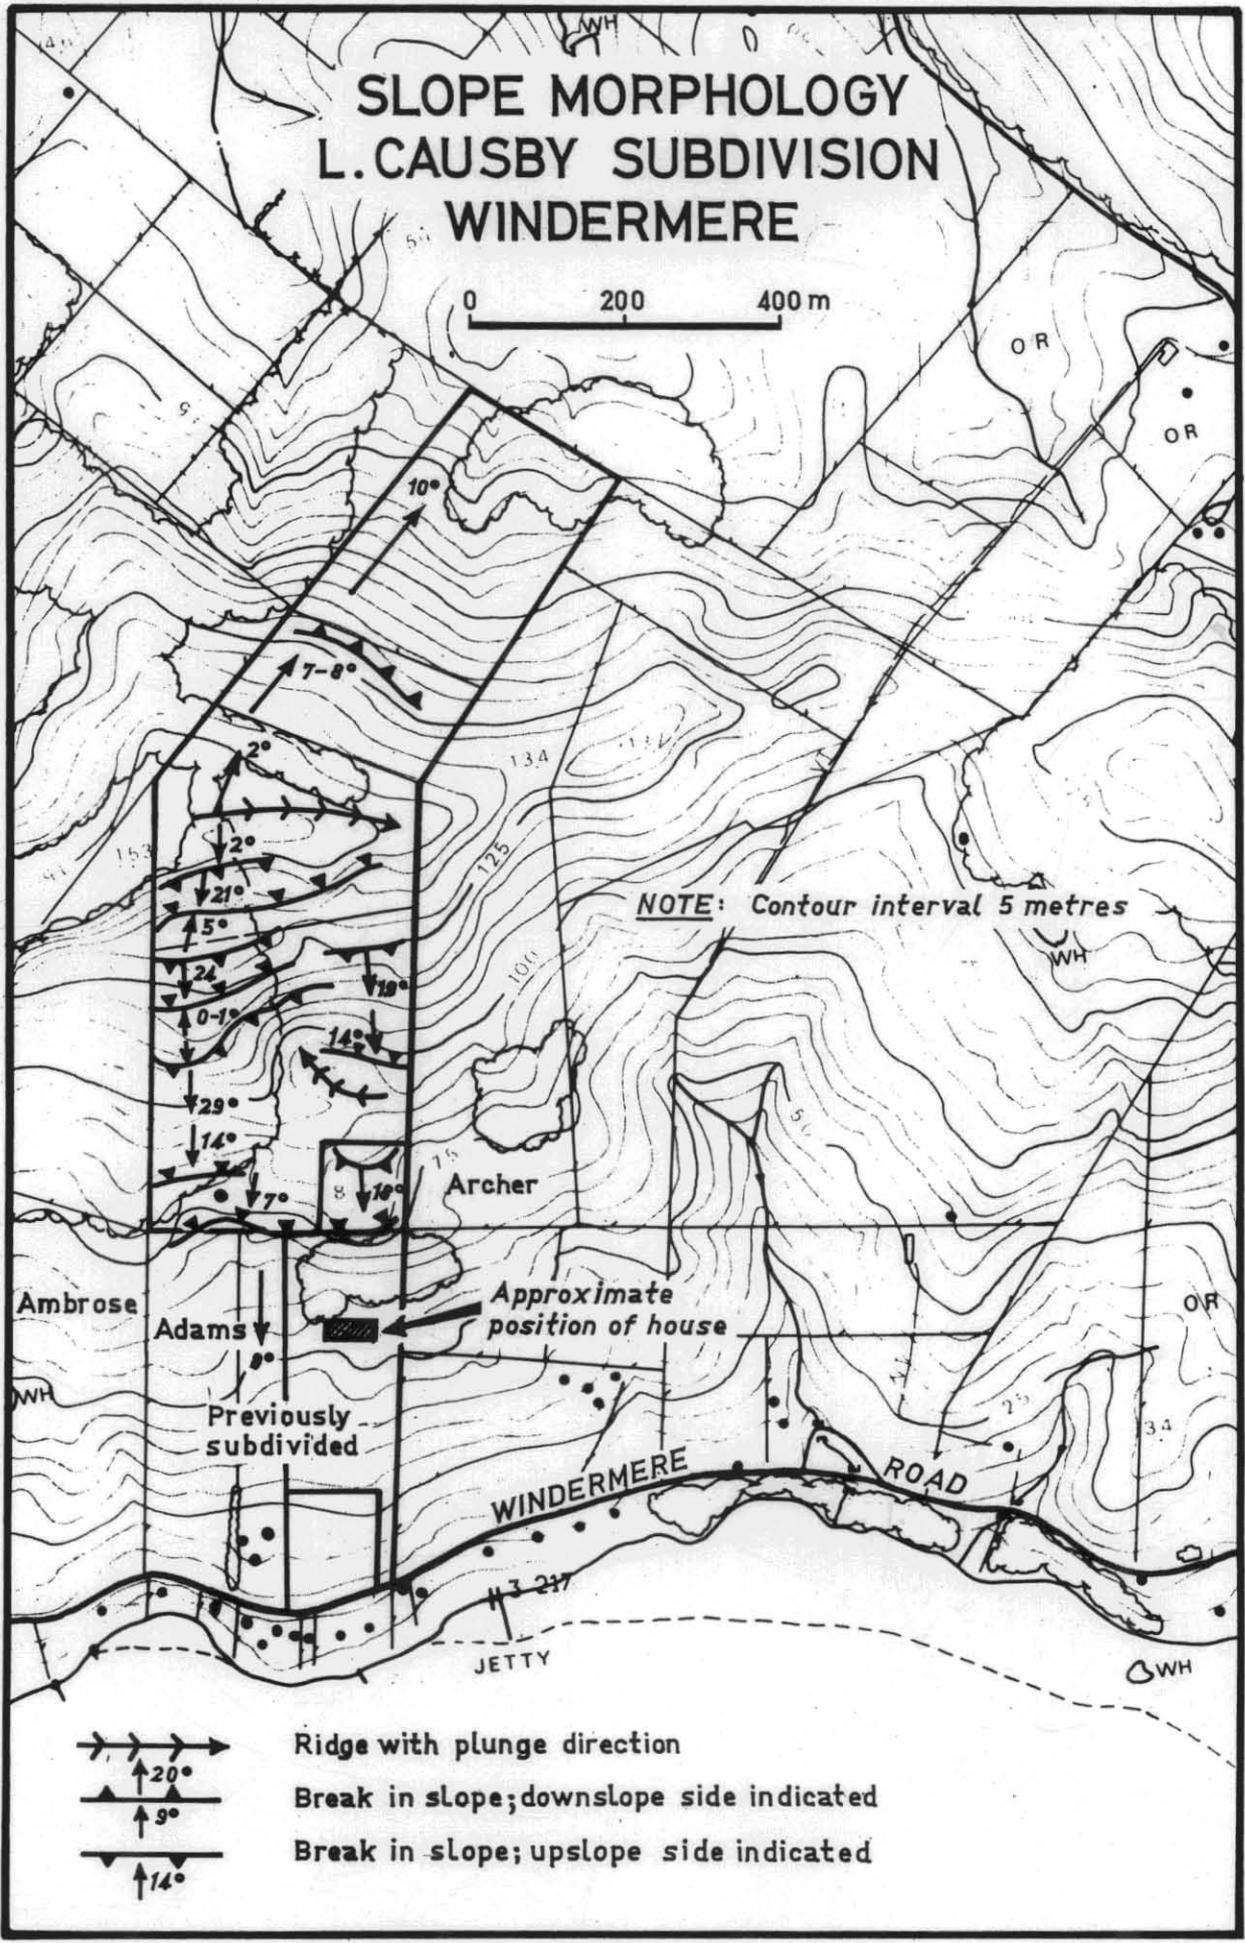
Figure 3.

Towards the centre of the block is a broad and flat east-west trending ridge with 2 - 3° slopes on the south-eastern and north-eastern margins (fig. 3). This ridge reaches an altitude of 155 m and is an outlier of the Gaunts Hill ridge one kilometre to the north-west.

The south side of the ridge ends with an abrupt steep scarp of 21° at the block's western boundary. This scarp becomes less noticeable eastwards, flattening and finally disappearing towards the eastern end of the ridge. The southern slope is a complex series of steps, composed of short steep scarps and narrow flat terraces at the base of the scarps. The scarps are steep with measured slopes of 19 - 29°. Slope inversion of up to 5° occurs on the flats at the base of the scarps, but the overall slope of the flat terraces is 1 - 2°.

These steps continue to the southern boundary of the block where the slope of 14° flattens to 7° near the water hole. Outside this boundary a break in slope occurs on the neighbouring block, with long slopes of 7 - 8° to Windermere Road. The steps are better developed on the western side of the block and some appear to merge towards the eastern side of the block. In the south-eastern part of the block is an isolated well developed, flat ridge and step with a 19° slope on the south side.

On the southern slope basalt boulders have slumped and have been transported downslope by either a series or one very large old landslide, to form the existing talus slope with its stepped topography. There is no evidence of failure on the north-eastern slope. No talus deposits were seen and the few basalt boulders and their smaller size, and poor outcrops of clay, indicate that the area is underlain by clay of the Launceston Beds. It is unlikely that the basalt flow ever extended northwards over this area.

The presence of a series of scarps and the inversion slopes of the terraces indicate to the writer that the talus slope failed as a large multiple type of landslide. This single failure slide hypothesis appears more likely than a series of small failures causing the basalt ridge to retreat. Stevenson (1974) observed a very large failure on Ambrose's block to the west.

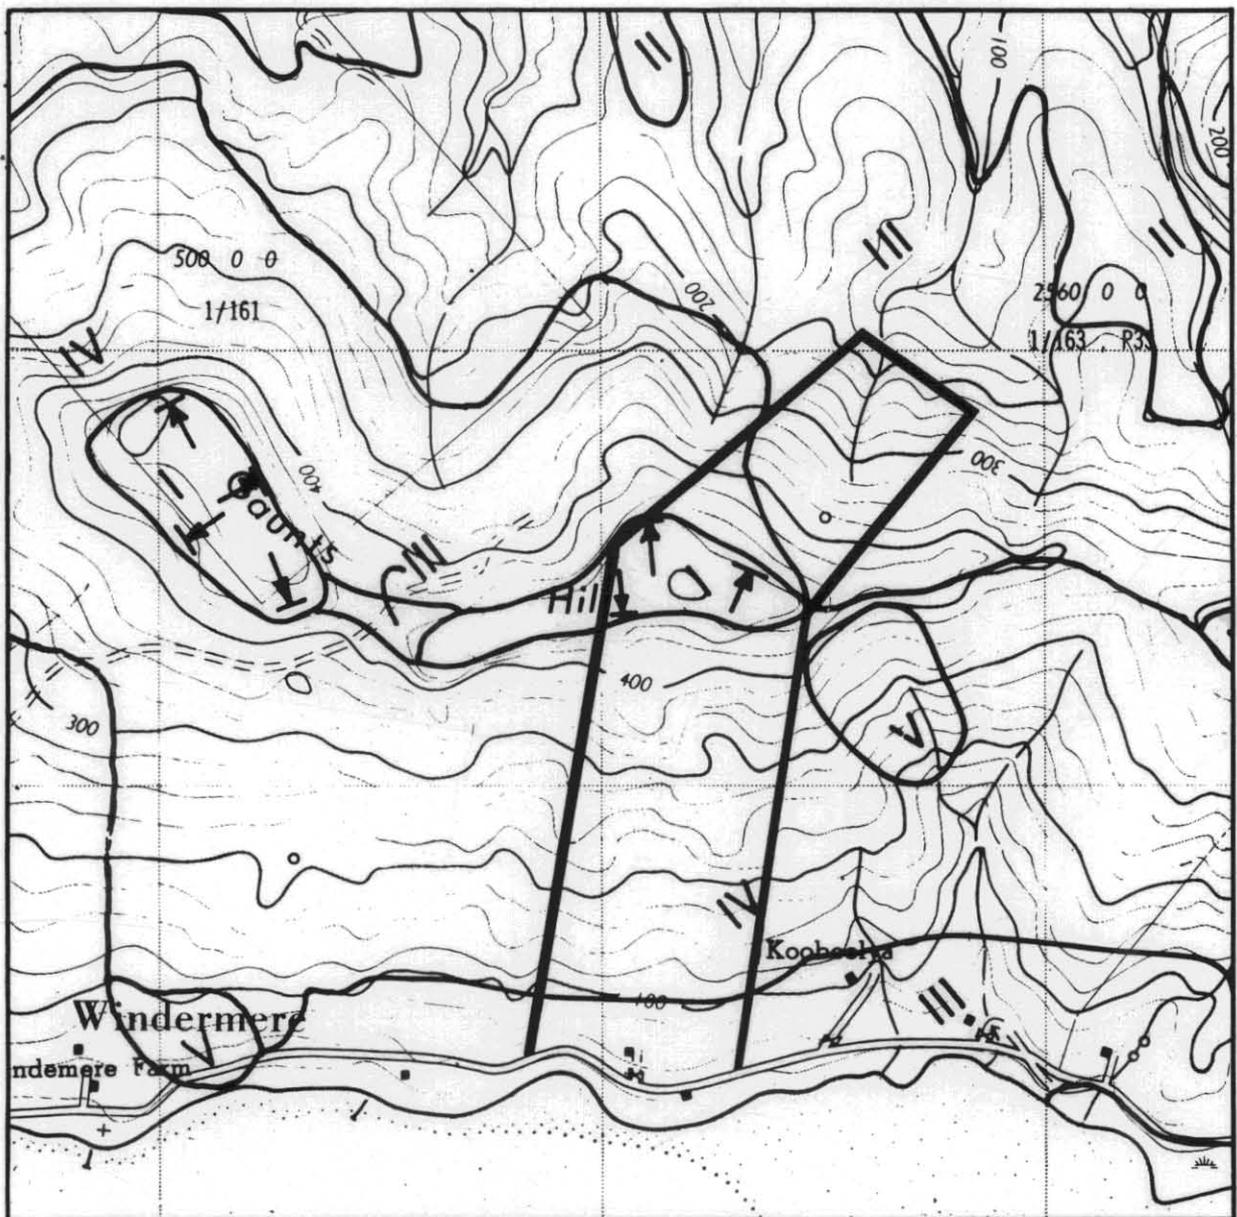
Figure 4. Landslip zone map, Windermere area

This investigation confirms that little modification of the existing regional landslide zoning of the block (fig. 4) is possible. The most stable area of the block (Zone 1) is the flat ridge which is underlain by basalt rock. There is little to no risk of slope failure here, especially if all septic tank overflow and sullage drainage is confined to the ridge area. With such extensive flats this would appear to be no great problem.

The entire southern slope is considered to compose an old landslide and by definition must remain as a Zone IV area. Of the north-eastern slope, it is possible that the upper 7 - 8° slope should be considered as potential landslide zones rather than as mapped as an old landslide area. With this slope increasing to give long uniform 10° slope the risk of slope failure is considered to be very high, particularly as aerial photographs show in the nearby area what appears to be a shallow translational type of slide. This north-eastern slope area is best considered a Zone IV area.

(1) Only one house site be considered on the southern slope. This should preferably be situated on the largest available flat area on the ridge in the south-east part of the block. Whether this site is acceptable will depend on if the septic tank water overflow can be drained off this area to the satisfaction of the Lilydale Municipal Council.

(2) The area of least landslide risk is the ridge area and this area is the preferred site for any house.

(3) Any further subdivision, especially on the north-eastern slope, will require further subsurface investigation.
