1982/47. A groundwater test hole at Hagley Station Lane

W.L. Matthews

Abstract

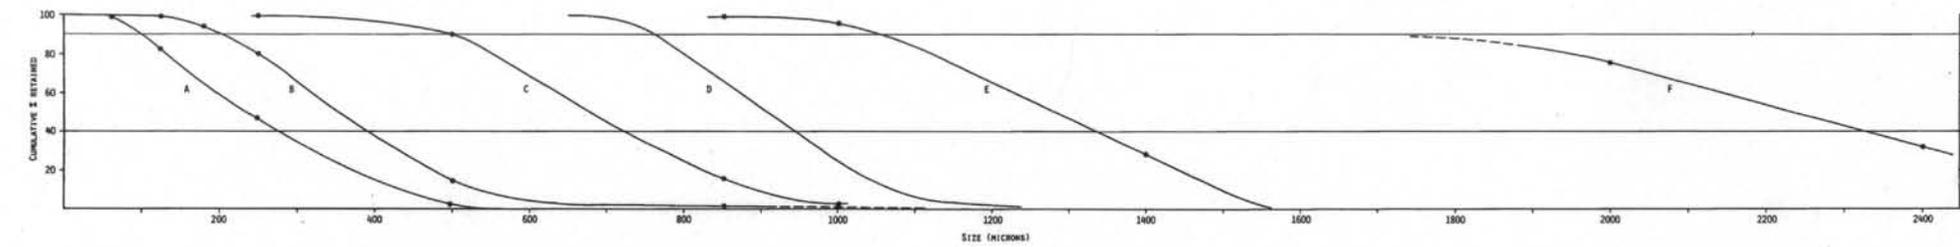
Figure 1. Grading curves of materials.

- A - Sand blown from hole
- B - Aquifer material in pump
- C - Industrial Sands 16-32
- D - Most suitable gravel pack for screen size
- E - Industrial Sands 10-16 (gravel pack used with 30/1000 screen)
- F - Industrial Sands 8-10 (gravel pack used for slotted casing)

Uniformity coefficients:

Aquifer	2.75
Aquifer in pump	2.0
16-30	1.45
10-16	1.26
