Examination of a proposed subdivision north of Legana

by W. R. Moore

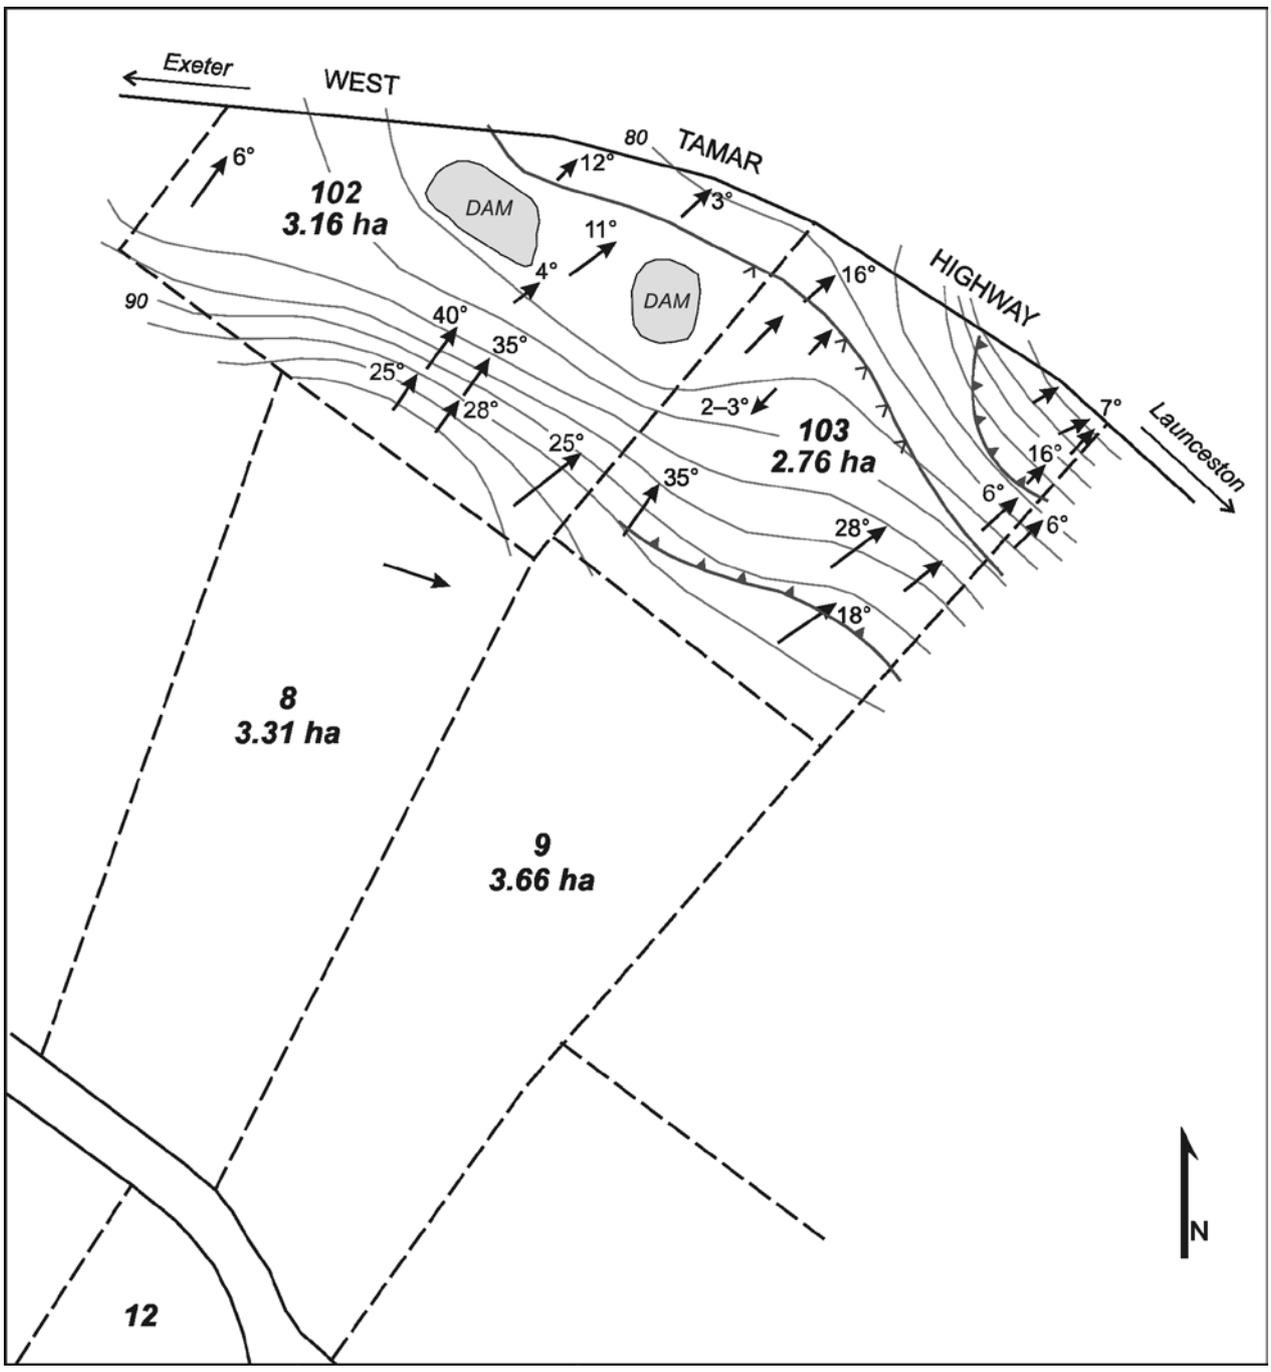
Figure 1

This low area has a complex topography (fig. 1). At the base of the cliffed section on block 103 is a flat low ridge with an inversion slope of 2–3° towards the base of the cliff. This ridge widens rapidly westwards through block 103 so that it covers most of the lower area of block 102. A swampy marshy area with a pond is present at the foot of the scarp and the inverted south-west slope on block 103. The inverted slope of the ridge flattens towards block 102 to give a broad ridge with a long sloping north-east limb of 4° to 6° degrees on the north-eastern boundary of block 102. The north-eastern slopes of this ridge are long and vary from 6° at the western boundary of block 103 to 11° on block 102. The north-eastern limb of the ridge ends by a short steep slope of 12–16° which near the West Tamar Highway flattens to 3°–6° to form a narrow flat area along the northern boundary of the blocks. At the north-eastern corner of block 103 is a small structure that appears to be an old parasitic landslide with a semi-circular scarp of 16° which flattens to 7° near the highway. Along the north-west boundary is a marshy area, possibly one of the old filled dams.

From this limited surface inspection it appears that most of the low area of blocks 102 and 103 is the northern end of a very old and probably very large landslide which has moved to form the inverted slope at the base of the cliff on block 103. Further movement or steps in the original slip are likely to have formed the steep scarplet along the northern boundary of the blocks with a smaller parasitic slide developing at a later date on north-east corner of block 103.

As well as having only a limited area available for building and limited access, blocks 102 and 103 have a potential slope stability problem. To evaluate this potential instability will require more detailed mapping over a wider area than undertaken in the above reconnaissance survey, followed by trenching and probably drilling. With the West Tamar Highway adjoining these two blocks care will have to be exercised so that any future increase in the amount of groundwater through septic tanks and stormwater soakage pits does not disturb this highway as has occurred north of the subdivision at Bradys Lookout.

Before any further slope stability investigation is undertaken it appears that decisions concerning access, available space and location of any future houses and limiting the soakage of septic tanks etc. away from the road should be made concerning blocks 102 and 103.
