**TASMANIA DEPARTMENT OF MINES
UNPUBLISHED REPORT 1982/49**

Examination of a proposed subdivision at Deviot Road, Deviot

by W. R. Moore

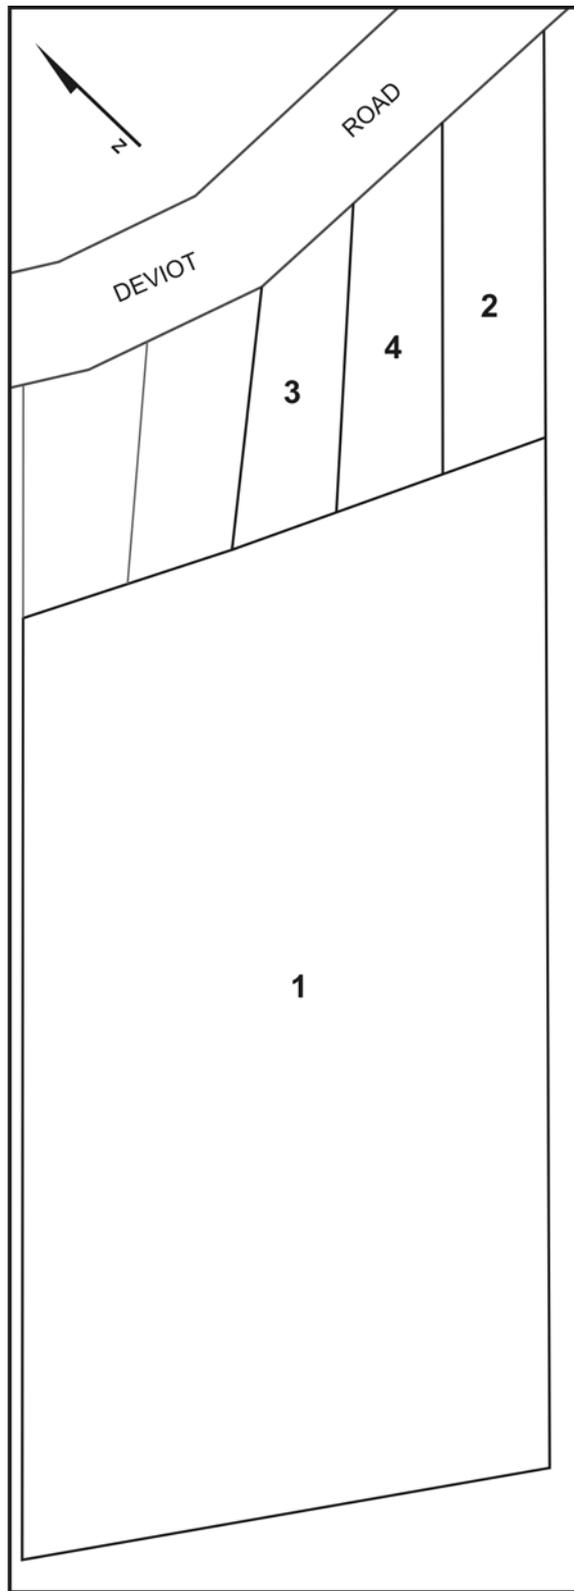
Figure 1

The land covered by the proposed subdivision was examined on 20 May. Only proposed lots 2, 3 and 4 (fig. 1) were examined as lot 1 was steep and scrub covered. This lot will require further examination when a contour map has been obtained, either by enlarging any existing maps or by surveying.

The three proposed lots between Bowman's house to the west and the property to the east are extremely narrow and small. In view of the difficulty Bowman is currently experiencing in confining the septic tank overflow to his property, there appears no possibility of three additional houses on the size of the proposed blocks being able to confine their overflow. At the most only one house appears feasible but severe misgivings are felt even about one house.

The blocks form a natural depression into which all the surrounding surface water collects. In winter much of the area is under water. Draining the area without putting the water onto the road appears unlikely. The road in front of these blocks currently shows severe cracking, with the cracks spreading across the road towards the River Tamar. Some of these cracks have been filled with bitumen but have cracked again. These tension cracks are strong evidence of potential failure and give a general indication of the general instability of the locality.

Proposed subdivision, Deviot Road
