1983/14. Investigation of a leaking dam at Evandale

W.L. Matthews

A permeable layer in a leaking dam at Evandale is probably too deep to be economically sealed with a cut-off trench. Covering the permeable area with clay where it is exposed in the dam storage is suggested.

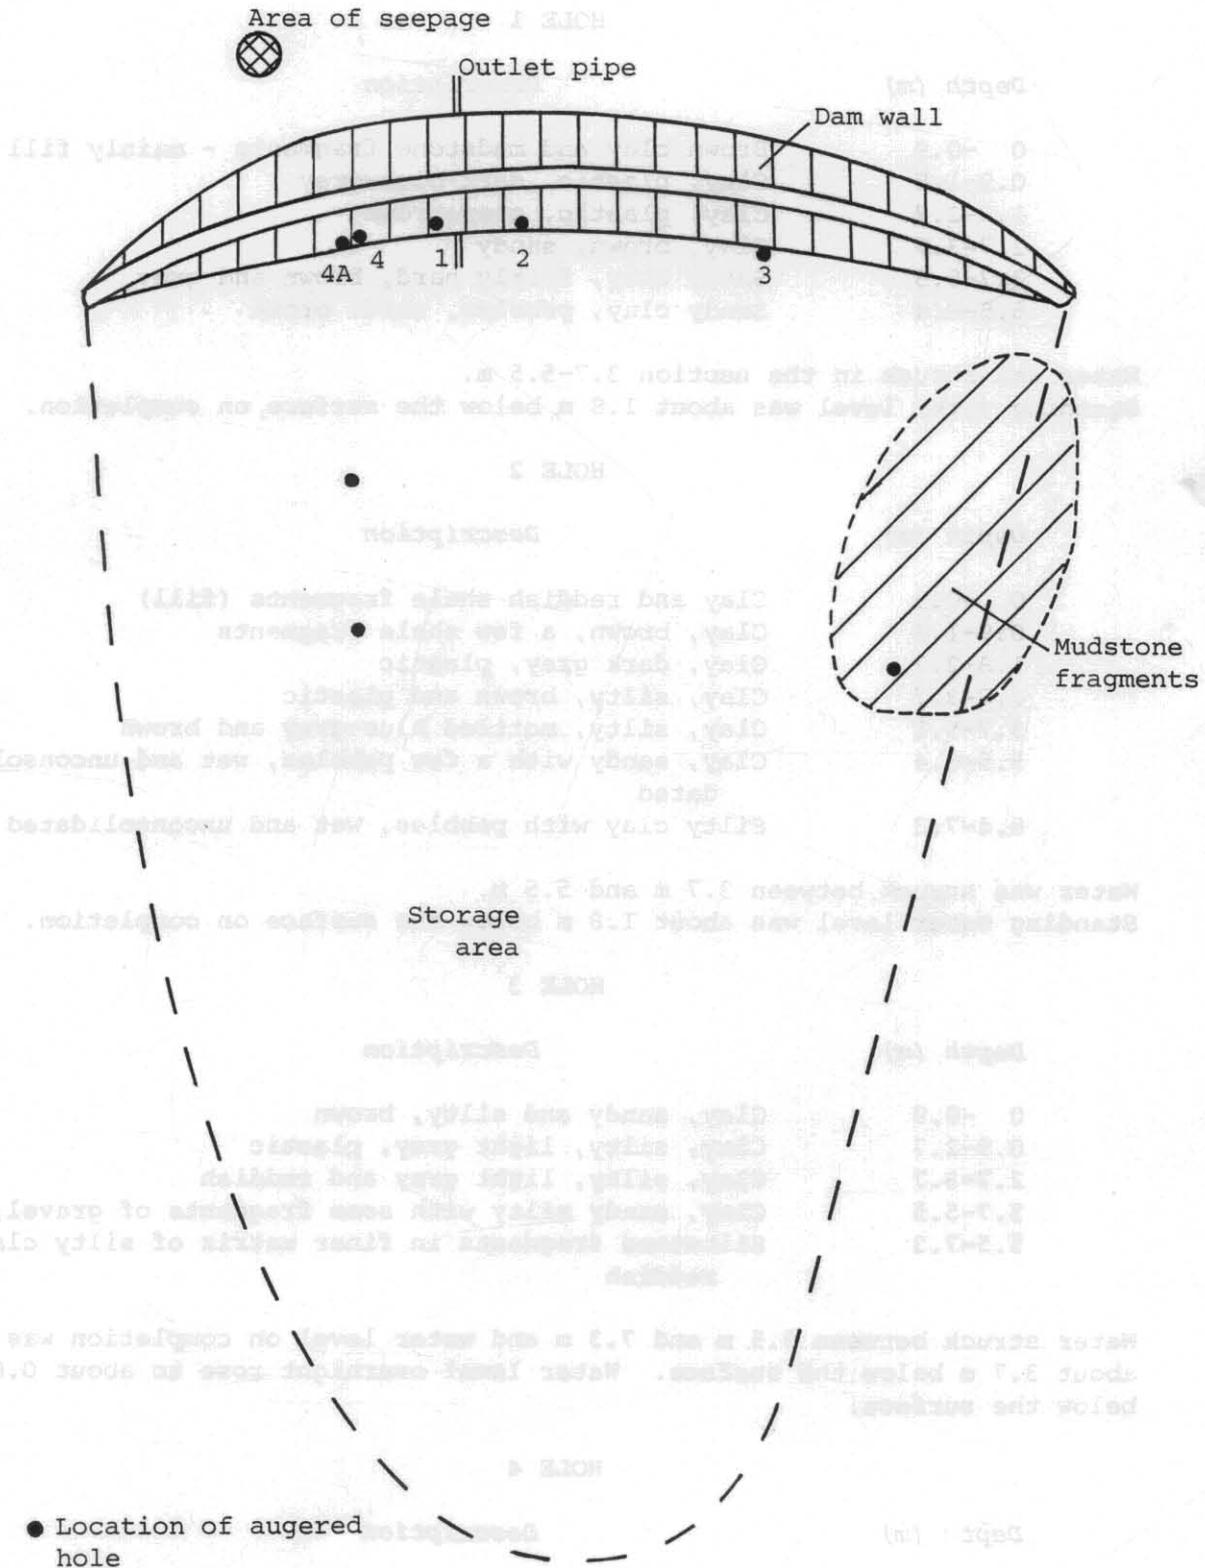
Figure 2. Sketch plan of dam (not to scale).

The logs of the holes drilled are given in Appendix 1 and the approximate locations of these holes are shown on Figure 2. Although each hole encountered water, much of the material encountered has a low permeability, being mainly clay and sandy clay, particularly in the upper portions of the holes. Pebbles in the clay were encountered in each hole; in Holes 1 and 2 these were found towards the bottom, while in Holes 3 and 4 they were struck at shallower depth and continued to the bottom. It was not possible to obtain undisturbed tube samples below about 4.2 m in Hole 4a, and this is almost certainly due to loose, low-cohesion material at this depth.

Holes were drilled in the storage area to depths of between 1.8-3.7 m. On the western side, the holes were drilled to examine if clay extended to these depths and whether it would be suitable for use as a seal for the base of the dam. Clay and silty clay were encountered in each hole to the depth drilled. A hole was drilled to 1.8 m on the eastern side of the storage area and loose clayey material with mudstone fragments was encountered for the whole section.

The probable cause of the leakage is the presence at the surface on the eastern side of the storage area of a zone of material consisting of mudstone fragments with varying amounts of clay, sand and silt-size material. This material extends under the dam and is sufficiently permeable to allow excessive leakage. As this material extends to a depth of greater than 7.3 m, it is probably too deep to be economically cut-off with a clay-filled trench.

The more permeable material appears to only extend over a relatively small area of the storage, and it should be possible to seal this area with a layer of low permeability clay. This material appears to be abundant in other parts of the storage area.

If the permeable zone is sealed, it would be advisable to excavate some of the existing material to form an even surface. This would make placement of an adequate thickness of covering material over the whole area more certain. A layer up to 0.6 m thick or greater should be considered. This would need to be well compacted and at the correct moisture content when placed to make the operation more likely of success. Extra care should be taken with compaction because of the slight dispersive nature of some of the clay. Clay would also need to be placed on the wall of the storage area where the mudstone pebbles occur. Some levelling and compacting of other areas of the storage area, particularly near the dam wall, would also be worthwhile.
