1983/42. Slope stability and subsurface investigation of a subdivision at Deviot.

W.R. Moore

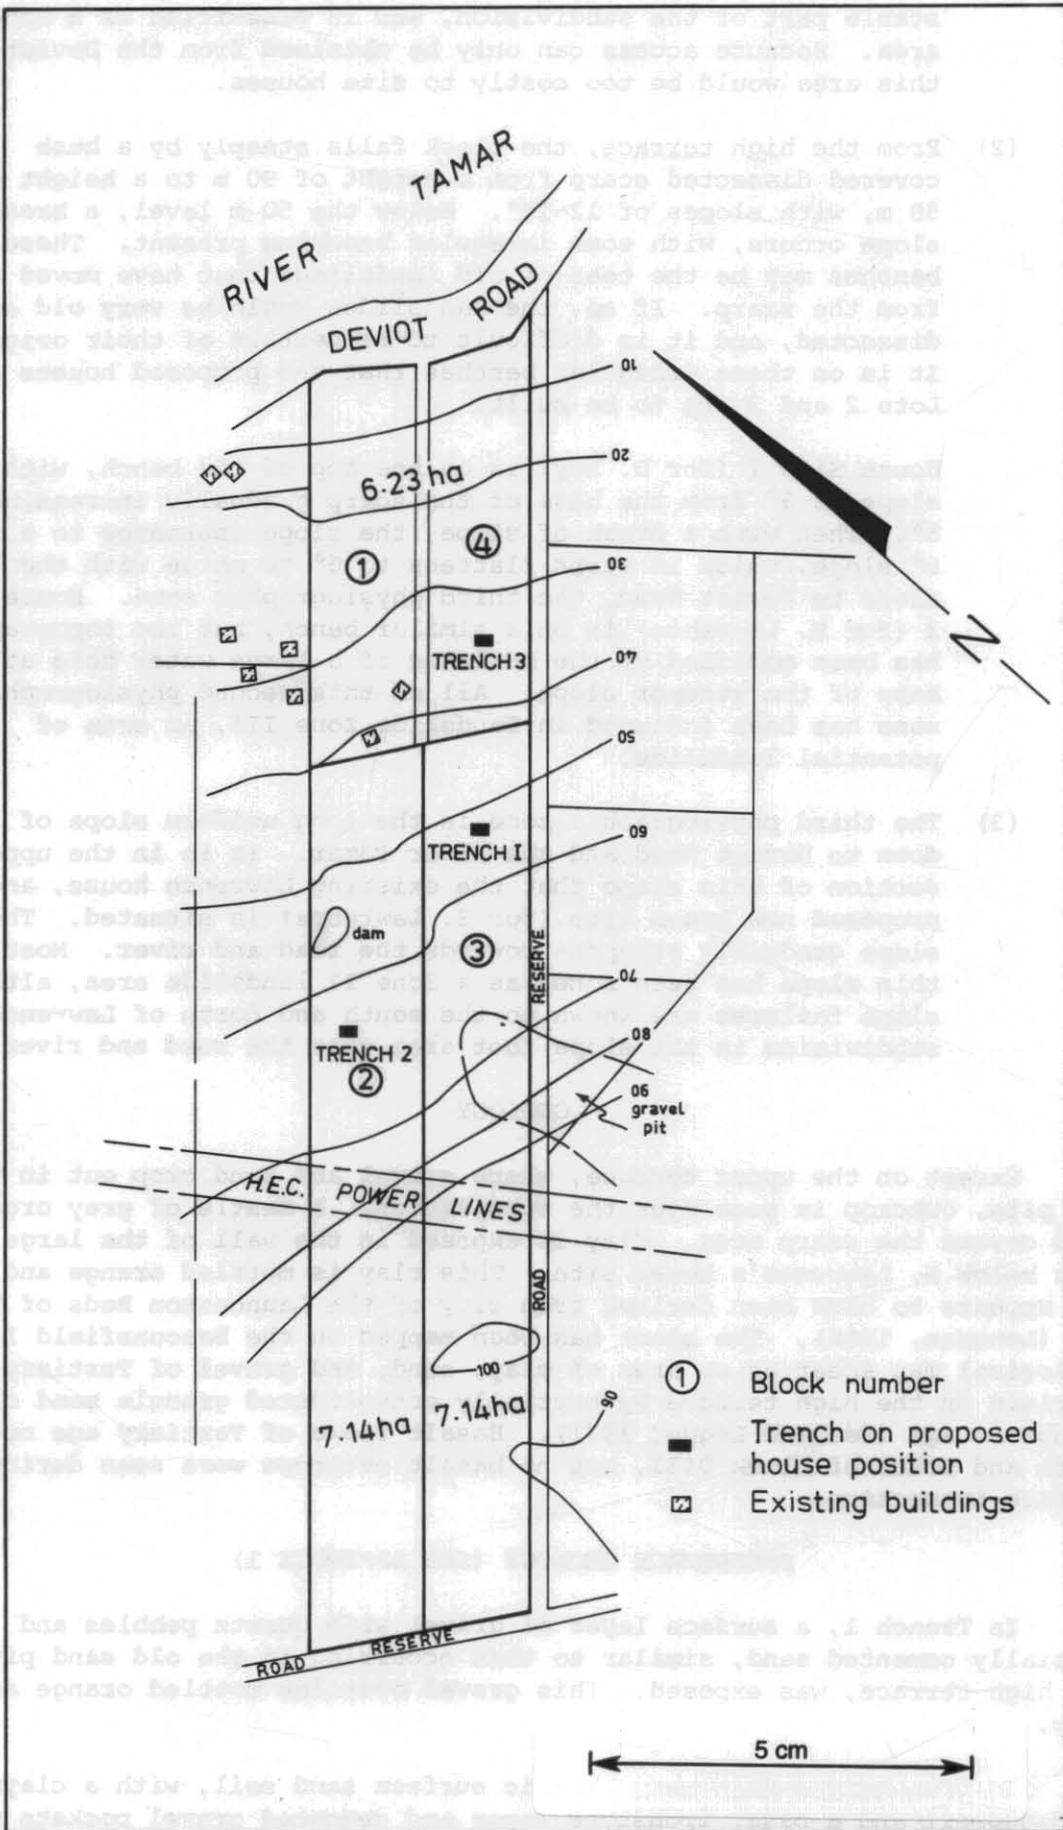
Figure 2. Plan of proposed subdivision with trench sites marked.

The block was examined on 27 April and it was recommended that a subsurface investigation be required if the proposed house sites on the three new lots were in the Zone III area. Three new house sites were proposed by S. Lawrence and her family. Two of these were in the Zone III area and one was at the same level as the existing house in a Zone II area. The Lawrence's decided that all three new sites should be investigated when the backhoe was digging the investigation trenches for Lot 1. The location of the subdivision is shown on Figure 1, and the four lots and the position of the investigation trenches is shown on Figure 2.

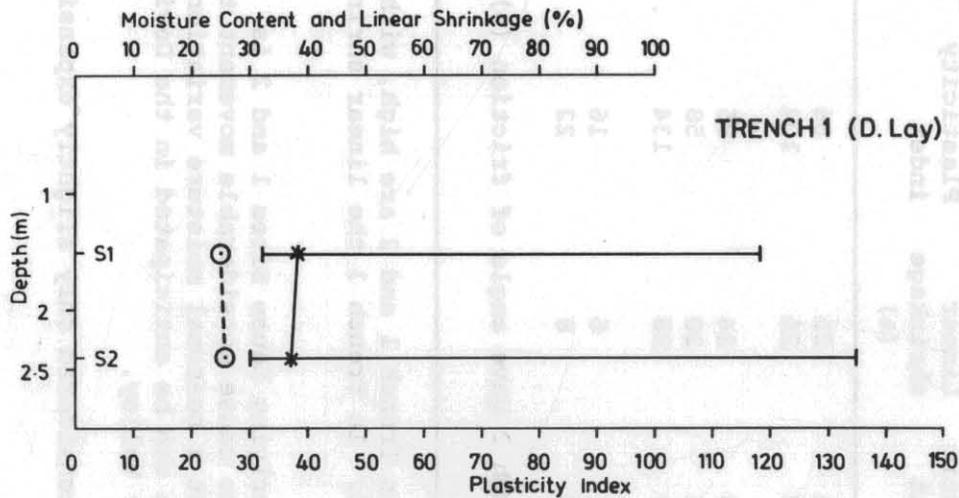
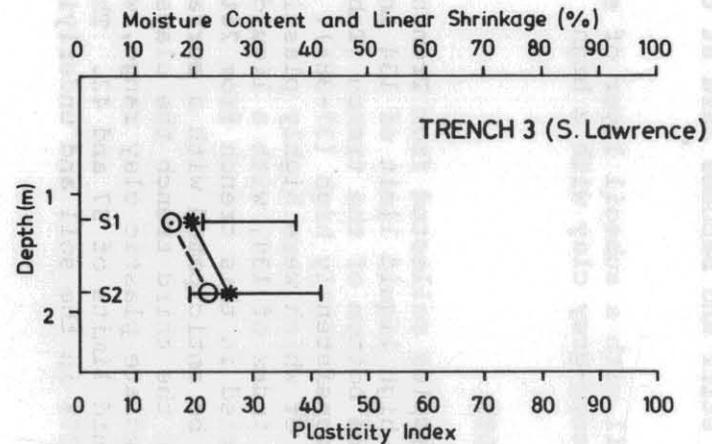
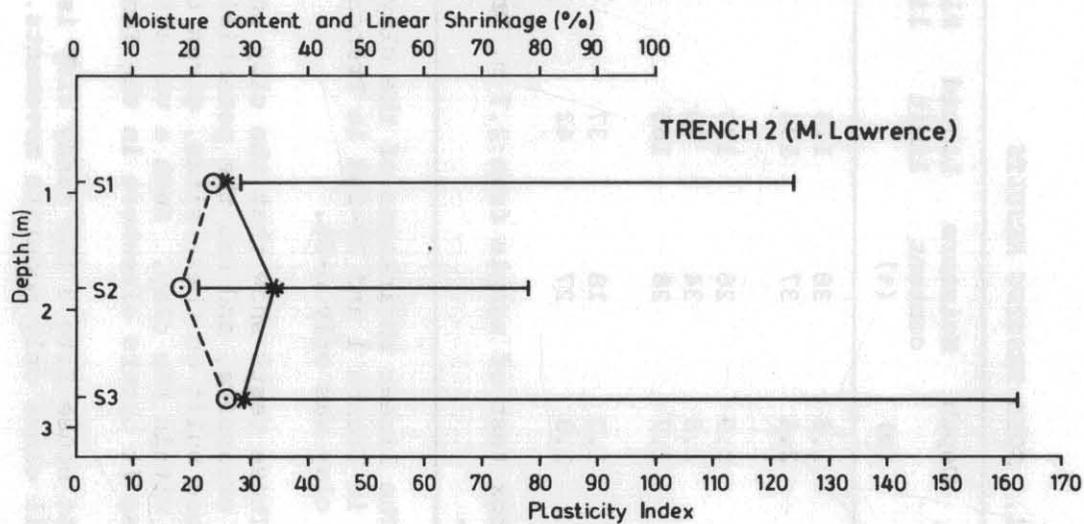
Figure 3.

The Atterberg limits of the two clay samples collected from Trench 1 showed the clay to be highly plastic, with a high liquid limit of 134 and plasticity index of 104 in the sample from the bottom of the trench (Table 1, fig. 3). The field moisture content was consistently high (37-38%). Three samples were tested from Trench 2, all of which were highly plastic. The fissured grey clay had a high plasticity index of 134, with a liquid limit of 163. The field moisture content varied in this trench from 26% to 34% to 28% (fig. 3). These results would be anticipated with a surface sand and a sand lens present in the clay. In the third trench the clays are not highly plastic but are in the intermediate plastic clay range, with a plasticity index between 16 and 22 and liquid limits of 37 and 42. The moisture content increased at depth from 18-27% in the soil and underlying clay.

The linear shrinkages of the clay in Trench 1 and 2 are high, with 25-26% in Trench 1 and 20-28% in Trench 2. In Trench 3 the linear shrinkage of the clay was only 6-8%.

These tests show that the clay underlying House Sites 1 and 2 is highly expansive, and has the potential to cause considerable movement to any house built on these sites, given that a seasonal moisture variation occurs within the clay. Such a variation can be anticipated in the Deviot area, as it occurs elsewhere in the Tamar Valley.

At House Site 3 the sandy clay is considered only slightly expansive and will cause only moderate movements.

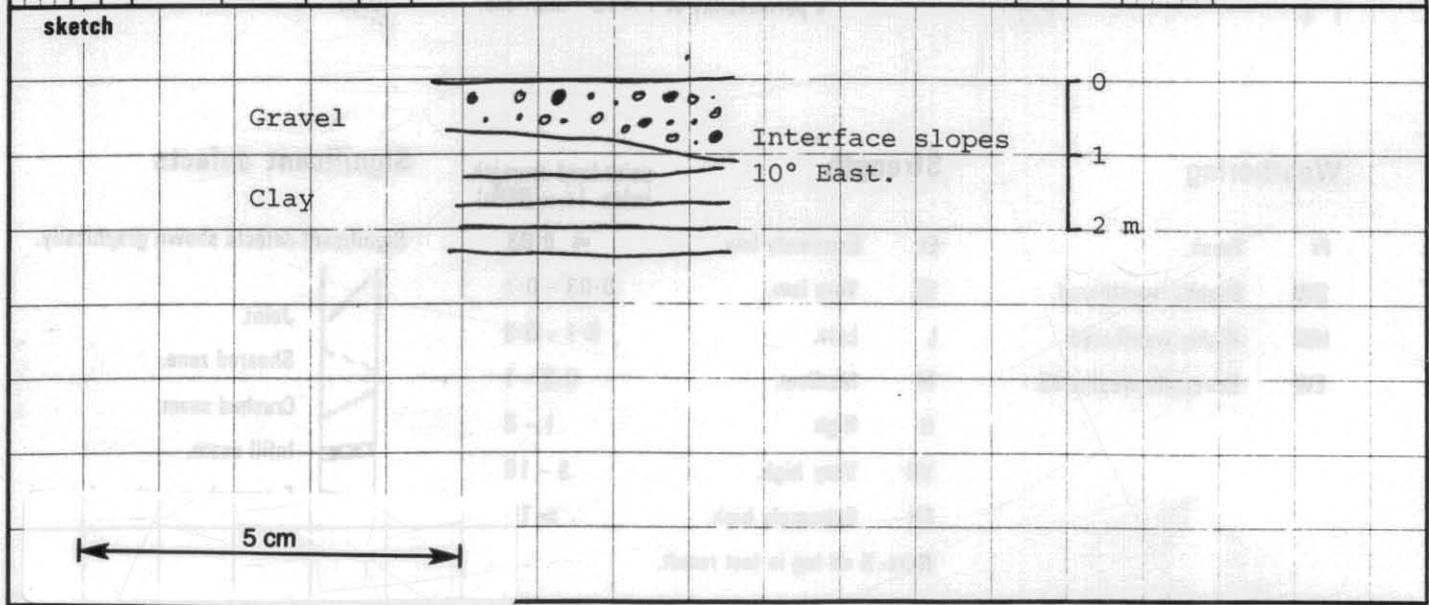
excavation no. 1
sheet 1 of 1

In Trench 1, a surface layer of gravel with quartz pebbles and partially cemented sand, similar to that occurring in the old sand pits on the high terrace, was exposed. This gravel overlies mottled orange and grey, highly plastic clay.

This site is on a bench possibly produced by a landslide, and is underlain by clay which is highly expansive. The surface gravel, although slightly cemented, is unlikely to stop water reaching the clay. Slope failure appears unlikely with suitable drainage of excess water from the house. Considerable soil movement can be anticipated and will remain a problem. The house foundation will need to allow for this movement. Good site drainage will help alleviate the problem.

penetration 1 2 3	support water	notes samples, tests	metres R.L. depth	graphic log	classification symbol	material soil type: plasticity or particle characteristics, colour secondary and minor components	moisture condition	consistency density index	hand penetr- ometer kPa	structure, geology
									25 50 100 200 400	
	None		1		GW	GRAVEL, Fine to medium, well graded. Pebbles 2-10 mm. Sand >10%. Sharp interface.	D	HD		Surface gravel
	None	PL 32 LL 118 S1	2		CH	CLAY, grey-orange, mottled, fissured. CLAY - grey	D	St		Grey clay of the Launces- ton Beds.
		LL 134 PL 30 S2.				Bucket unable to dig the hard clay. [Sand % estimated visually]

- (1) At House Site 1, a strengthened raft foundation be designed by a structural engineer to meet the anticipated movements of the expansive soil. High priority should also be given to site drainage and drainage maintenance when the house is built. Building should be in accordance with Special Building Regulations for 'B' landslide areas.

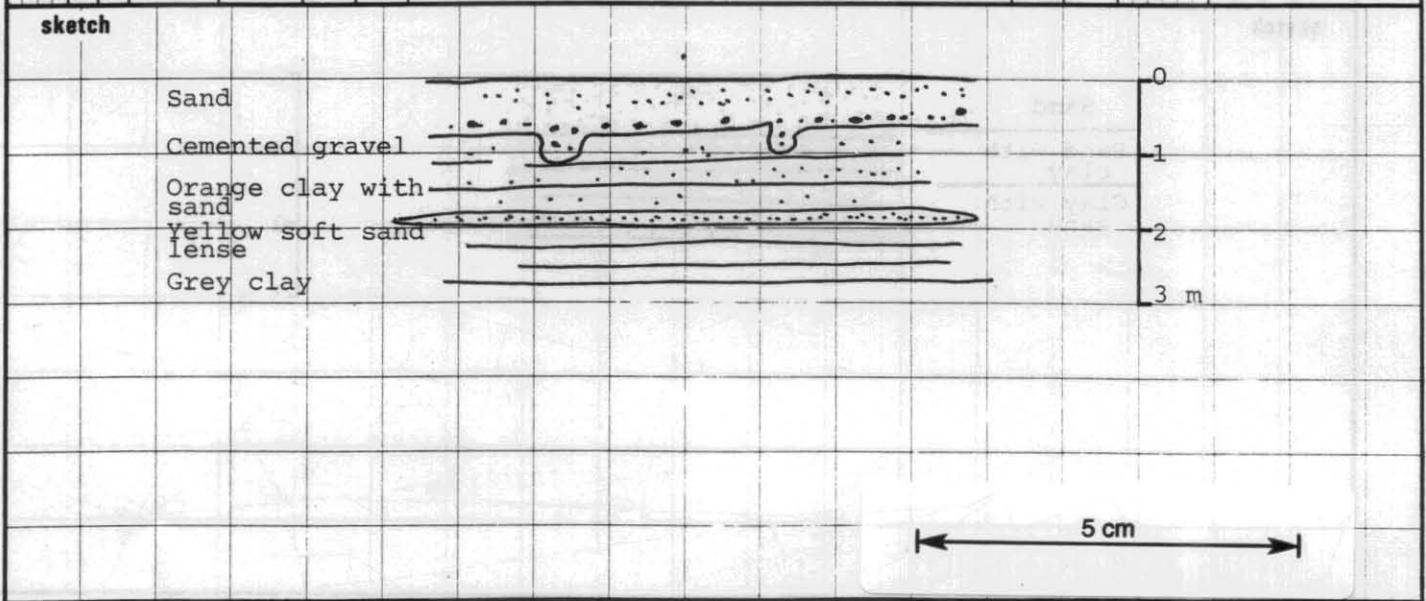
excavation no. 2
sheet 1 of 1

In Trench 2, a dark grey organic surface sand soil, with a clayey sand subsoil and a basal ironstone layer and cemented gravel pockets was exposed. These soil horizons overlies (with a sharp interface) an orange-grey clay with sand. The clay with fine sand grades into a lens of fine

yellow sand 300-500 mm thick. This sand is moist and unconsolidated, but makes no water. Underlying this sand is the grey, fissured clay of the Launceston Beds. The highly plastic clay is stiff and becomes hard at the base of the trench.

Both field evidence and soil testing show this is the worst of the three sites. The underlying clay, both in the subsoil and deeper, is very expansive and fissured. A permeable sandy soil and unconsolidated sand lenses within the clay make it difficult to prevent water reaching the clay. Satisfactory and efficient drainage at the depth at which the unconsolidated sand occurs will be difficult and expensive. As the site is high and close to the scarp, excess water from the scarp may add to the problems of this site.

penetration 1 2 3	support water	notes samples, tests	metres R.L. depth	graphic log	classification symbol	material soil type: plasticity or particle characteristics, colour secondary and minor components	moisture condition	consistency density index	hand penetr- ometer	structure, geology
									kPa	
	None	S1 PL 28 LL 125 S2		[Graphic symbols for SP, CH, SP, CH]	SP CH SP CH	SAND, Fine, organic dark-grey - becoming more clayey towards base. Sand with clay	M	VL L		Surface sand soil Ironpan Gravel
	None	PL21 LL79 S3	1							
		S4 LL 163 PL 29 S5	2		SP CH	SAND, Fine, yellow cemented and hard in places. CLAY, Grey, fissured with some roots.	M D	VL H		Sand lense Clay of the Launceston Beds
		φ=16				Backhoe limit reached. Too hard to dig				
[N.B. Sand visually estimated]

- (2) Because of the likely problems associated with House Site 2, an alternative site lower down the slope should be chosen, preferably below the water hole level. Similar trenching and testing should be carried out at the new site.
- (3) At House Site 3 it is recommended that a raft type of foundation be used which should be designed to withstand some vertical movement; strict adherence to the Building Regulations is necessary.

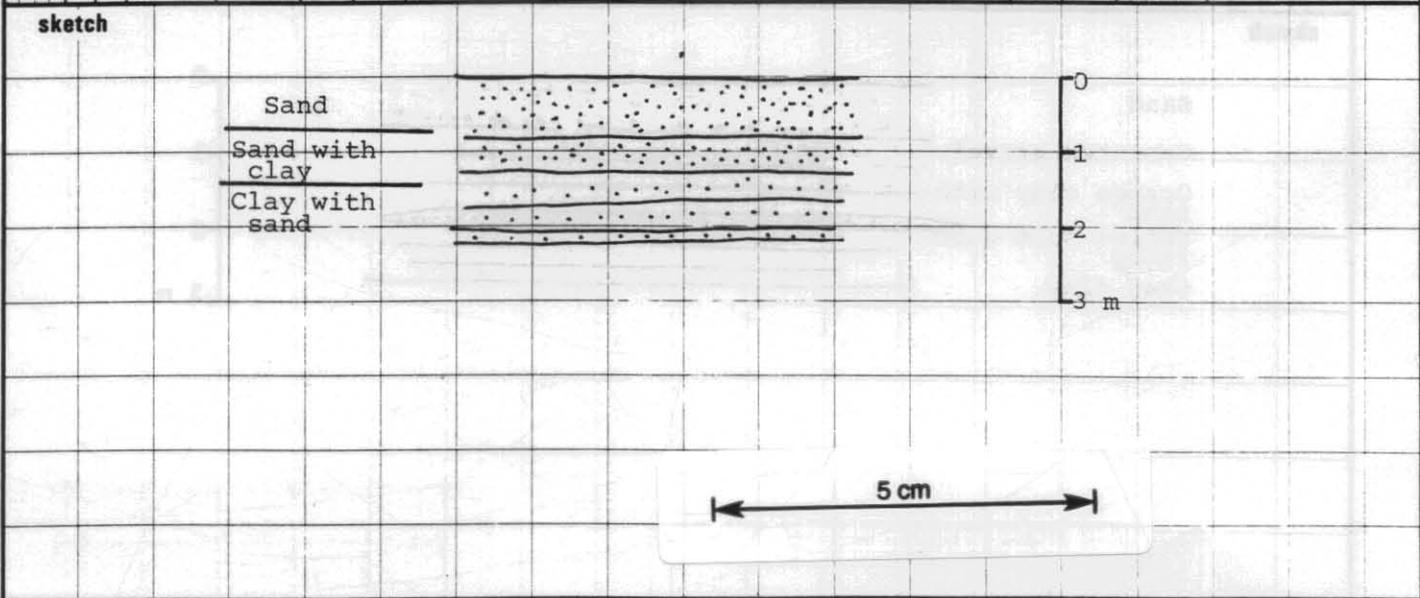
excavation no. 3
sheet 1 of 1

In Trench 3 is a grey organic sandy soil with a subsoil layer of sand with clay. Underlying the soil layers is orange-grey clay with a high percentage of sand.

This site appears to provide few problems with slope stability, and the clay with sand below the sandy soil is only slightly expansive.

penetration 1 2 3	support water	notes samples, tests	metres R.L. depth	graphic log	classification symbol	material soil type: plasticity or particle characteristics, colour secondary and minor components	moisture condition	consistency density index	hand penetr- ometer kPa	structure, geology
									25 50 100 200 400	
	None	PL 21		[Graphic log symbols for SW and CH]	SW	SAND, Fine, Dark-grey, organic	M	VL		Sandy soil
	None	LL 37 S1	1		SW	SAND WITH CLAY, Clay >12%, grey, sand fine, light-grey.	M	L		Sandy sub- soil.
		PL 20		[Graphic log symbols for CH]	CH	CLAY WITH SAND, Clay orange-grey. Sand fine >12% but variable.	M	St		Clay with sand
		LL 42 S2	2							
Adequate depth reached.										
[N.B. Sand % estimated visually]
