1983/50. Subsurface investigation of a proposed house site at Hillwood,
East Tamar

W.R. Moore

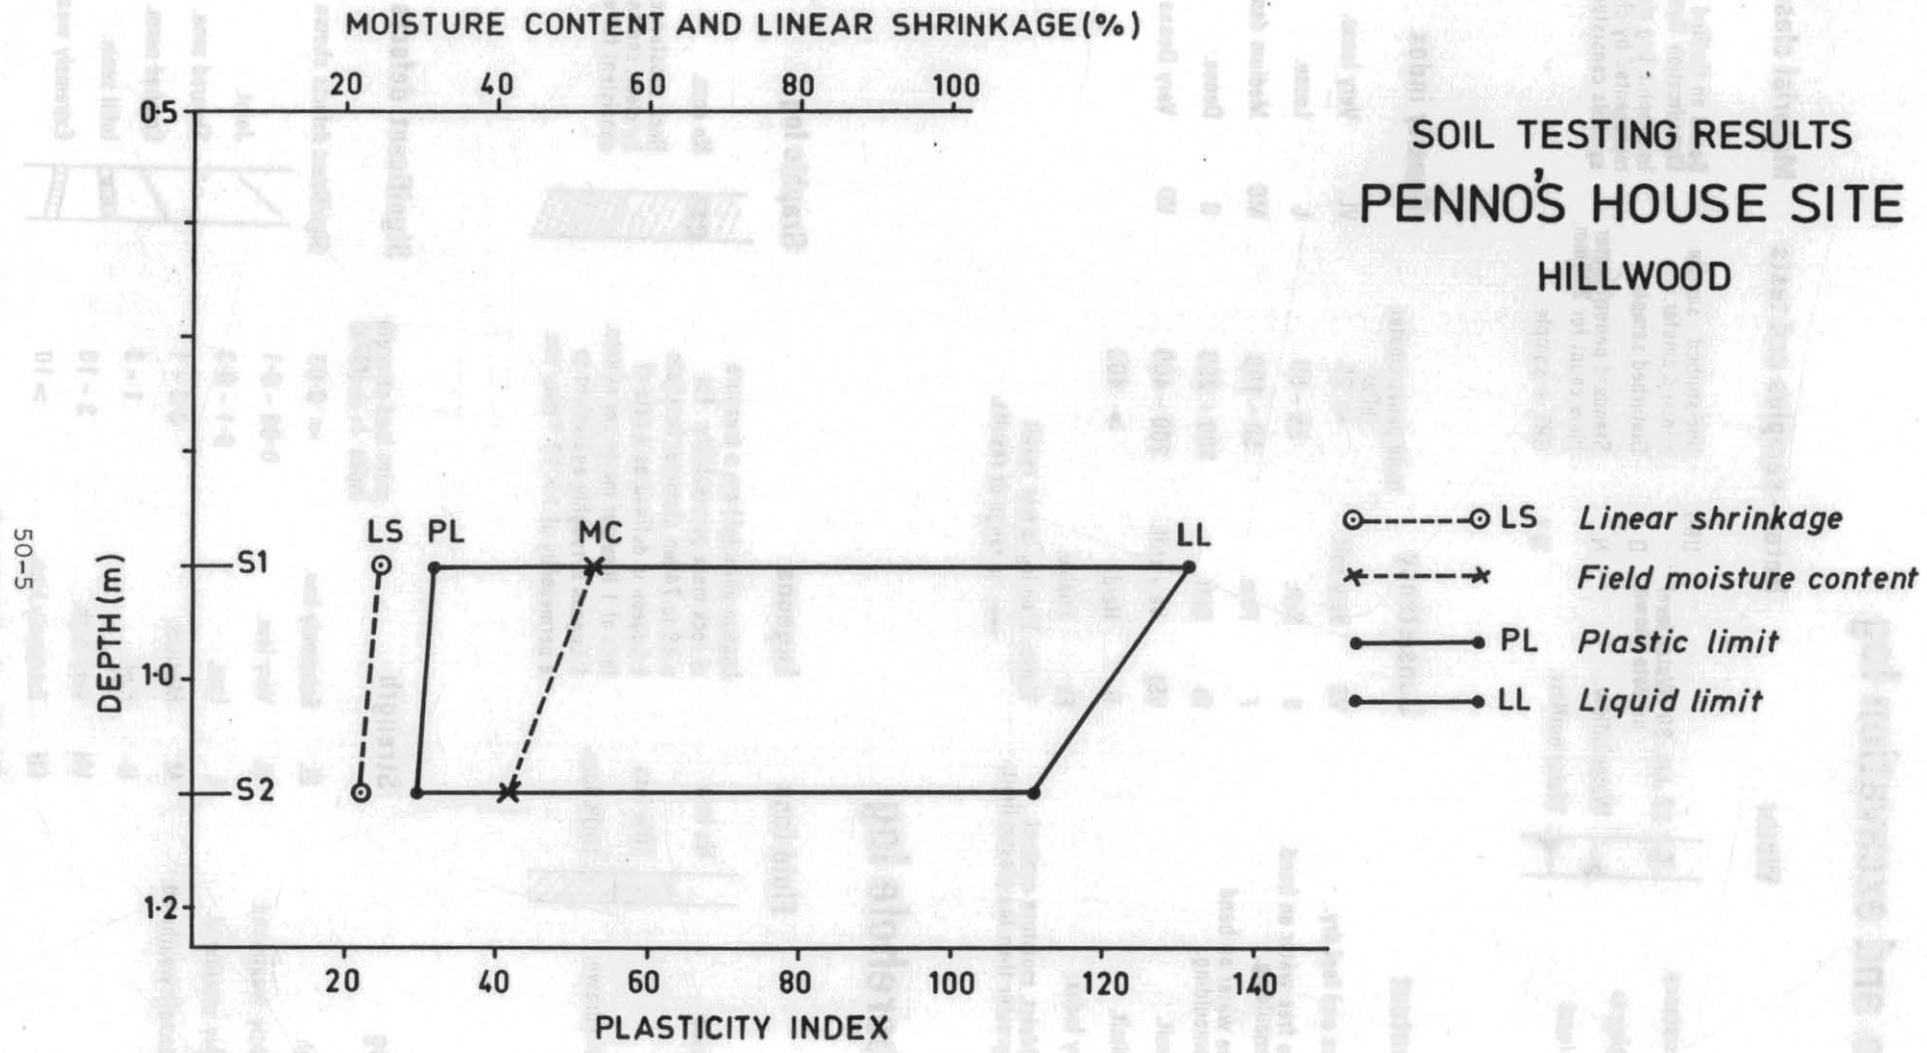
Figure 2. Soil testing results, Hillwood.

The soil laboratory results are given in Table 1 and shown graphically in Figure 2. The natural moisture content of the two samples tested was high, with the 53% for the subsoil horizon thought to be reflecting the poor natural drainage of this block. Both clay samples have high plasticity indices of 99 and 82, with considerable linear shrinkages of 25% and 23%.

The XRD analysis of the sample showed that the expansive montmorillonite clay group is present in moderate amounts, as is the less expansive kaolinite.

- (3) Even though the clay soil layer appears to be thin, considerable seasonal heave movements can be anticipated at the site. From the properties of the clay tested, these soils appear to be equivalent to some of the most expansive soils shown in Table 2.3 and Figures 2.3 and 2.4 in Holland (1981). Clay with similar properties found elsewhere in the Tamar Valley has caused houses to crack (Moore, 1983).
