A recently constructed dam on the University property, Craigow, at Cambridge is losing some of its water through leakage. Any large scale leakage is occurring under the dam and it is probably due to the cut-off being too shallow to fully penetrate unconsolidated sediments (including gravel and sand) although seepage through bedrock (dolerite and sandstone) is a possibility.

The Rivers and Water Supply Commission has been involved with a dam on the University property, Craigow, which appears to be losing some of its stored water through leakage and requested some geological advice on the area. It is sited in a side valley near the lower part of Cross Rivulet [EN361593] and covers an area of about 4 ha. It was built about a year ago and was filled by run-off from Cross Rivulet by diversion down the side valley last winter (1983).

GEOLOGY AROUND CRAIGOW DAM

SKETCH CROSS SECTION - CRAIGOW DAM

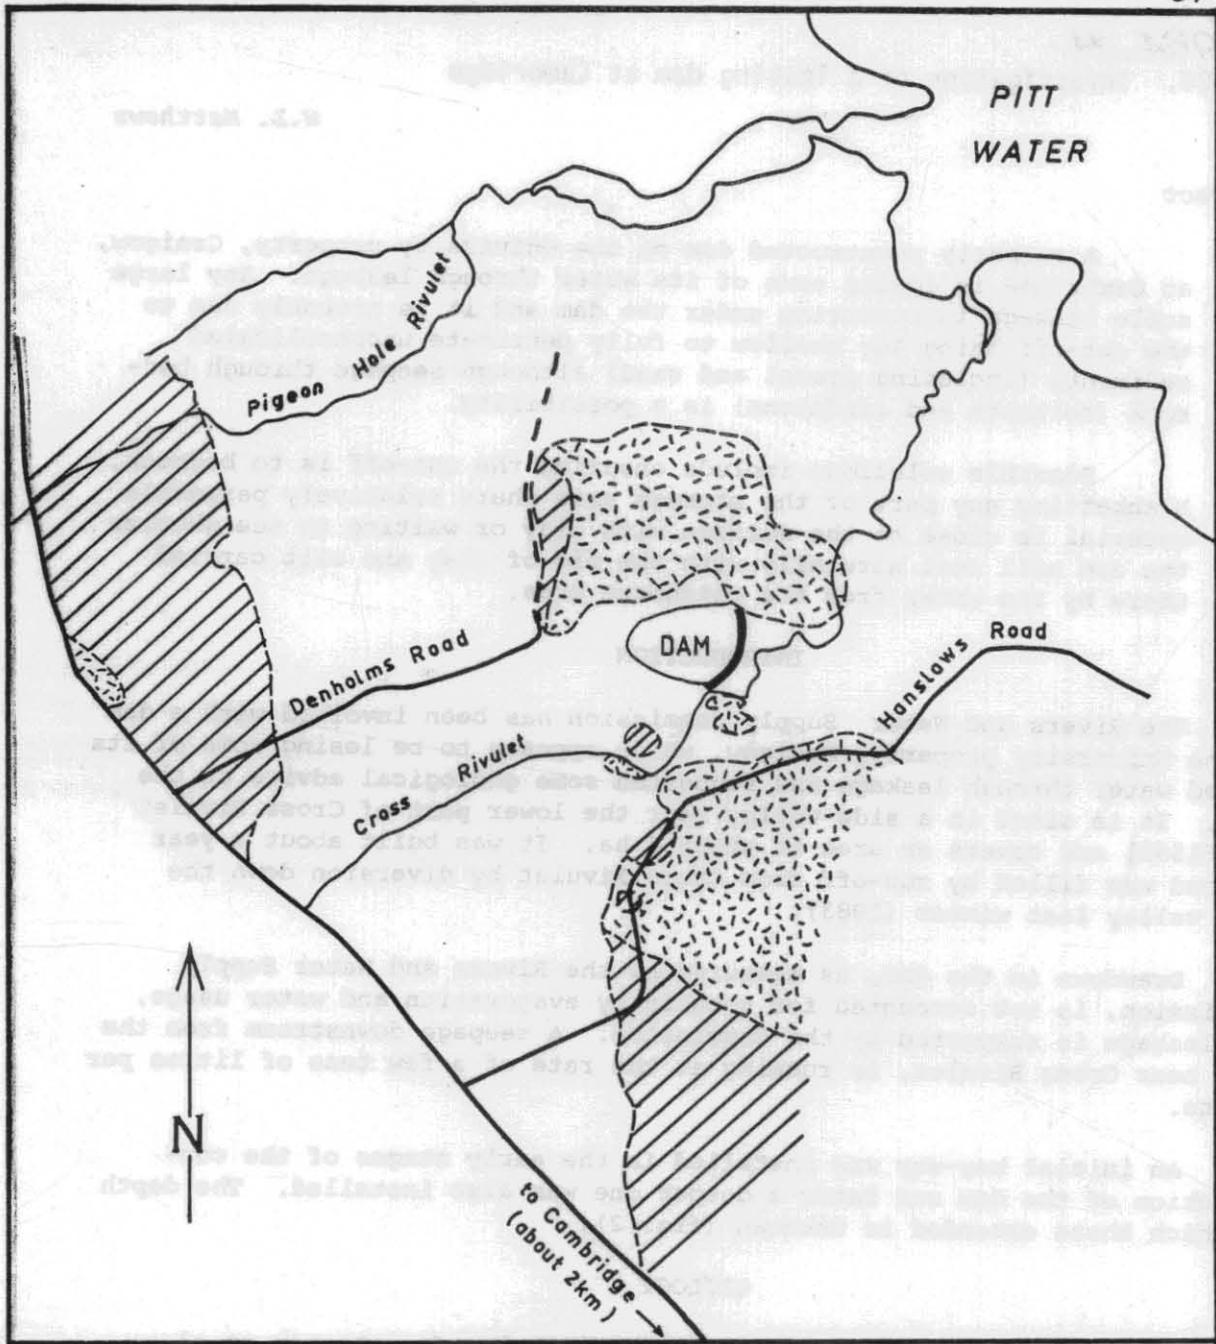
A sketch of the geology of the area (largely after Leaman *et al.*, 1972) is shown as Figure 1. Triassic sandstone occurs at several points on either side of the valley. Jurassic dolerite is also exposed on the slopes above the dam as well as in small outcrops in the bed of Cross Rivulet. The unconsolidated material of Tertiary to Recent age consists of clay, sand and gravel.

At the dam site, the north end of the wall is probably on *in situ* dolerite (a test pit dug a little away in the storage area struck weathered dolerite). The southern end of the wall is probably also on or near outcropping dolerite as very fine-grained dolerite is exposed in the spillway nearby. The middle part of the dam and the storage area is underlain by an unknown thickness of unconsolidated material. Where test pits have been dug in the storage area, the top section consists of clay and gravelly clay. In and near the small valley which enters the dam, compacted clay with shiny slip surfaces was struck in the lower parts of test pits 4 and 5. Downstream from the dam wall a series of test pits have been dug which have encountered mainly gravel fragments (Permian sediments and dolerite) with one hole having two large angular boulders of sandstone on the spoil dump.

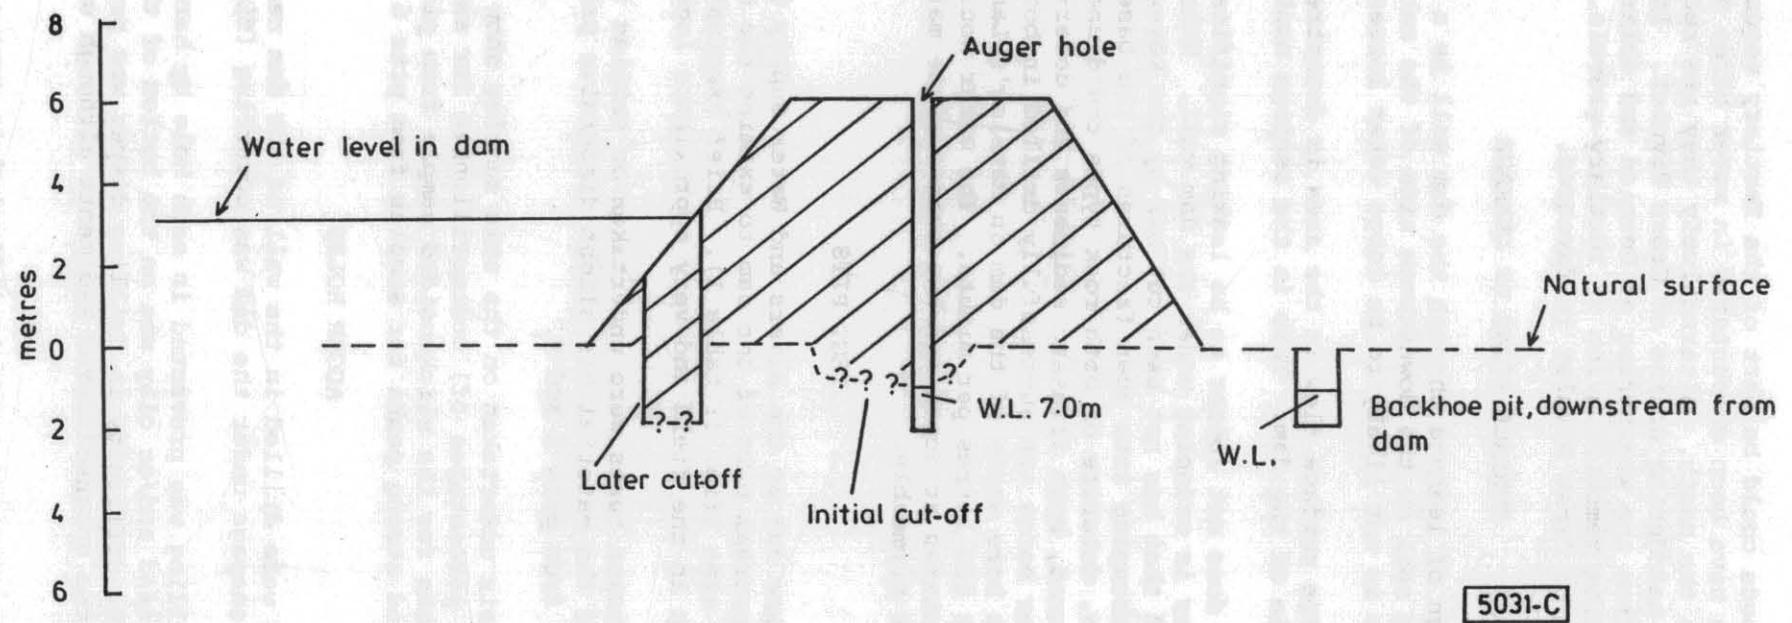
Figure 2.

An initial key-way was installed in the early stages of the construction of the dam and later a deeper one was also installed. The depth to which these extended is unknown (fig. 2).

Free water was encountered in only two of these holes (2 and 3). It is probable that the water is under a slight amount of pressure (about 0.3-0.6 mm for hole 2), but, as shown in Figure 2, the water level in the auger holes and downstream backhoe pits is much lower than the level in the dam. This difference is almost certainly due to partial cut-off of the unconsolidated sediments (or if these have been totally cut-off, seepage is taking place through the bedrock under the dam and this water re-enters the gravelly material downstream from the cut-off). In either case the permeability of the zone through which the seepage is taking place under the cut-off is less than the gravelly material downstream from the cut-off, otherwise the low water level in the auger hole and backhoe pits would not be maintained.

If leakage is taking place through permeable unconsolidated material, a deeper cut-off is a possible solution. If the present cut-off extends to bedrock and seepage is occurring through either dolerite or sandstone, a clay blanket over zones of the storage where permeable material is near the surface is a possible solution. Sufficient material to undertake this would need to be proved.

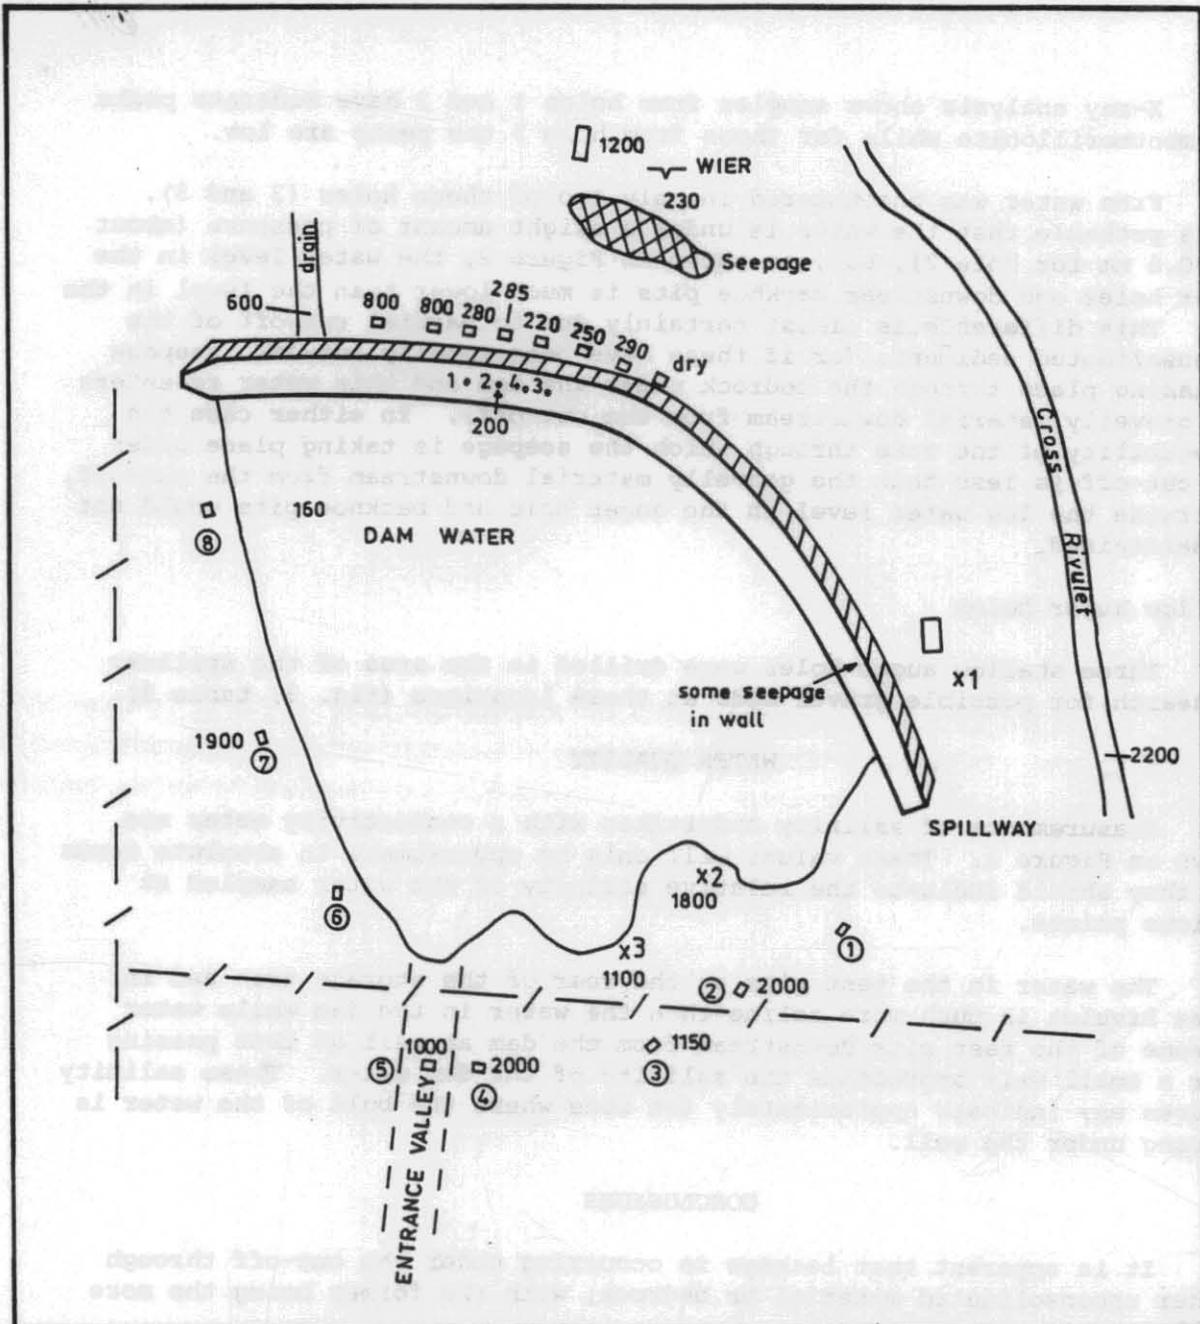
Test pits were dug by the Rivers and Water Supply Commission around the edge of the upstream part of the dam to examine the materials underlying the storage area (fig. 3; table 1). Brief examinations of the material were made in the field and very approximate logs were prepared.

Auger holes were drilled in the wall of the dam near where it was thought that the seepage under the dam was occurring (fig. 3; table 2).

Three shallow auger holes were drilled in the area of the spillway to search for possible gravel beds at these locations (fig. 3; table 3).

Measurements of salinity undertaken with a conductivity meter are shown on Figure 3. These values will only be approximate in absolute terms but they should indicate the relative salinity of the water sampled at various points.

The water in the test pits at the rear of the storage area and in Cross Rivulet is much more saline than the water in the dam while water in some of the test pits downstream from the dam as well as that passing over a small weir approaches the salinity of the dam water. These salinity figures may indicate approximately the zone where the bulk of the water is seeping under the wall.
