1984/58. Stability assessment of the Leichhardt subdivision proposal

P.C. Stevenson

A 100 ha tract of land in the valley of Jinglers Creek, near Relbia, is underlain mainly by Tertiary sand and clay. Active landsliding is taking place in several parts of the area. Failure has occurred on slopes of 10°-11°, and slopes steeper than this should be excluded from development.

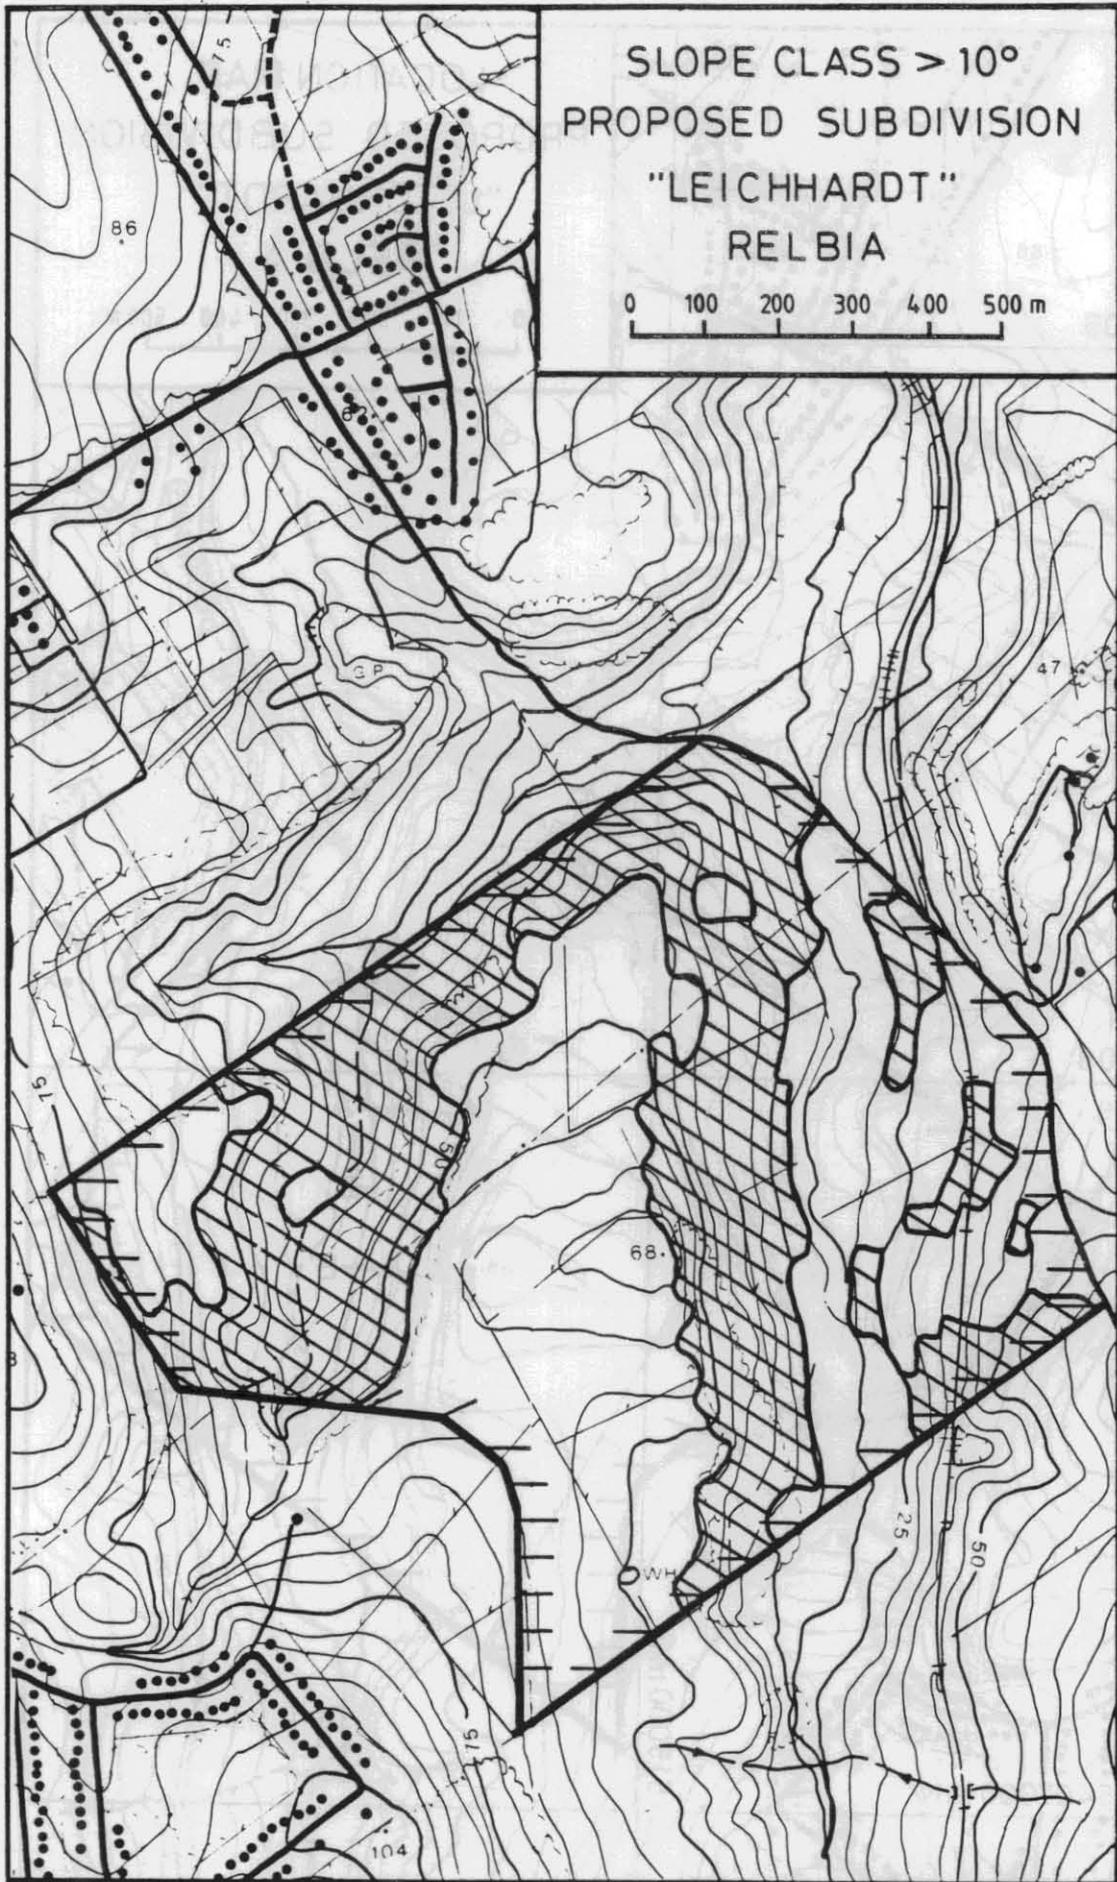
This analysis cannot be pushed too far. The only real fact to come from it is that slopes around 10°-11° have failed and there is no reason why they should not do so in future.

When this central fact is applied to a 10° slope class map of the area the useable area is revealed. All slopes of 10° and over are shown shaded in Figure 2. This analysis is limited by the coarse contour

interval but analyses at greater angles are not markedly different.

The useable area should be treated conservatively, that is to say that dwellings should be sited set back from slopes by 30 m, although roads may be closer.

Detailed subdivision layout should be done in consultation with a Departmental geologist, and excluding the >10° areas and their 30 m buffer zones.

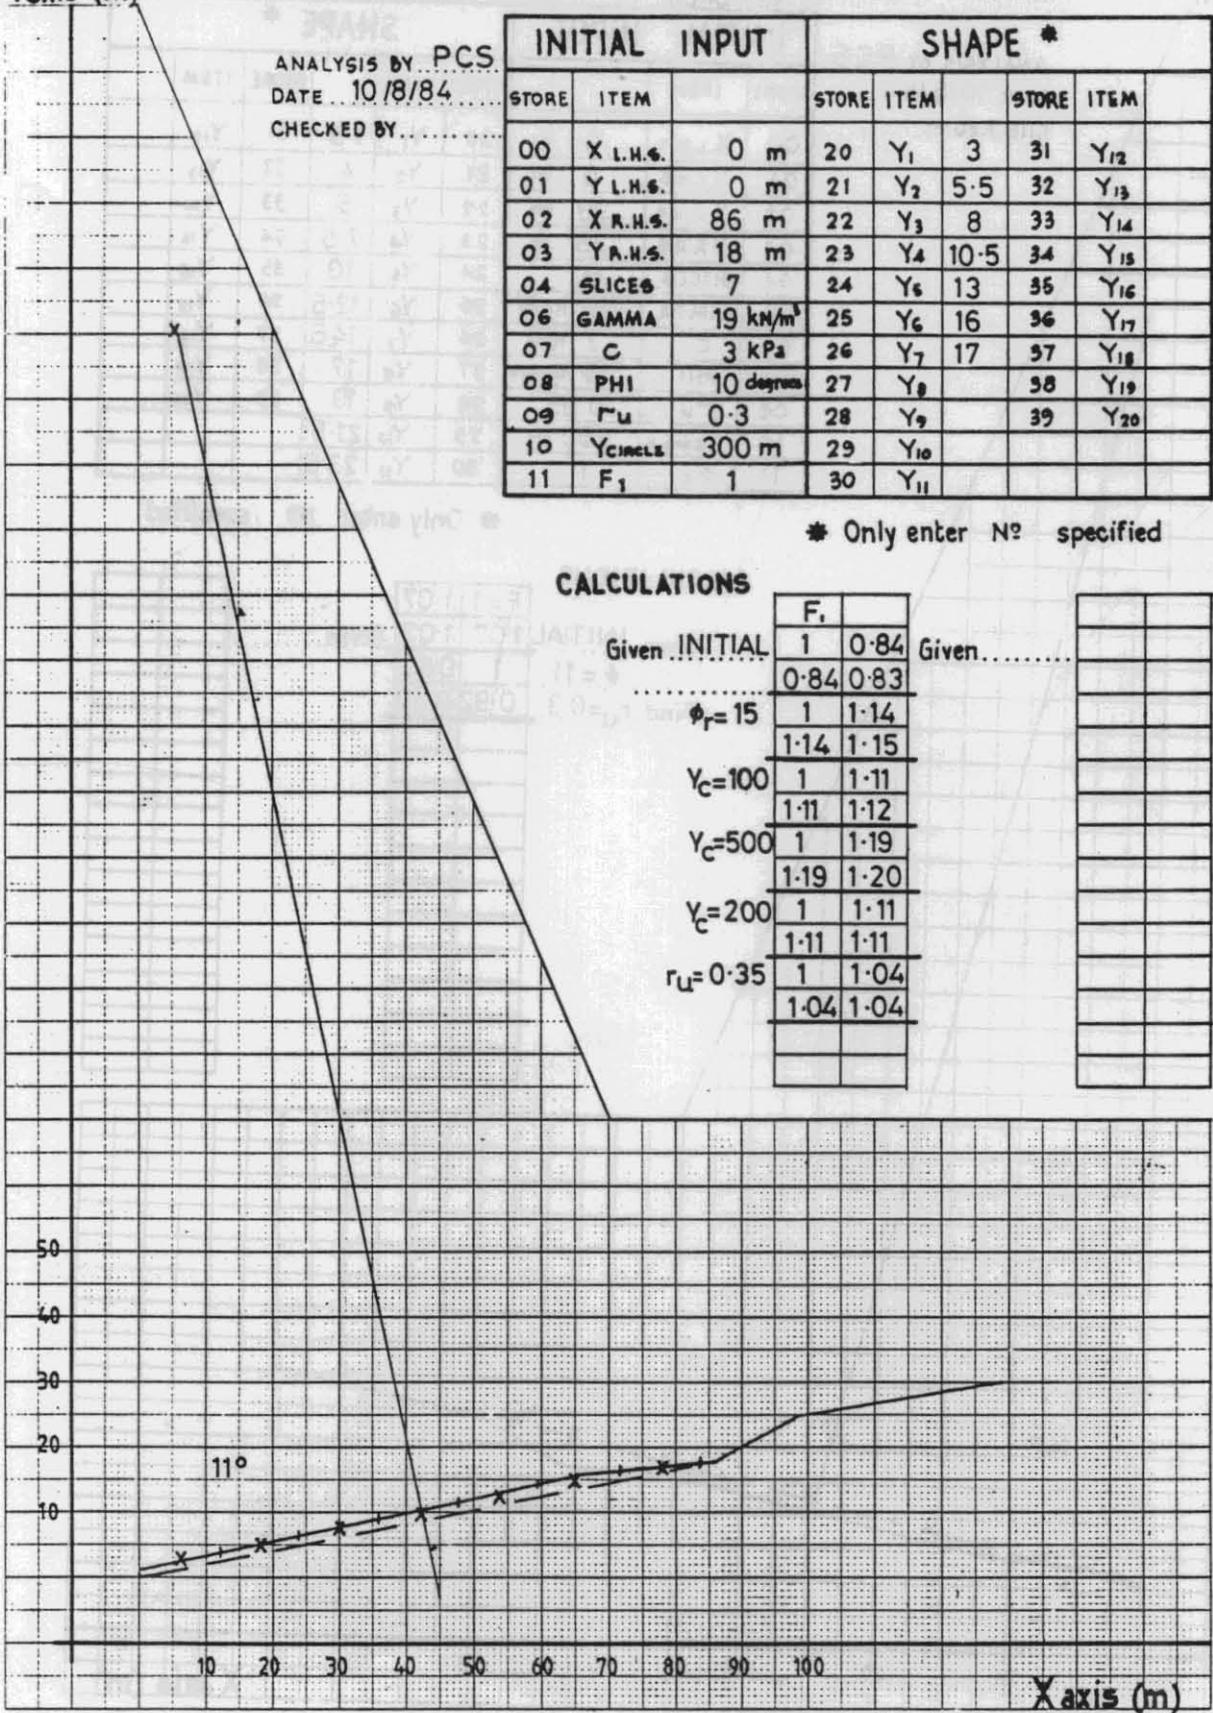
NAME OF SLIP LEICHHARDT.AA'... MAP REF...EQ.152078.....

In section A-A' the initial conditions are incorrect and variation of ϕ' to a median rather than a lower value gives a factor of safety (F) just over 1. Variation of Yc (the radius of the slip surface) to give a deeper or shallower slip is relatively insensitive. Increase of saturation from a low to a moderate value is sufficient to render the slip marginally stable at F = 1.04.

F ₁	
Given INITIAL	1	0.84
	0.84	0.83
φ _r = 15	1	1.14
	1.14	1.15
Y _C = 100	1	1.11
	1.11	1.12
Y _C = 500	1	1.19
	1.19	1.20
Y _C = 200	1	1.11
	1.11	1.11
r _u = 0.35	1	1.04
	1.04	1.04
