1984/59. Subsurface movement in expansive clay: An alternative explanation for house cracking at Sandown Road, Launceston

W.R. Moore

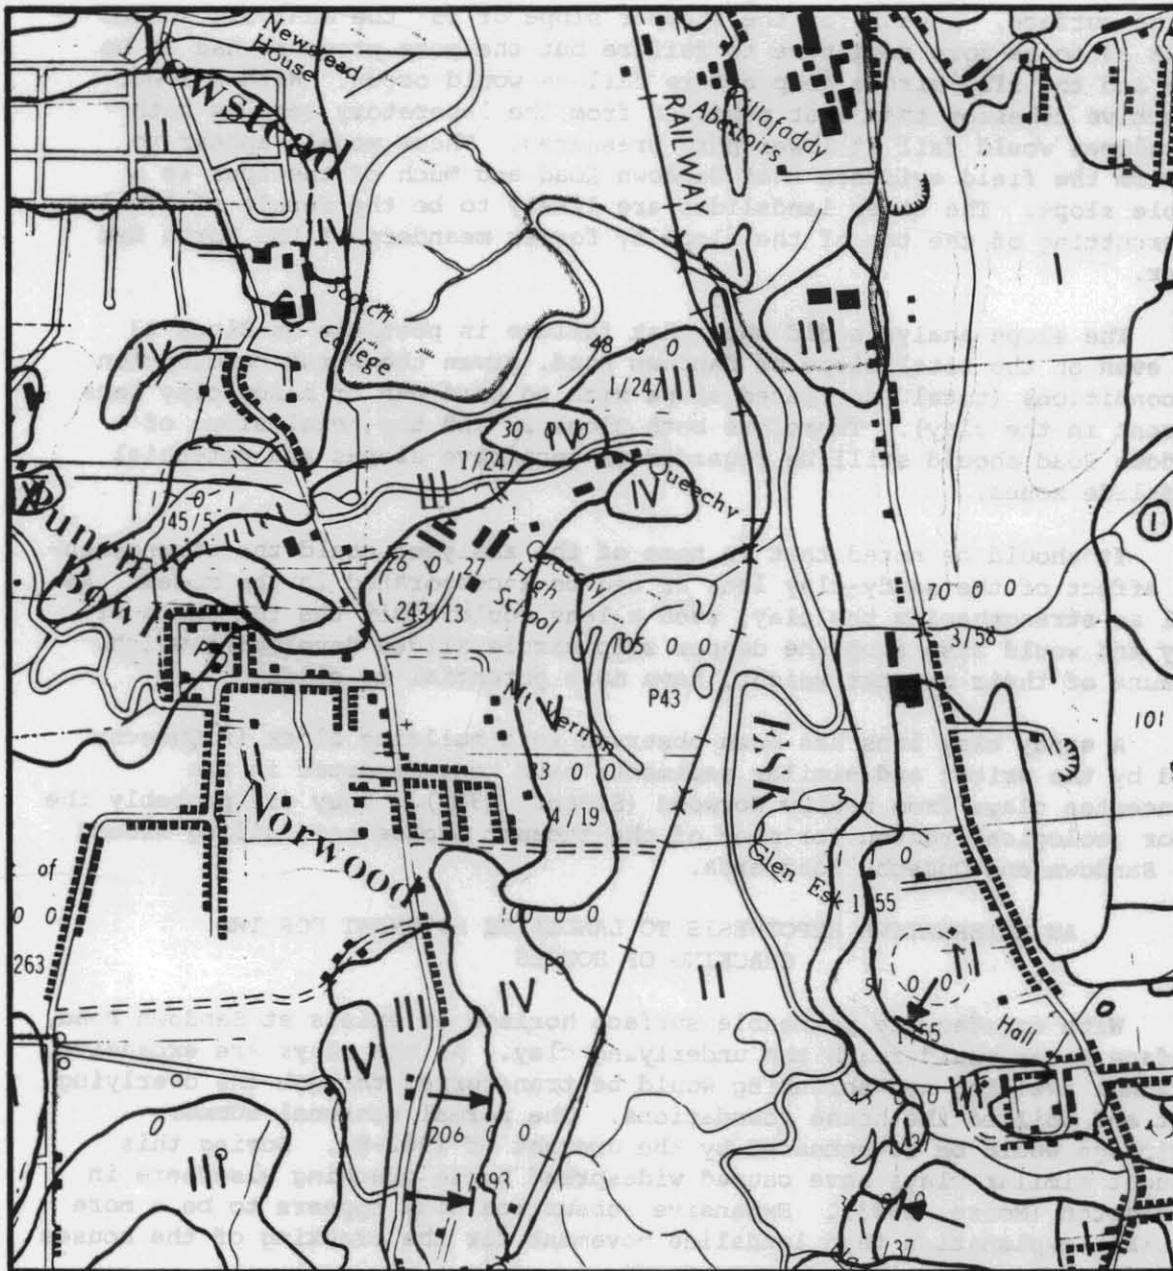
Figure 3. Landslip zone map, Sandown Road area.

Block 23 (and most of Sandown Road) has been mapped on surface evidence as a potential landslide or a Zone III area (fig. 4). Two old landslide areas (Zone IV) occur on steeper sections of the spur. An active landslide (Zone V) has been mapped and investigated at Norwood, along the same scarp to the south (Sloane, 1979).

Block 23 has a slope of 15° and this is considered, on regional field evidence, to be very close to the critical slope angle when a potential slope failure is possible in the Launceston clay. The steep section of Block 23 is short when the total slope of Sandown Road is considered. Consequently two separate slope analyses were undertaken:- one for the total slope of Sandown Road and the other for Block 23.

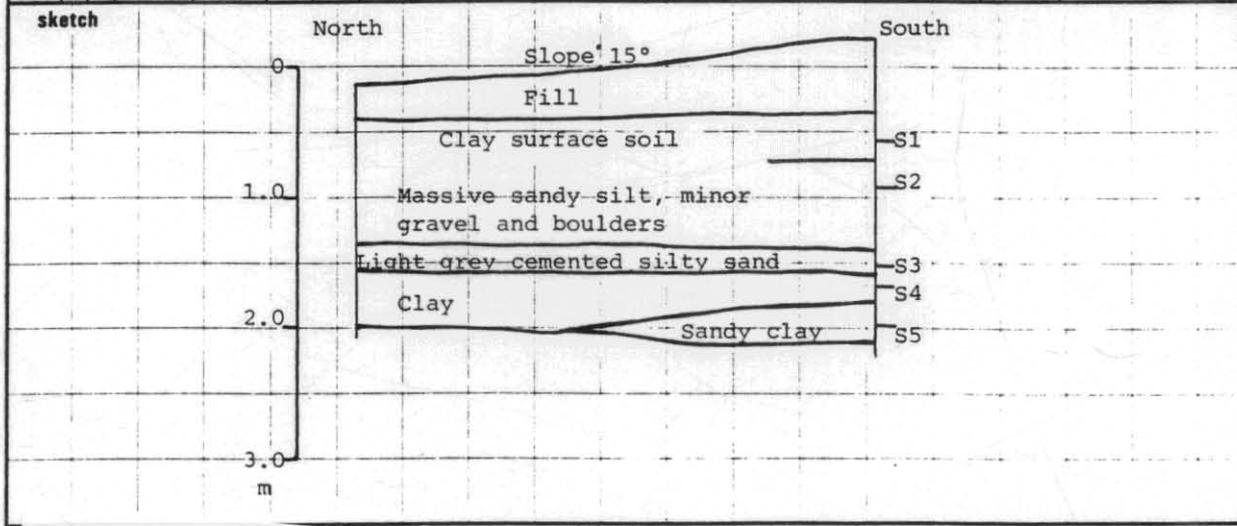
APPENDIX I

The trench exposed a surface layer of sand fill which is underlain by the original surface clay soil layer of 0.6 m thickness. In the clay soil were boulders and fine gravel. Beneath this soil layer was 0.6 m of soft, unconsolidated, friable sandy silt, at the base of which was a

200 mm thick cemented hard pan. In the cemented band was a fine gravel layer and some boulders. The sandy silt and gravel are considered to be river terrace sediments of Pleistocene age.

Below these river terrace sediments was 1.2 m of brown and orange-grey mottled clay of the Launceston Beds of Tertiary age (Longman, 1966). These clays were highly plastic and moist but with no visible shearing. A hard, sandy clay layer was exposed at a depth of two metres on the south side of the trench. Without moving the backhoe to another position it was not possible to dig beyond 2.1 m depth because of the slope and a large root crossing the trench. The sandy clay layer did not continue across the trench and appeared to be a lens but may have been continuous below the depth dug.

In Appendix 1 is a cross section of the trench showing the varying lithology and the depth at which samples were collected. Sample 1 was collected from the clay topsoil and Samples 4 and 5 were collected from the clay and sandy clay lens. These samples were tested in the soil laboratory for moisture content, Atterberg limits and linear shrinkage. Samples 1 and 4 were analysed for composition by X-ray diffraction. The clay of Sample 4 was slow shear box tested for over two weeks to obtain a residual value of the angle of friction. Samples 2 and 3 (silt and cemented basal horizon) were grain size analysed and Sample 2 (the unconsolidated silt) was also slow shear box tested.

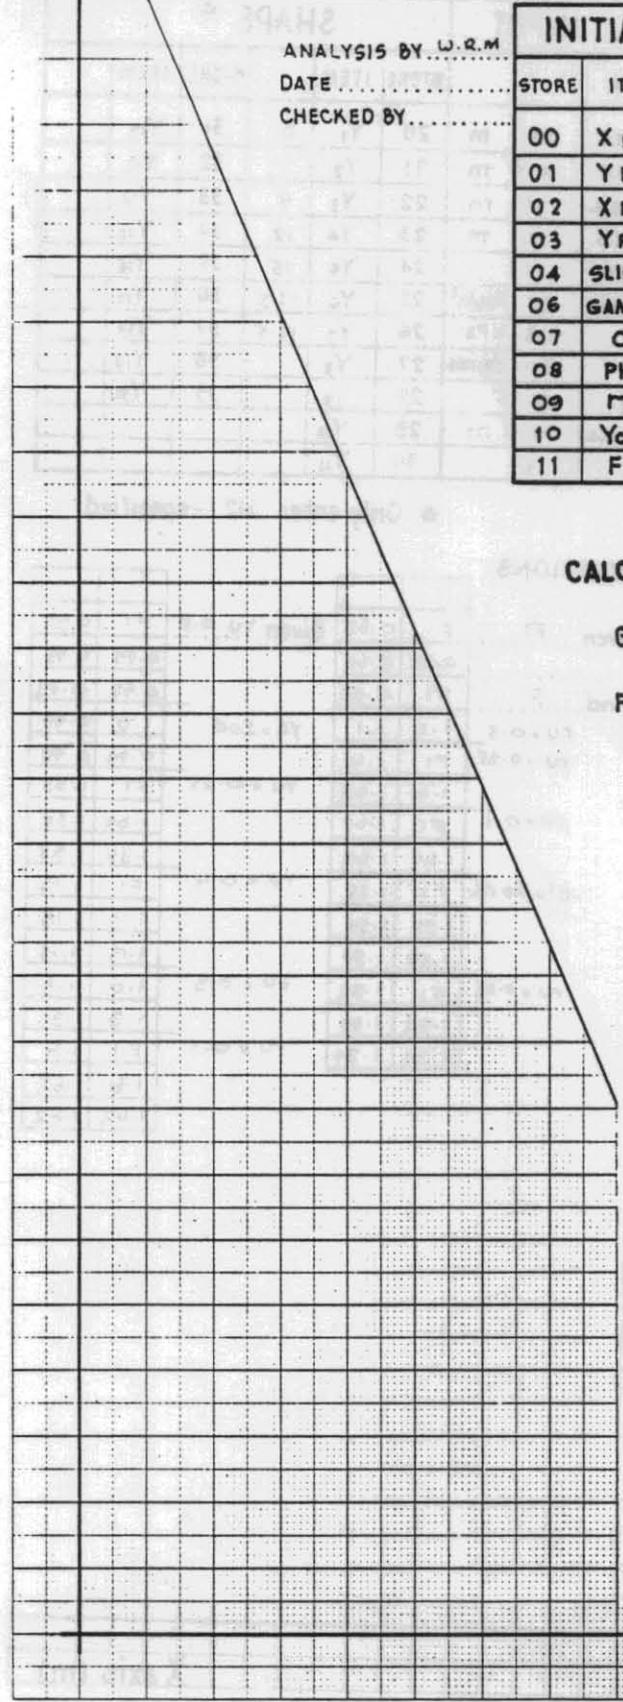
NAME OF SLIP SANDOWN ROAD - TOTAL SLOPE MAP REF. EQ148115

With the long slope, failure was only likely with a deep-seated slip plane in which the pore pressure was high (near total saturation with water)

The slope analysis did show that failure is possible on Block 23 and even on the total slope of Sandown Road, given the worst combination of conditions (total saturated slope with no hard pan or sandy clay lens present in the clay). Therefore both Block 23 and the total slope of Sandown Road should still be regarded as sensitive slopes and potential landslide zones.

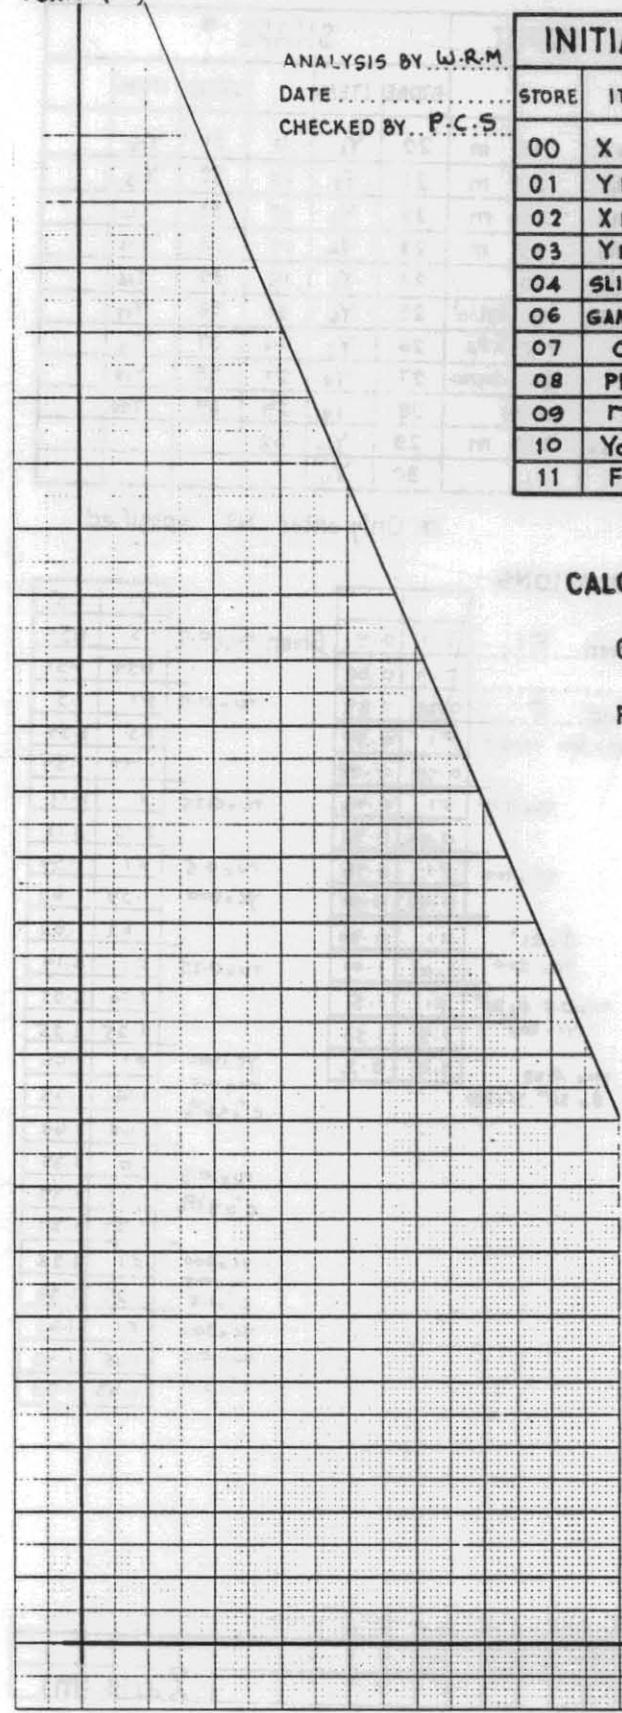
NAME OF SLIP SANDOWN RD, Block 23 MAP REF. EQ 148115

at the surface. Because of the steeper slope of 15° the analysis showed Block 23 to be more sensitive to failure but the pore pressure had to be high and the slip circle deep before failure would occur. With a lower effective cohesion than that produced from the laboratory results both the slopes would fail at lower pore pressures. These models appear to confirm the field evidence that Sandown Road and much of the spur is a stable slope. The older landslides are likely to be the result of local undercutting of the toe of the slope by former meanders of the North Esk River.
