UR1985-46

1985/46. Slope stability and site investigation of land at Sophie Place,
West Launceston

W.R. Moore

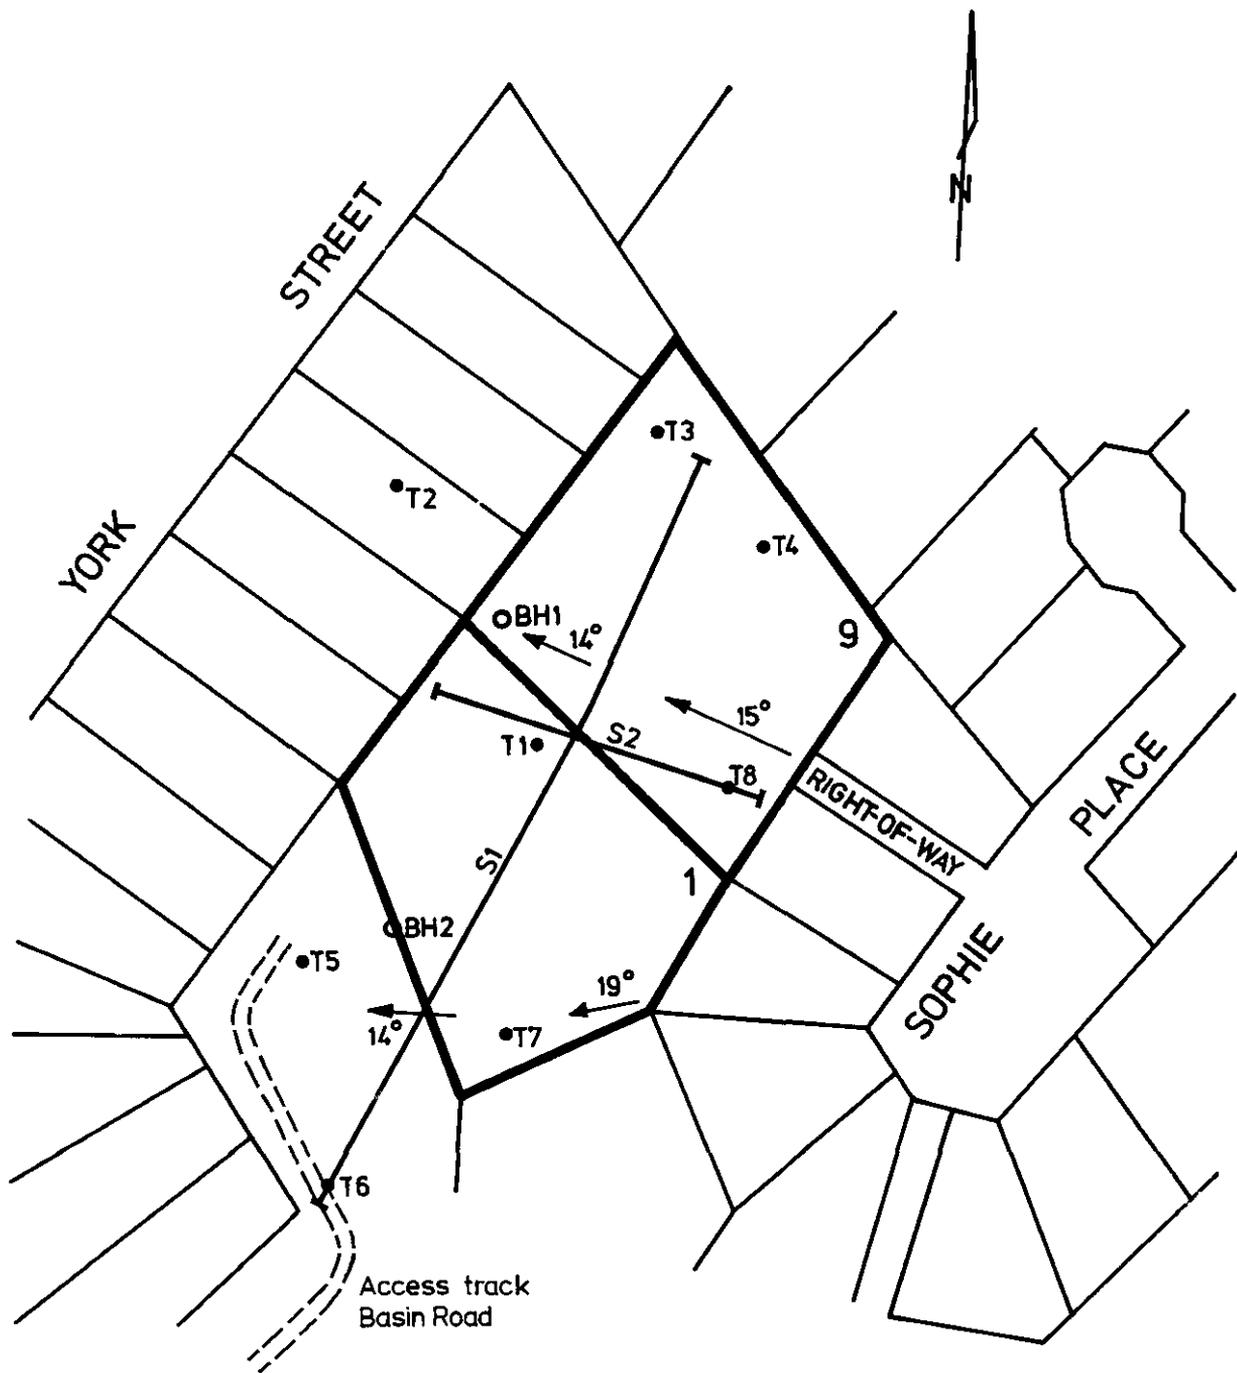
Figure 1. Location of investigations.

Eight pits were dug using a light backhoe. These pits were surveyed and their locations, together with the previous investigation seismic lines and later auger holes, are shown on Figure 1.

A light, trailer-mounted Treifus auger drill was used on the site. Even though not ideal for site investigation, as it produces no core, two holes were drilled within four hours to depths of 8.2 m and 5.0 m. Though not precisely on the seismic lines, these holes were adequate to indicate that the top seismic layer (clay) was very thick, because neither hole appeared to reach a harder, higher seismic velocity layer. The lithological logs of the two drill holes are given in Appendix 1, and their location is shown on Figure 1.

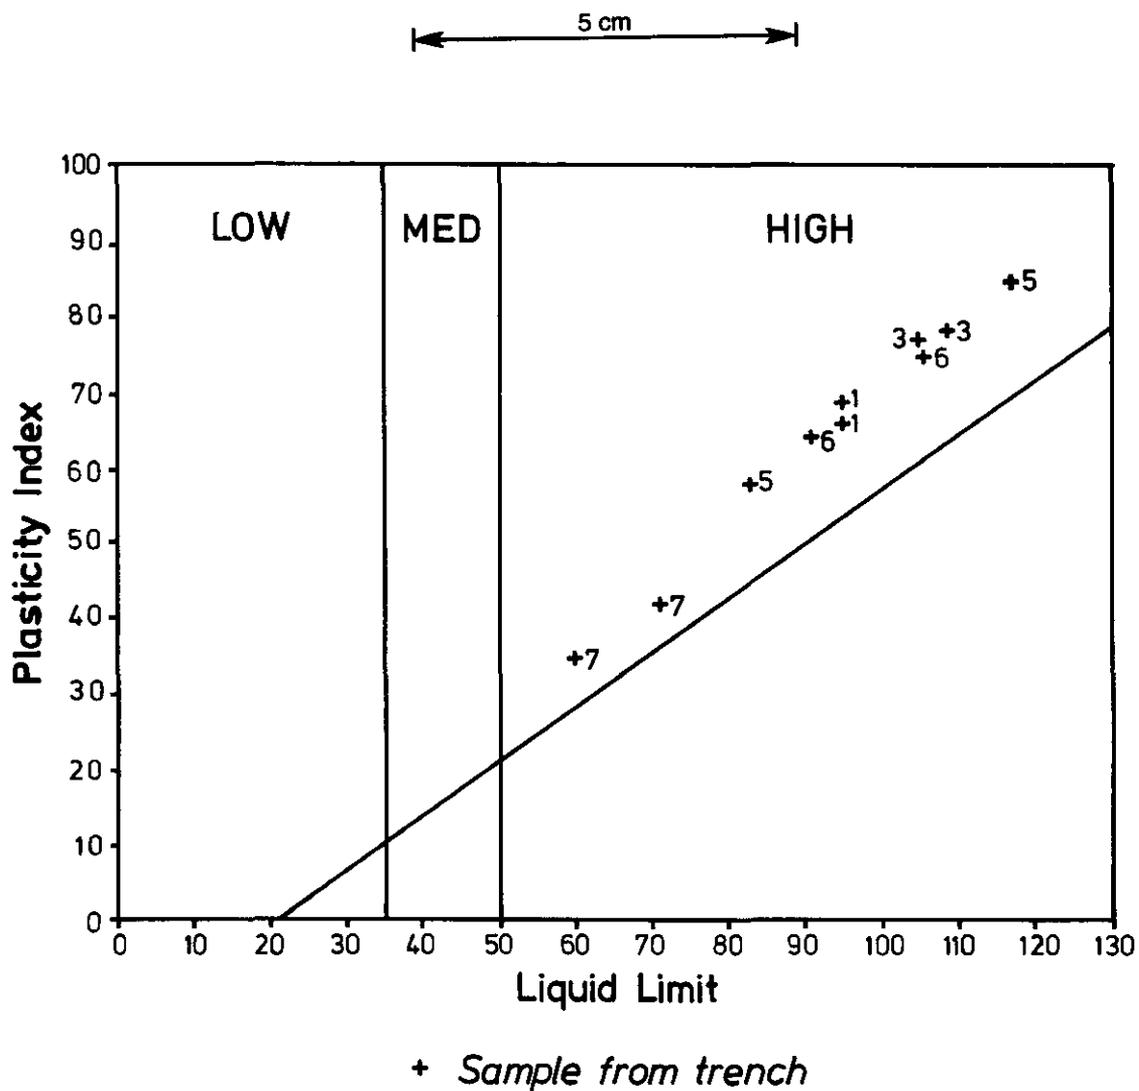
Figure 2. Plasticity range of samples.

The remainder of the samples were less rubbly and were weathered completely to a clay, even though some still retained an igneous texture. The samples had high liquid limits and covered a wide range in the high plasticity classification (fig. 2). The X-ray diffraction results of the fine fraction of these samples showed the dominant clay family present was montmorillonite, which gives the clay the high linear shrinkage.

Both the surface black clay and the brown and yellow flecked clay with the igneous rock texture were highly plastic, but the range of plasticity is wide with plastic indices ranging from 35 to 79 (fig. 2). Some low plasticity clay was present in the harder and more rubbly clays.

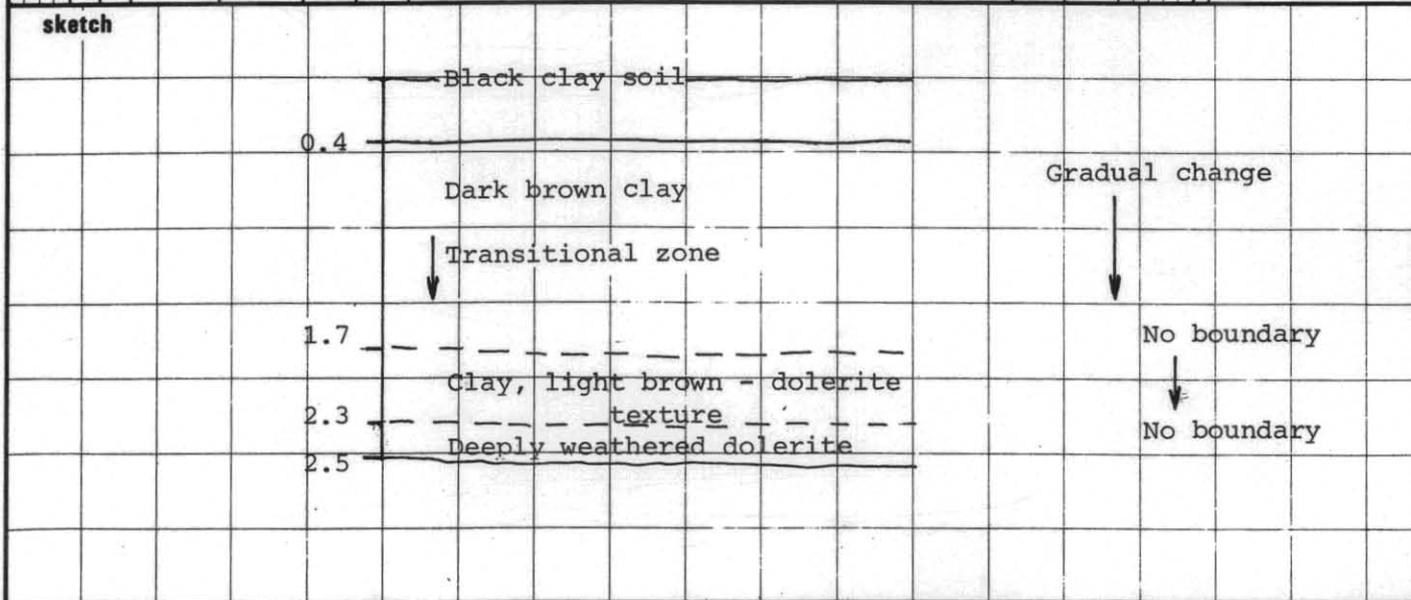
excavation no. 1
sheet 1 of 1

penetration 1 2 3	support water	notes samples, tests	metres R.L. depth	graphic log	classification symbol	material soil type: plasticity or particle characteristics, colour secondary and minor components	moisture condition	consistency density index	hand penetr- ometer kPa 25 50 100 200 400	structure, geology
					OH	Clay - Black, organic. High plasticity, with roots	M	V St.		Surface soil
	None		0.5		CH	Clay - Dark brown, medium to high plasticity. Flecked appearance which becomes igneous dolerite texture at base. Limonite staining. Massive and compact, + 500 kPa.	M D	H		Transition zone
	None		1.0

1.5							
			2.0		CH	Clay - Brown, spotted, high plasticity. Massive, almost rock - definite dolerite texture, + 800 kPa	D	H		Extremely weathered and decomposed dolerite

2.5		CH	Clay - Yellow, high plasticity. Massive - extremely weathered dolerite.	D	H		Dolerite
						Backhoe had difficulty penetrating, trench stopped.

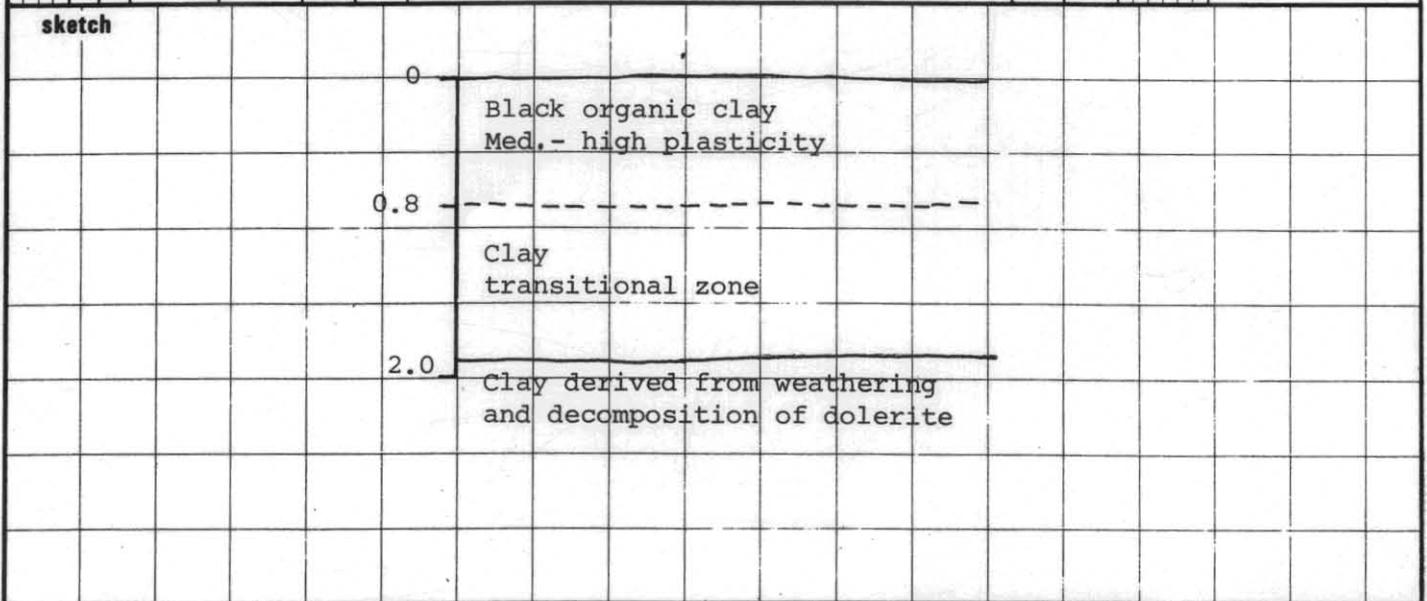
excavation no. 2

penetration 1 2 3	support water	notes samples, tests	metres R.L. depth	graphic log classification symbol	material soil type: plasticity or particle characteristics, colour secondary and minor components	moisture condition	consistency density index	hand penetr- ometer kPa	structure, geology
			0.5	OH	Clay - Black organic. Med.- high plasticity with roots.	M	V St		Surface soil
	None	None	1.0	CL ↓ CH	Clay - Yellow, flecked. Med.- high plasticity. Massive but igneous texture becoming apparent at depth.	D	H		Transitional- zone to decomposed and extremely weathered dolerite
			2.0	CL CH	Clay - Yellow, decomposed and extremely weathered dolerite.	D	H		Weathered dolerite
					Backhoe stopped. Penetration becoming difficult.

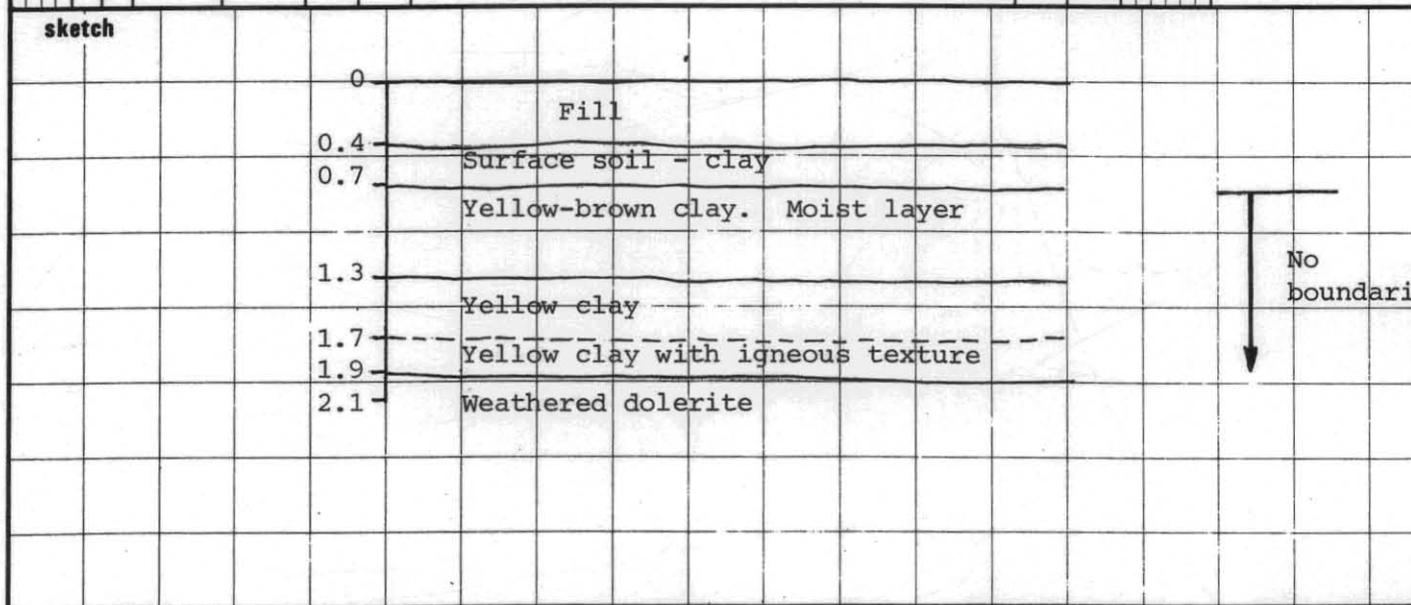
excavation no. 5
sheet 1 of 1

penetration 1 2 3	support water	notes samples, tests	metres R.L. depth	graphic log	classification symbol	material soil type: plasticity or particle characteristics, colour secondary and minor components	moisture condition	consistency density index	hand penetr- ometer kPa 25 50 100 200 400	structure, geology
	None				GW	Sand, soil and boulders - soil, clay	M	St		Fill
	None				SW	organic. Boulders dolerite, 30-60 mm.				
	None				OH	Sand wellgraded, fine - med., white				
		S1	0.5		OH	Clay - Dark brown, high plasticity with roots and white zeolite? carb.? spots and roots.	M	V St		Surface soil
		S2	1.0		CH	Clay - Yellow-brown with white flecks High plasticity.	M			Subsurface clay

1.5		CL	Clay - Yellow, fine, medium to high plasticity. No igneous texture	D	H		Transition zone
					CH					
					CL	Clay - Yellow, with harder, presumed ironstone band. Igneous texture	D	H		Extremely weathered

2.0		CL	Clay - Extremely weathered dolerite	D	H		Dolerite
						Backhoe stopped by a hard layer.
