UR1985_48

1985/48. House cracking at Devon Hills Estate, Breadalbane

W.R. Moore

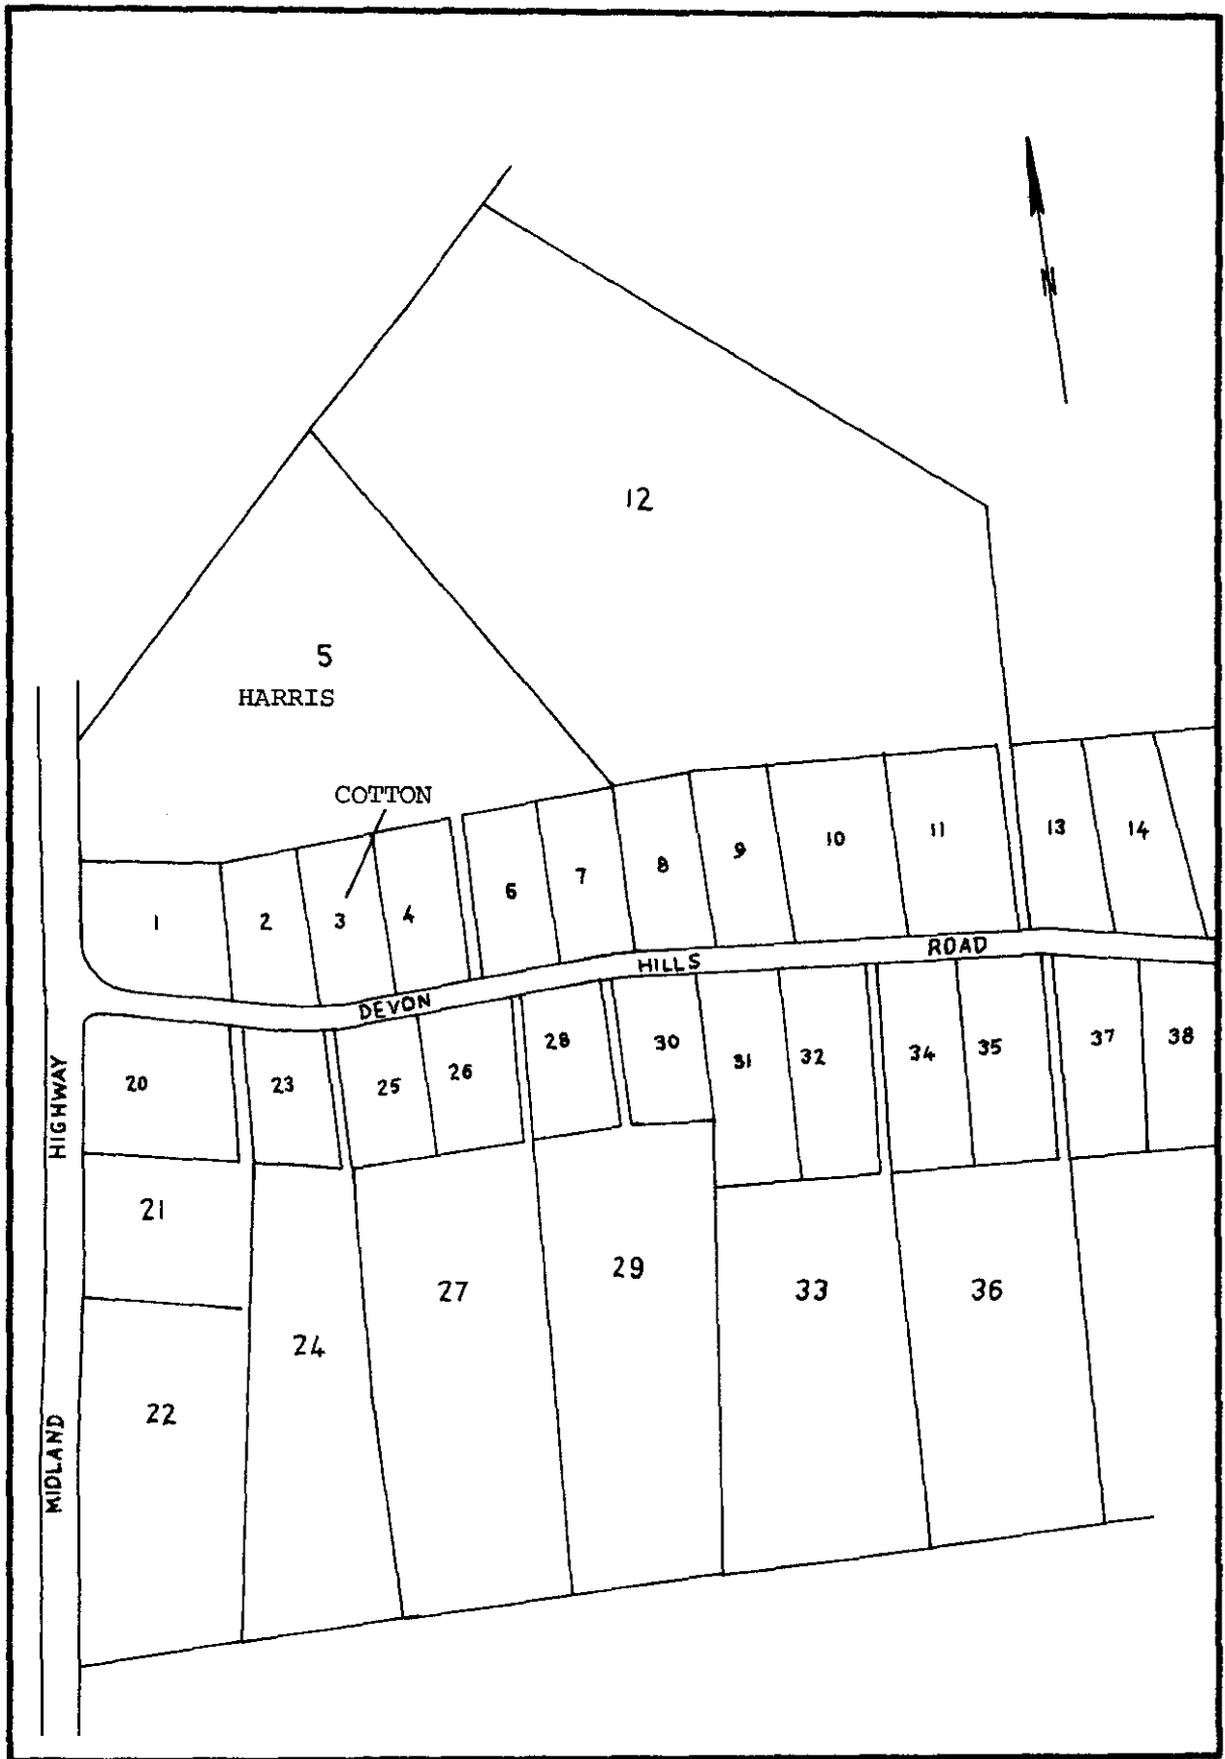
Figure 1. *Devon Hills Estate.*

In addition some complaints of house cracking were received, particularly from Mr Harris whose house on Lot 5 is the nearest on the estate to the quarry (fig. 1). Mr Harris was of the opinion that the cracking of his house was caused by the vibration from the quarry's blasting operations.

It is significant that although complaints of excessive vibration have been received from the residents of the houses on the northern side of the Devon Hills Road, as for example Cotton's (Lot 3, fig. 1), no house cracking has been reported. From surface mapping, these houses appear to be underlain by siltstone and possibly mudstone of Permian age. The only complaint of cracking associated with blasting was at Harris' (Lot 5, fig. 1). This house is located close to dolerite outcrops but appears to be situated on a black surface clay soil with a subsoil of brown clay, both of which are plastic and possibly with a high linear shrinkage.

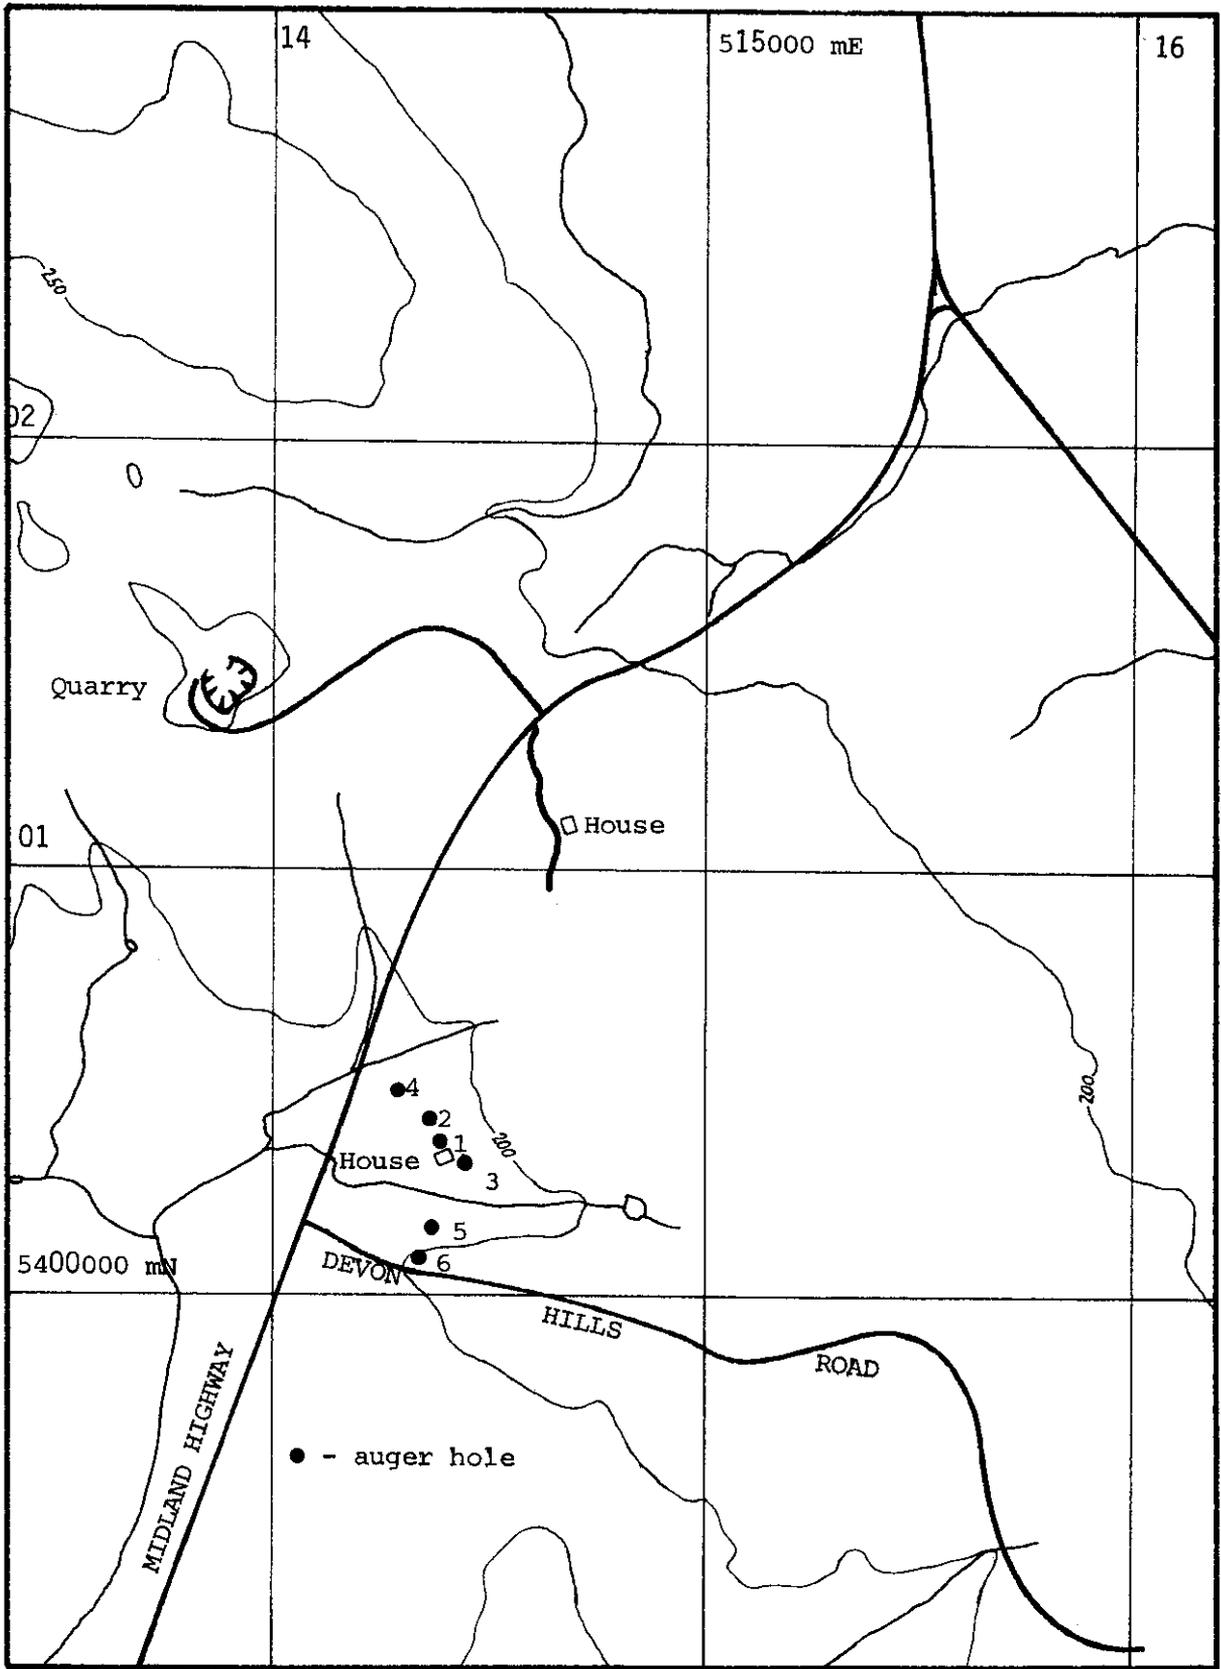
Figure 2. Location map, showing positions of auger holes

Six holes were auger drilled, the locations of which are shown on Figure 2. The lithological logs are given in Appendix 1. Four holes were drilled on Harris' property (Lot 5) and two on Cotton's (Lot 3). Three holes on Lot 5 were drilled around the house and the fourth was drilled between the house and the old quarry with dolerite outcrops, approximately in line with the Talisker quarry. One hole on Lot 3 was drilled south of the stream, close to where the dolerite/Permian sediment contact was thought to be located. The sixth hole was on the ridge on the west boundary of Lot 3, near the house.

All the holes on Lot 5 encountered dolerite at a shallow depth of between 0.8-0.9 m, overlain by black clay soil and clay subsoil, with the drill being stopped by the dolerite. In contrast on Lot 3, the drill was still penetrating when stopped in the Permian mudstone. The depths of these two holes were 1.7 m and 1.5 m. The hole drilled on the ridge of the Devon Hills Estate encountered silty soil with no clay, and little moisture was present in the soil or the underlying mudstone.

- (3) A house of similar age to Harris' exists on Devon Hills ridge on the east side of the Midland Highway (fig. 2). No complaints of damage or excessive vibration from blasting have been received by the Department of Mines from the residents of this house. This house is closer to the quarry and appears to be founded on dolerite. If the damage to Harris' house was the result of blasting vibration, damage would also be anticipated on a house located in this position and founded on dolerite rock.

Vibration measuring stations should be set up on the house on Devon Hill ridge founded on dolerite; on Harris' house on clay and dolerite; and on the ridge at Devon Hills Estate (for example Cotton's) on sites underlain by Permian sediments.

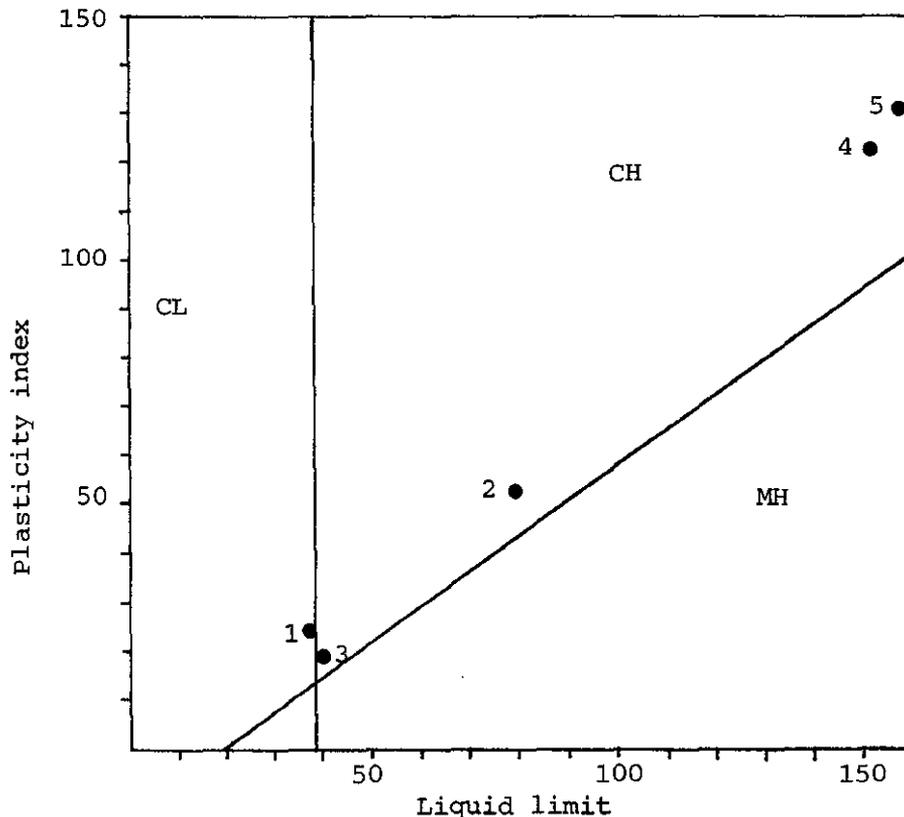
Figure 3. Plasticity chart of clay samples.

Clay samples were collected from the subsurface horizon in Holes 1-5 and the clay tested in the laboratory. The results of these tests are given in Table 1 and the plasticity classification graph in Figure 3. These results show that the subsurface clay in the dolerite area varies from a low to very high plasticity with a plasticity index range of <37 to 131. The clay with the highest plasticity index is that overlying the Permian mudstone in the shallow stream depression (Hole 5). The clay samples with a low plasticity index were rubbly but their laboratory values are lower than anticipated from field inspections.

The linear shrinkages reflect the plasticity indices for the low to medium plasticity clay. Sample 4, with the highest plasticity index, had a linear shrinkage of 28%.
