**TASMANIA DEPARTMENT OF MINES  
UNPUBLISHED REPORT 1985/80**

## **Inspection of Lot 5, Ambrose's Subdivision, Windermere**

*by W. R. Moore*

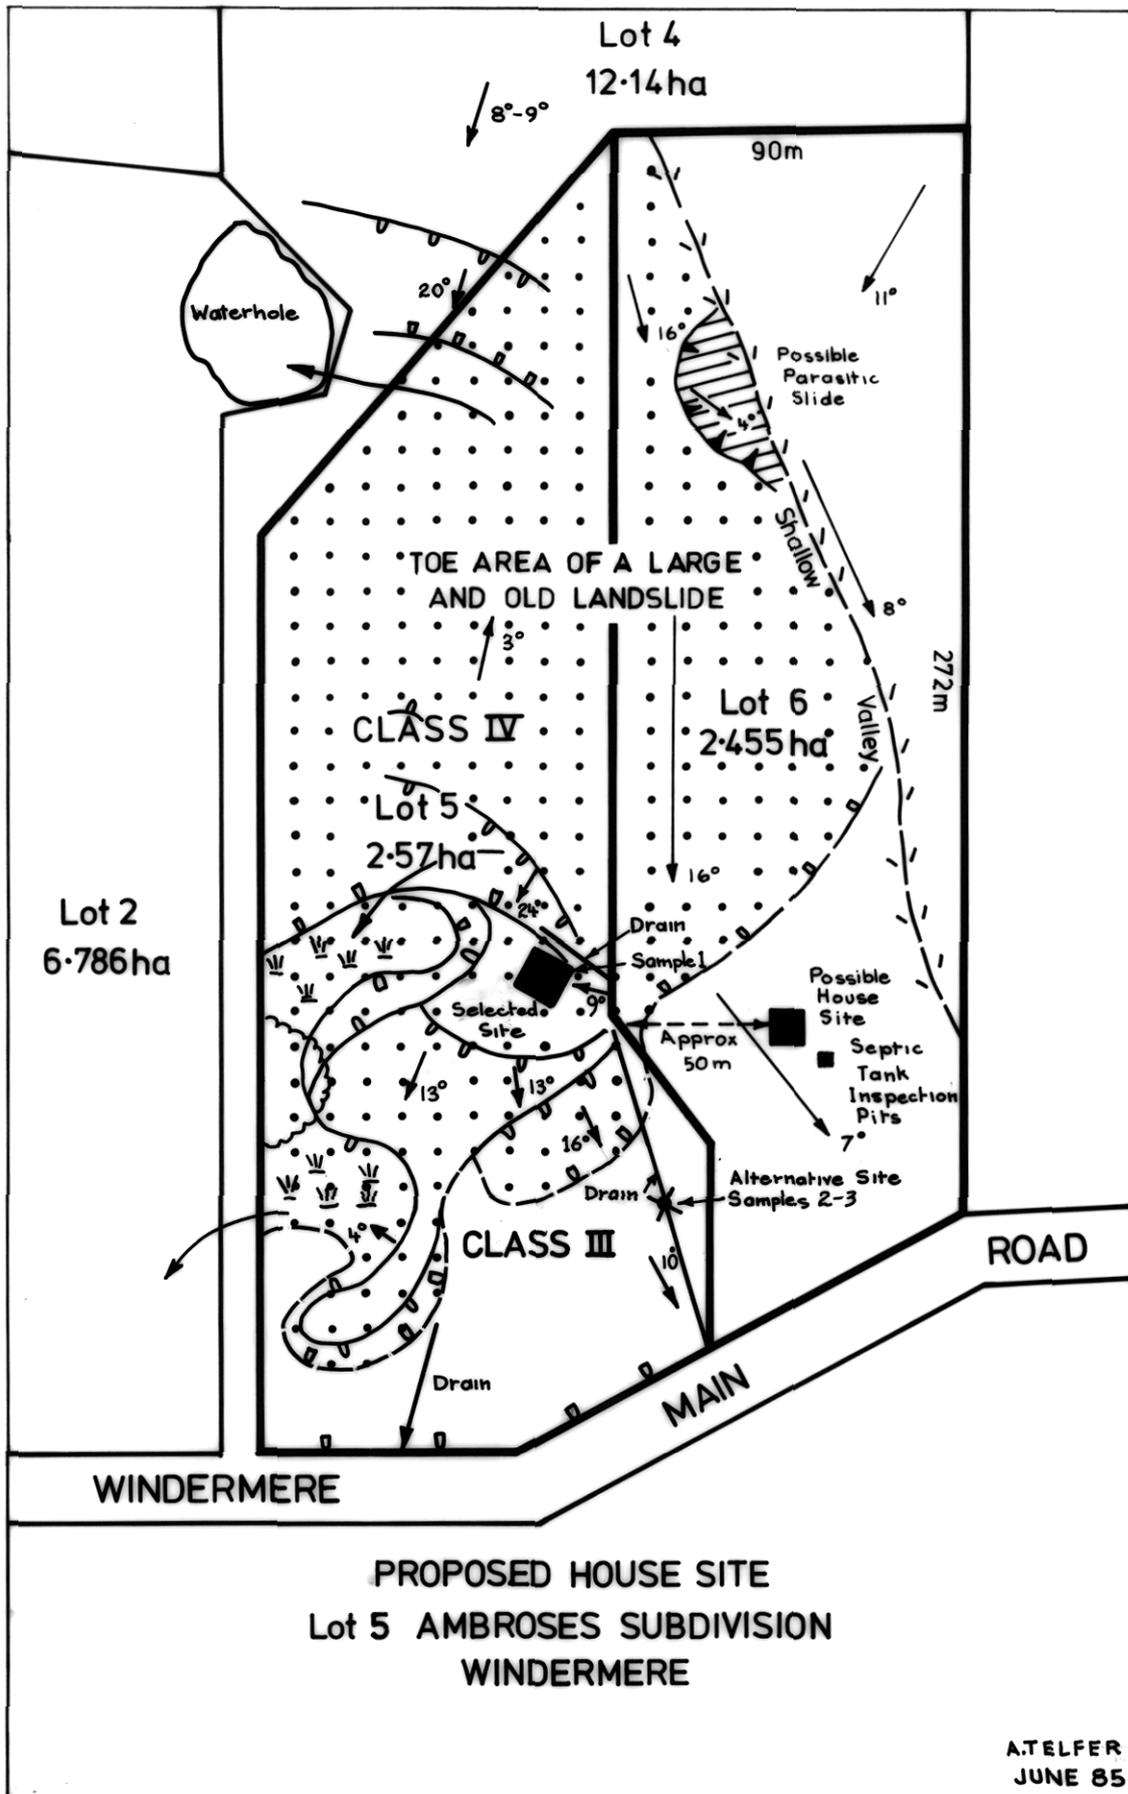
The owner contacted the Department and it was realised from this discussion that the house had been inadvertently sited on the Class IV area on the lowest and possibly youngest toe bench of the old landslide. Departmental geologist W. L. Matthews visited the site and confirmed that the house site was in the Zone IV area and collected a clay sample for soil testing. The following week A. Telfer, a research student working for the Department of Mines on landslides, mapped the morphology of the landslide on Lot 5 and collected two samples from an alternative house site in the Class III area. This site was located an adequate distance from the road for sullage disposal. These sites and the morphology are shown on Figure 1 and the soil test results are given in Appendix 1. Unfortunately time did not permit shear box testing to be undertaken but enough clay samples have been collected on Ambrose's subdivision to know that the angle of friction and effective cohesion of the clay are low.

The department wrote to the landowner expressing concern about the slope stability of his chosen site, although the owner had difficulty in appreciating, as his site was almost flat, why it was considered more unstable than the steeper Class III area on his block. The new morphology map of the block reduced the area of Lot 5 zoned Class III on the original subdivision plan by approximately one half. Two frontal lobes of the toe of the landslide are located on lot 5 and are well preserved, and any house site in the Class III area would be located extremely close to these lobes. If the old landslide was to become reactivated movement would most likely occur in this toe area, which would destroy a house if it was sited where the owner wished to build or in the alternative Class III area.

It appears that the difference of landslide risk between the Class III and Class IV sites was minimal, with the landslide risk being uncomfortably high at both. There appears to be no justification in forcing the owner to build in an alternative area on the basis of slope stability, especially in view of the costs already incurred in digging the foundations. Therefore the compromise suggested was that the owner be allowed to retain his house site in the Zone IV area but that all the stormwater and septic tank overflow would be piped off the site and the septic tank overflow be transferred to the Class III area.

It was stressed to the owner that this lot was in a high landslide risk area and drainage was the key to the future stability of the site. As the house is to be built on an old landslide area (Zone IV), the provisions of the 1978 Building Regulations, Division 5, are recommended.

All stormwater and all drains should be located so that they can be easily inspected for future leakage. On this site the next toe upslope from the house should not be touched or excavated. As many trees as practical should be planted on the site, the driveway to the house site be adequately drained and any cut into any of the slopes be kept to minimum height. If a swimming pool is to be located on this site it should be an above ground type so that any leakage can be observed.

Any wet areas or small seepages on the higher benches, as well as the lowest house site bench, should be drained. If drainage of the toe of the old landslide can be achieved and maintained, the risk from landslide can be reduced to acceptable levels. It is the maintenance of this drainage system over a long period of time that is the cause for concern to the engineering geologist. If a change of ownership of the house occurs the new owners should be made aware of the importance of maintaining the drainage system.
