## Inspection of a proposed subdivision at Windermere

*by B. D. Weldon*

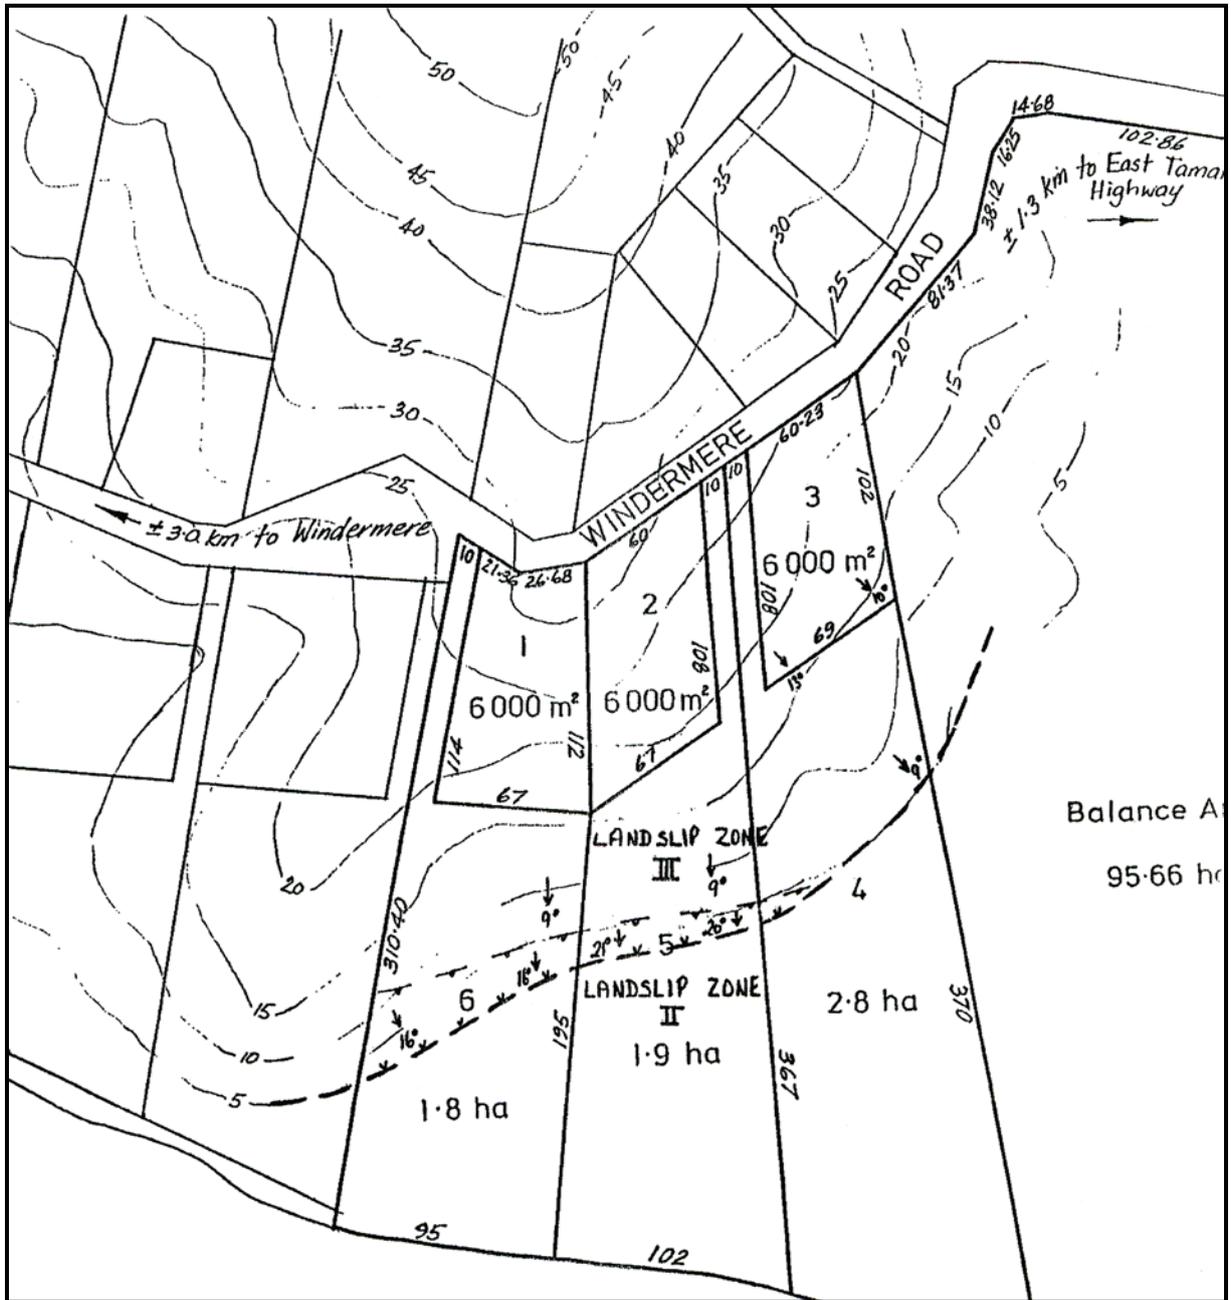
Figure 1

A proposed subdivision on the southern side of Windermere Road (fig. 1) was inspected. The proposal consists of the subdivision of six lots from the balance of the title. Three lots are 'internal' with frontages to Nelsons Shoal on the River Tamar. The lots are located on an undulating to rolling mid-slope segment and on the floodplain of the River Tamar. The floodplain segment is classified as landslip Zone II (i.e. stable ground but on soft rocks) on the advisory Tamar Valley Landslip Zone Map. The mid-slope segment is classified as landslip Zone III (i.e. potential landslip area).
