# The Storys Creek pollution problems

by P. Allan

## SYNOPSIS

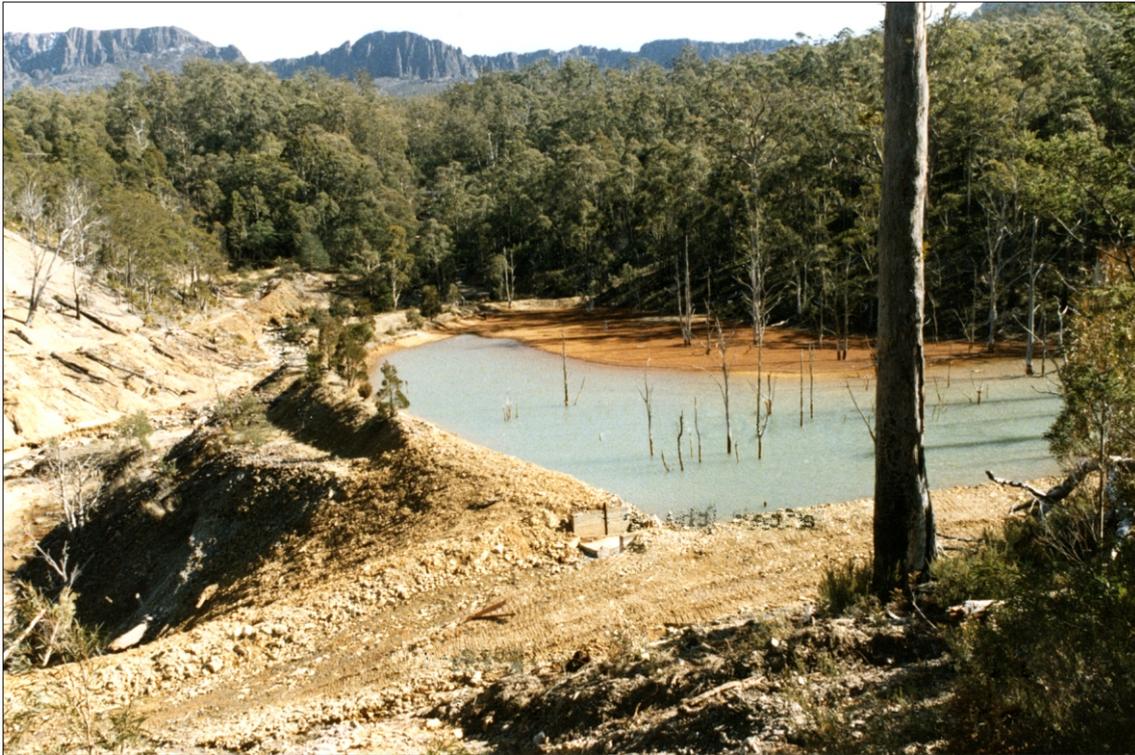
**Plate 1**

Plates 1 and 2 show the general configuration of the impounded area with the dam repaired and the spillway installed.

The dark-coloured area of the dam wall is the original dam with its rock facing. The new spillway marks the end of this original dam wall. The spillway is approximately 2½ metres wide.

The light-coloured portion of the wall is the repaired section. The original spillway was positioned about the mid-point of the repaired section and fed directly over the wall to Storys Creek. This site was the most probable cause of failure as it appears it became blocked and was then eroded out.

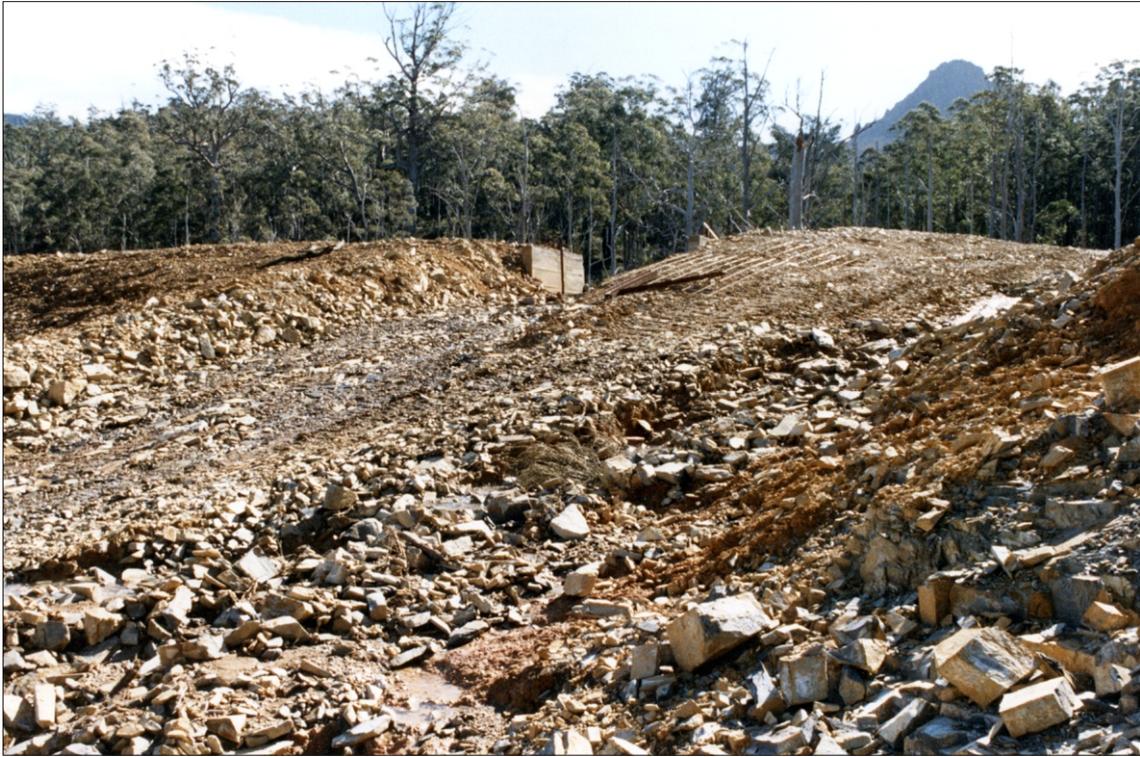
**Plate 3**

The new spillway site is on solid rock on the side of the hill and is separated by a rock bank from the newly installed diversion channel which will prevent a major run-off entering the dam. The spillway and diversion channel are connected and water is now carried along the hillside to enter Storys Creek well downstream from the dam.

Plate 3 shows the spillway (centre) and the diversion channel to the right from the confluence while Plate 4 shows the diversion channel above the dividing wall relative to the spillway.

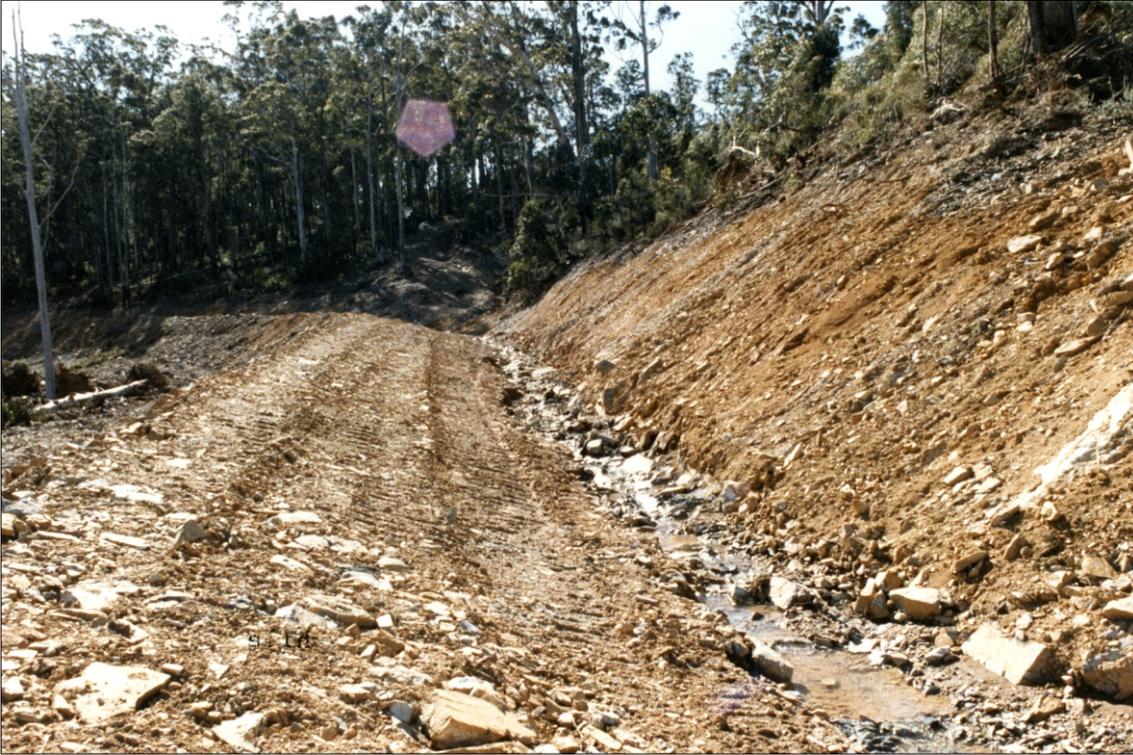
**Plate 5**

Plate 5 shows the lower portion of the diversion channel while Plate 6 shows the upper portion connected to the feeder creek.

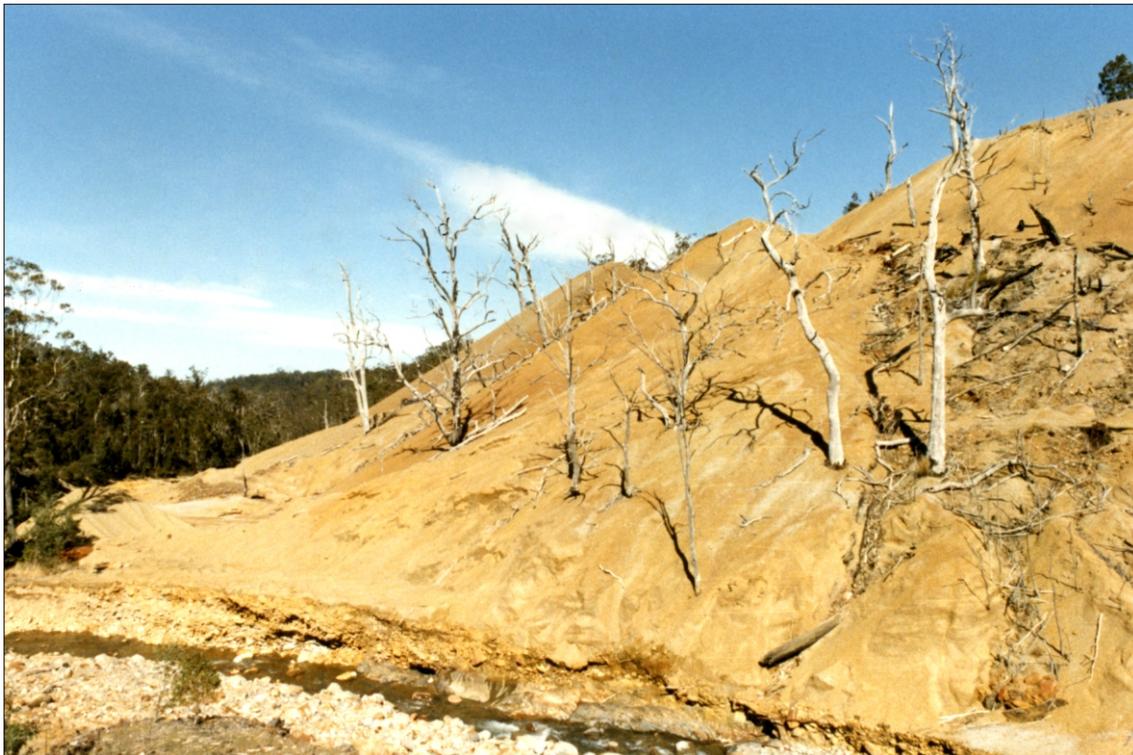
**Plate 7**

Plate 7 shows a subsidiary problem which existed on the opposite bank of Storys Creek where tailings on an undermined bank were threatening to divert the creek towards the dam. The area at most risk was cleared of tailings.  
Plate 8 demonstrates that the dam is sound and water is building up to cover the slimes.

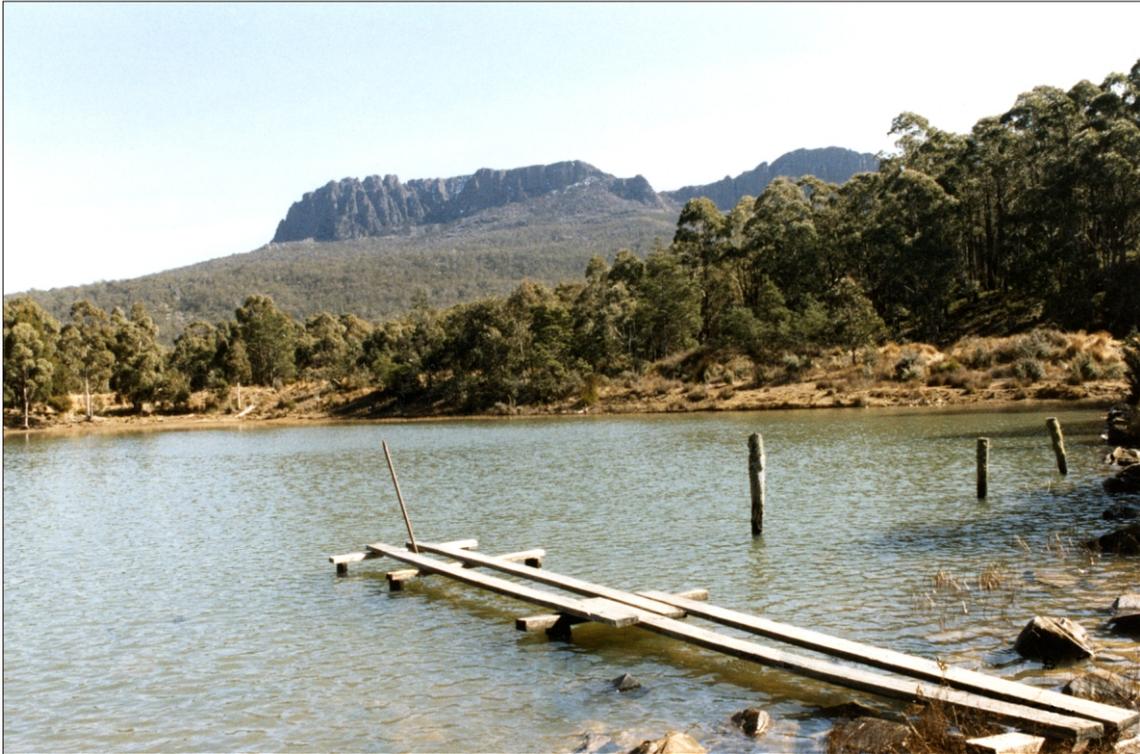
**Plate 9**

Plate 9 is a general view of the lower level freshwater dam serving the Storys Creek township with the upper level dam behind the earth wall bearing vegetation in the middle distance. The spillway is at the other end of the dam and is shown in Plate 10.

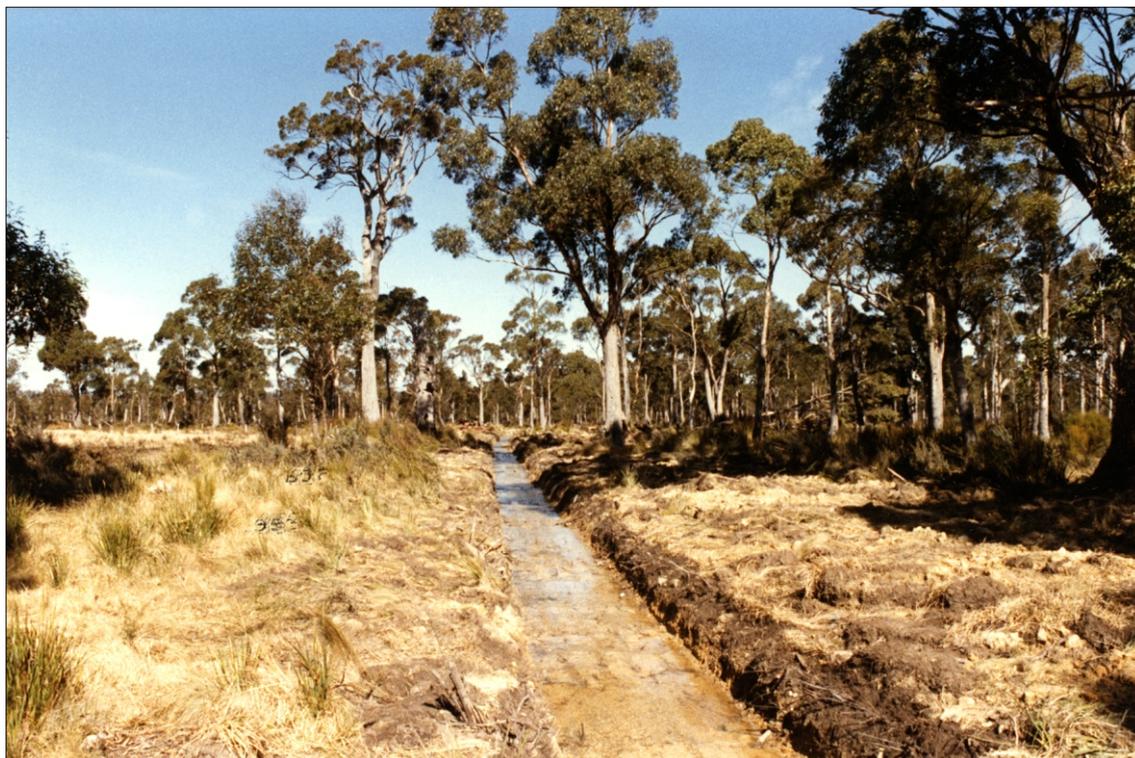
Plate 11 shows the diversion channel which has been established to carry water from the freshwater spillway away from Storys Creek.

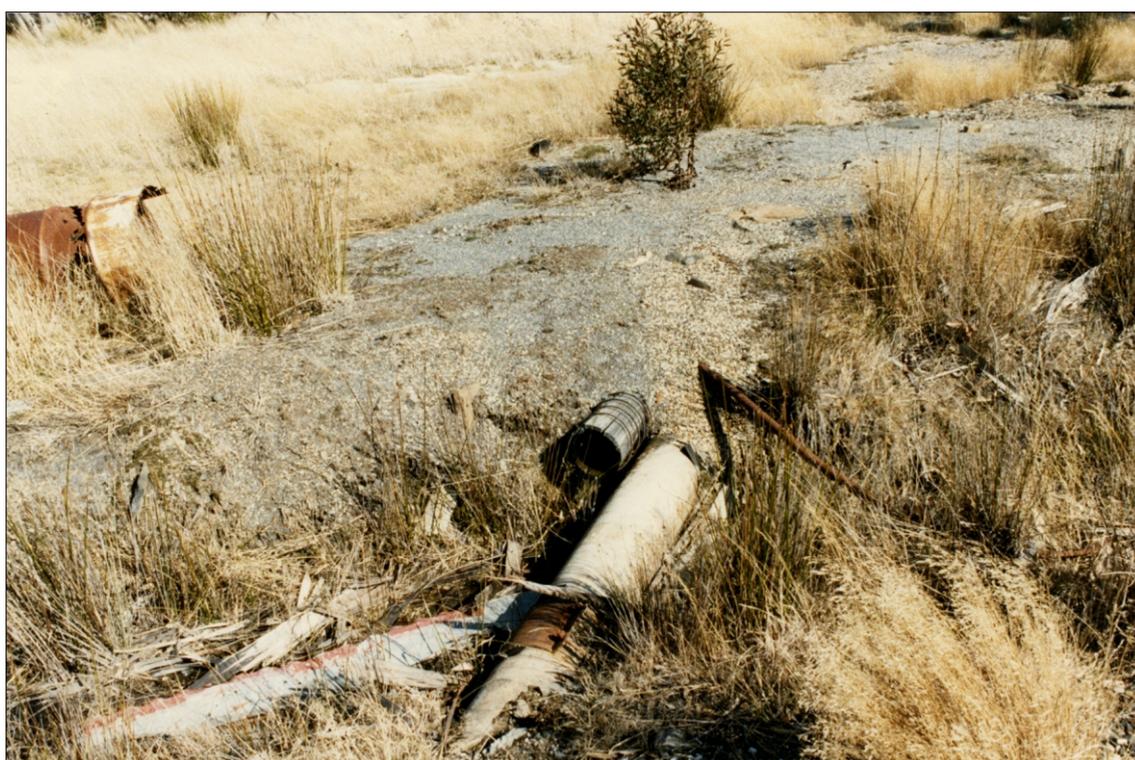
Plate 12 shows a historical wood-stave pipe close to the old mine site running a reasonable flow of water draining from the ground.

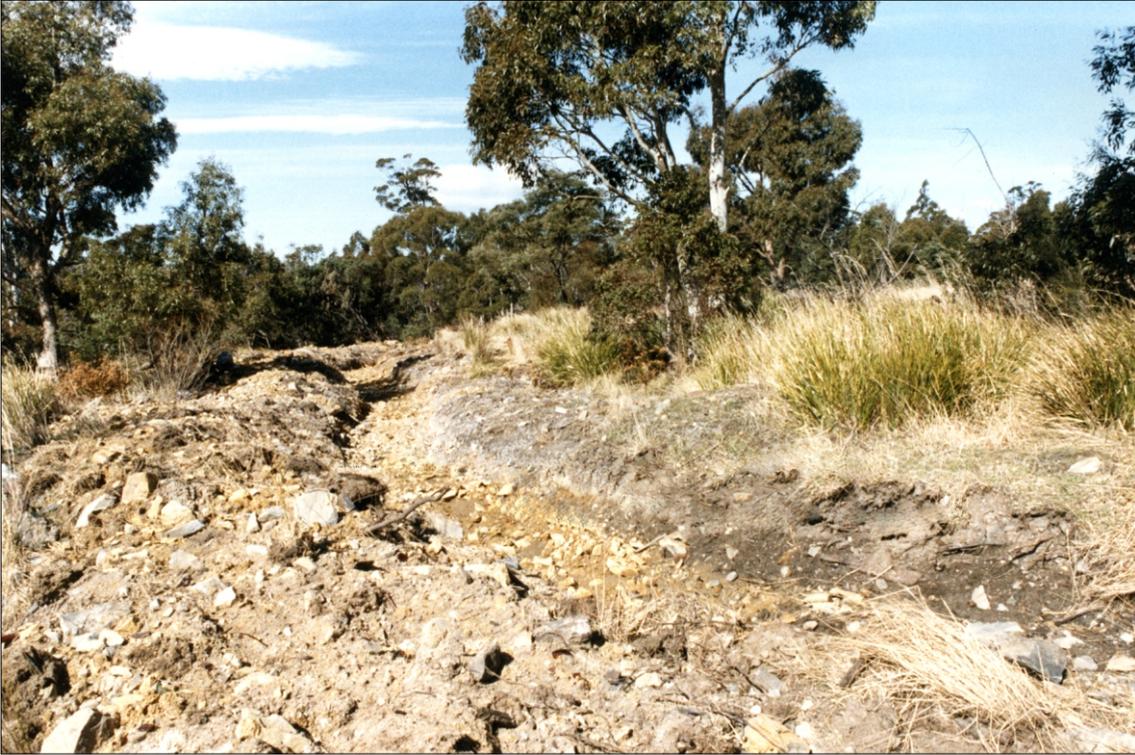
Plate 13 shows the stormwater channel cut at the far end of the township to carry run-off well clear of Side Creek.

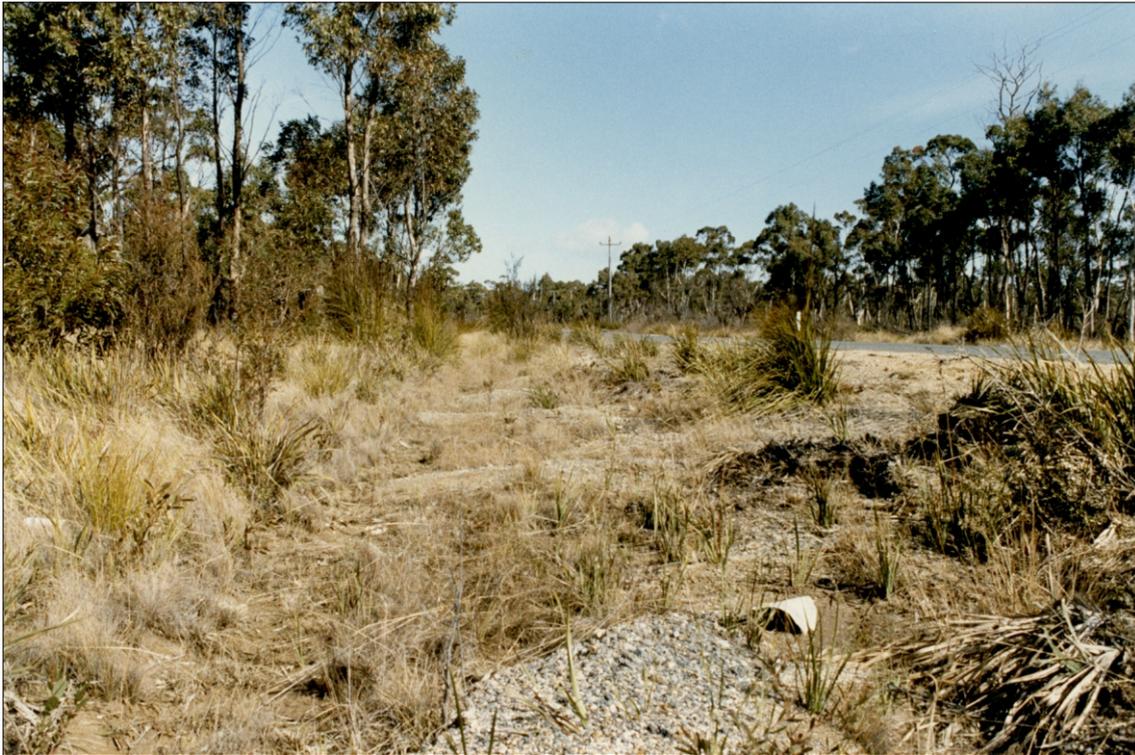
**Plate 14**

Plate 14 shows the side of the Rossarden–Storys Creek road. The road surface is on the right and the tailings dam wall is on the left just behind the tree line. The drainage is from right to left with the roadway acting as a dam.

The water was in such volume that it forced material from under the road and this can be seen as the lighter patches in the middle of the photograph.

The tailings dam wall prevented run off which was forced down an access road between the dams.

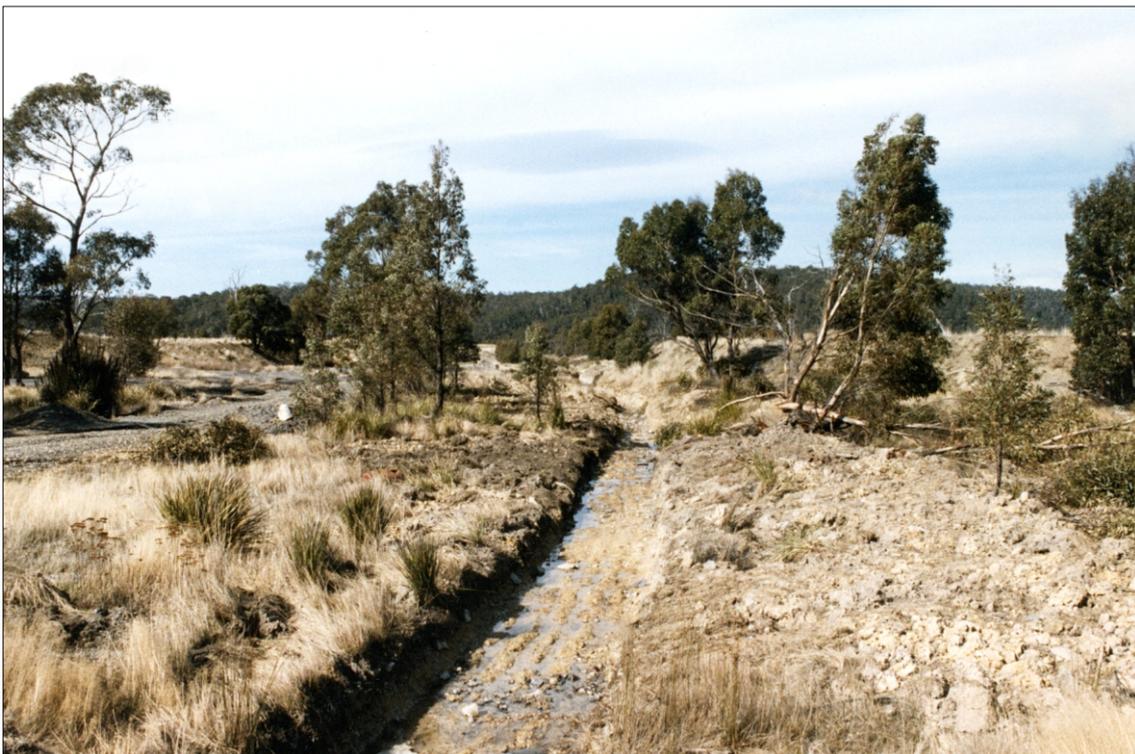
**Plate 15**

Plate 15 shows this access road on the left with the new stormwater drain which has been installed from the road to the crest of Aberfoyle Creek.

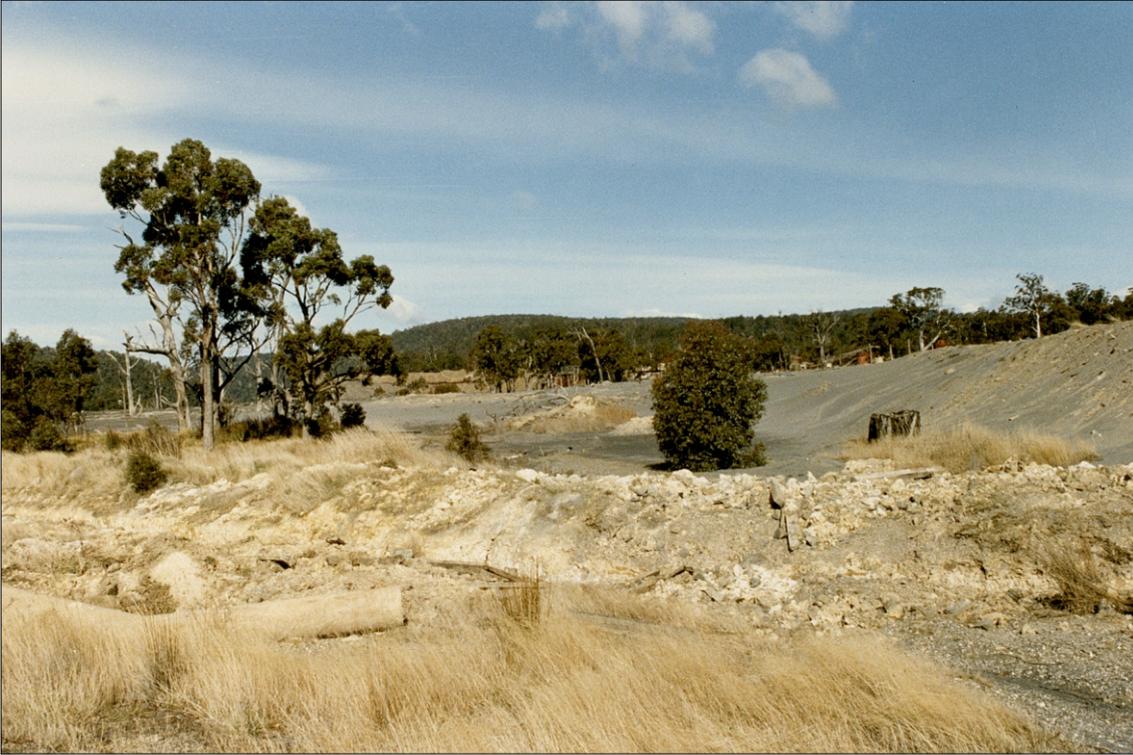
**Plate 16**

The water breached the dam wall down the access road and Plate 16 shows where this was repaired while excavating the storm drain.

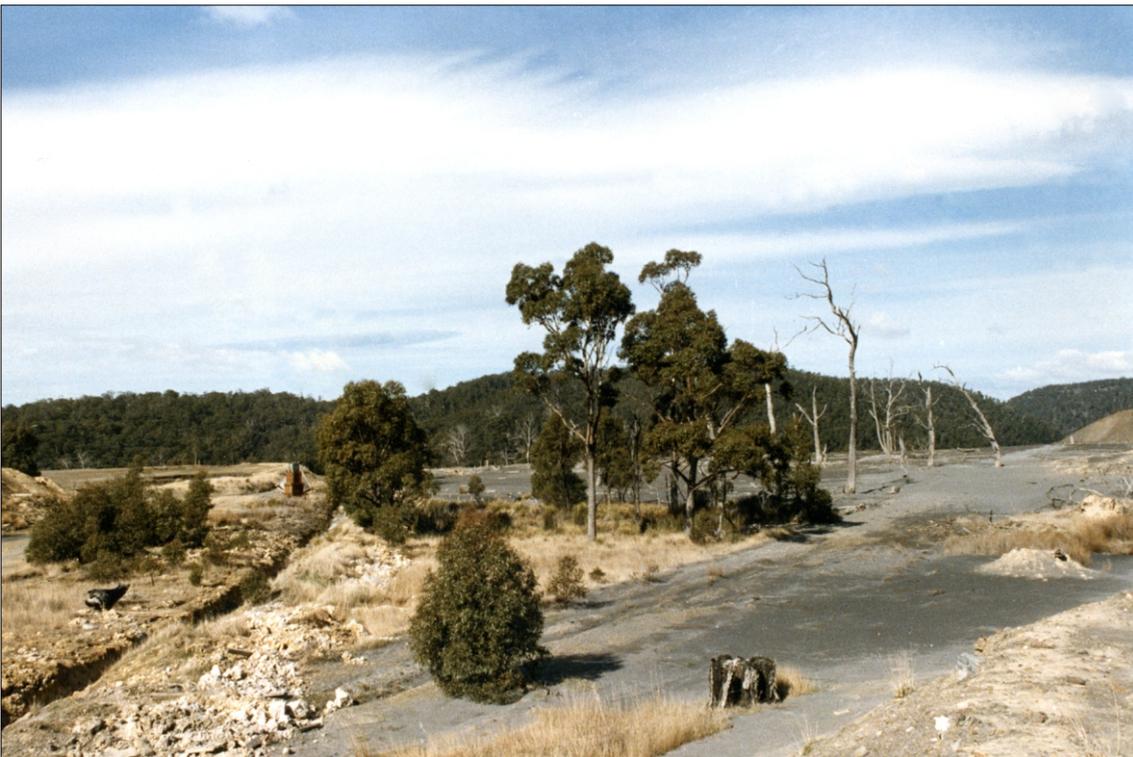
**Plate 17**

Plate 17 illustrates the road-like pathway the water established for itself towards the middle of the tailings area.

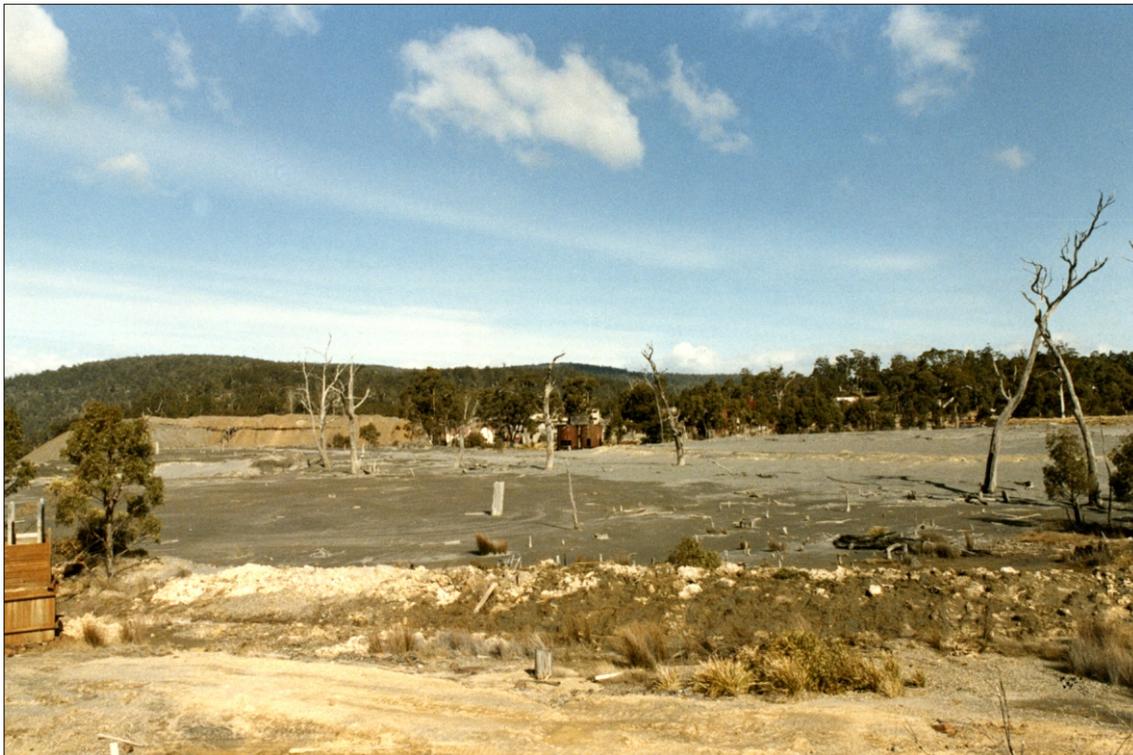
**Plate 18**

Plate 18 shows the scouring effects of the water as it flooded the area. The breach in the front wall is on the extreme left edge. Plate 19 shows the repaired breach from outside the dam area. The cutting is approximately six metres deep.

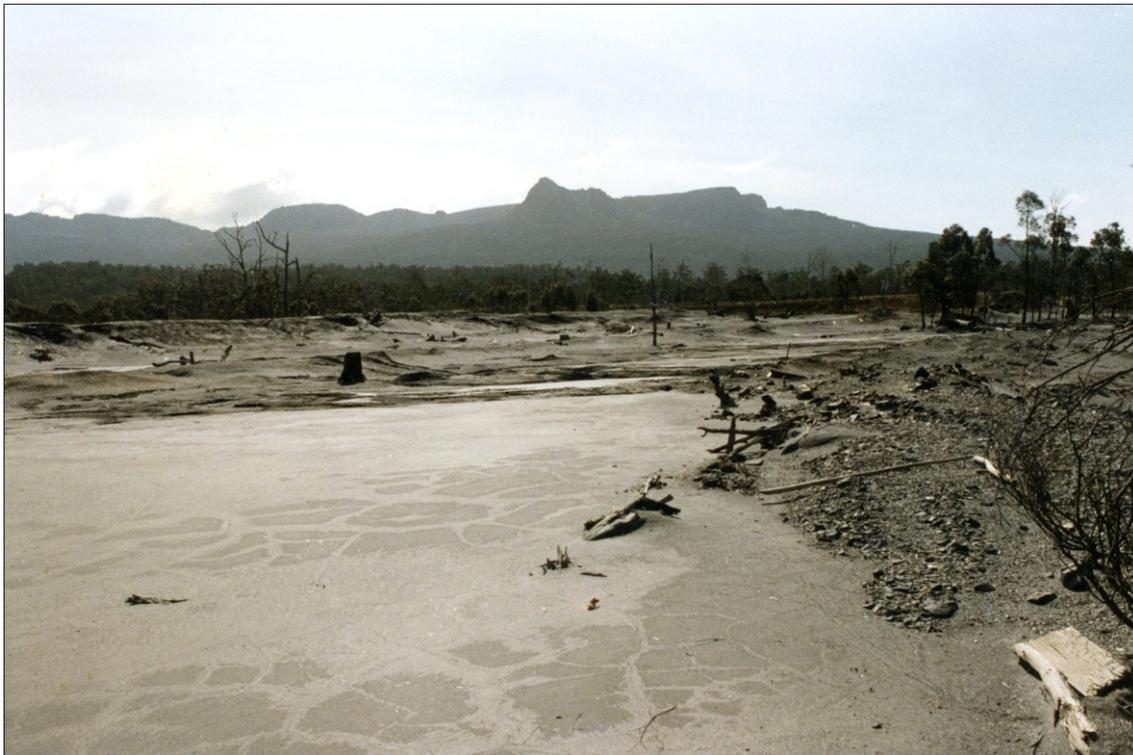
Plate 20 is a further illustration of the destruction caused by the flood.

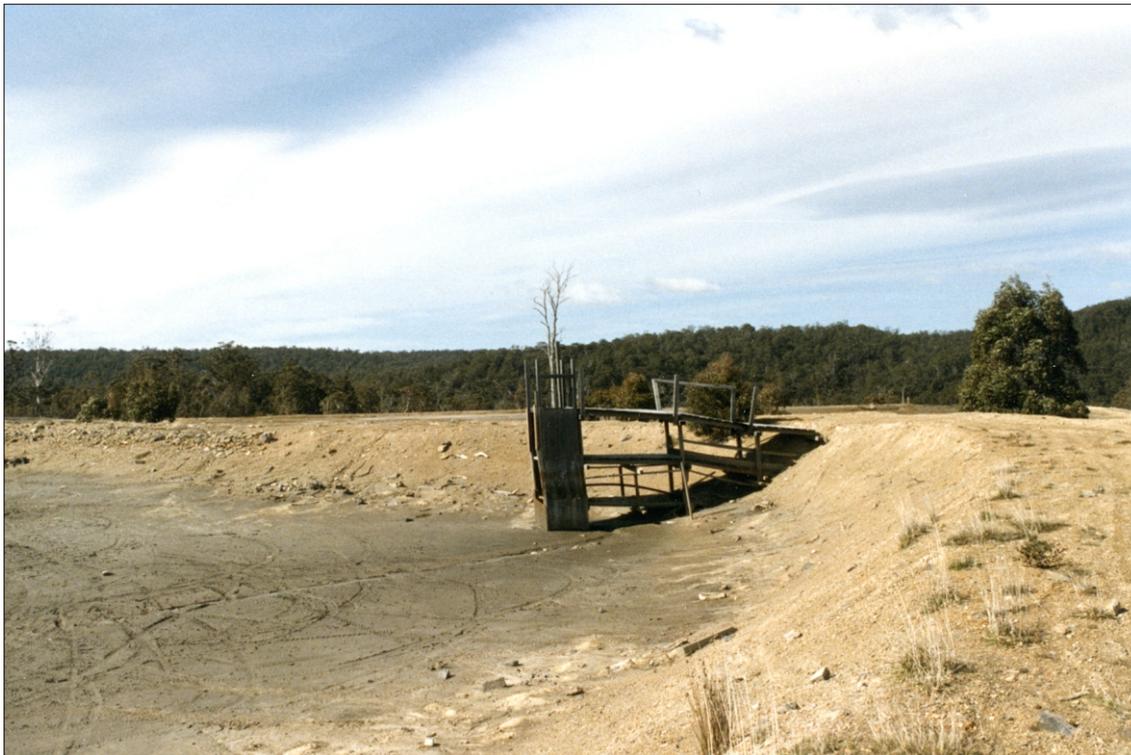
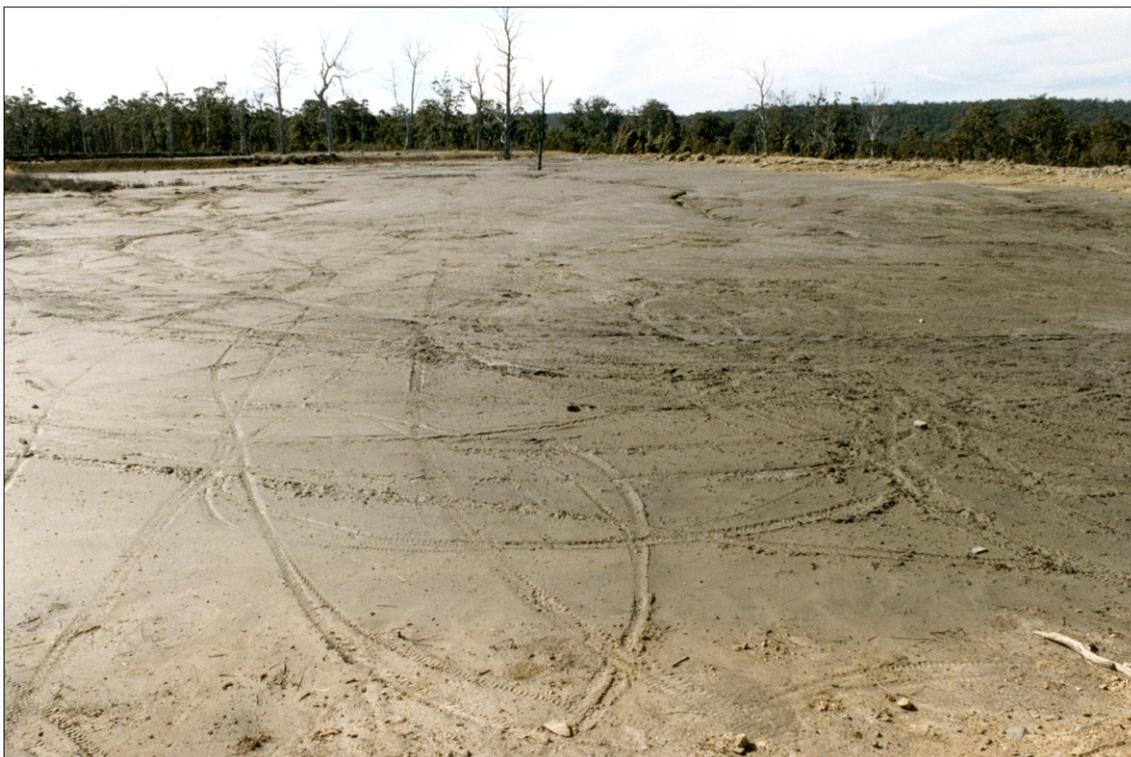
Plates 21 and 22 show the slimes dams which were not affected by the flood but illustrate the damage caused by trail bike riders.

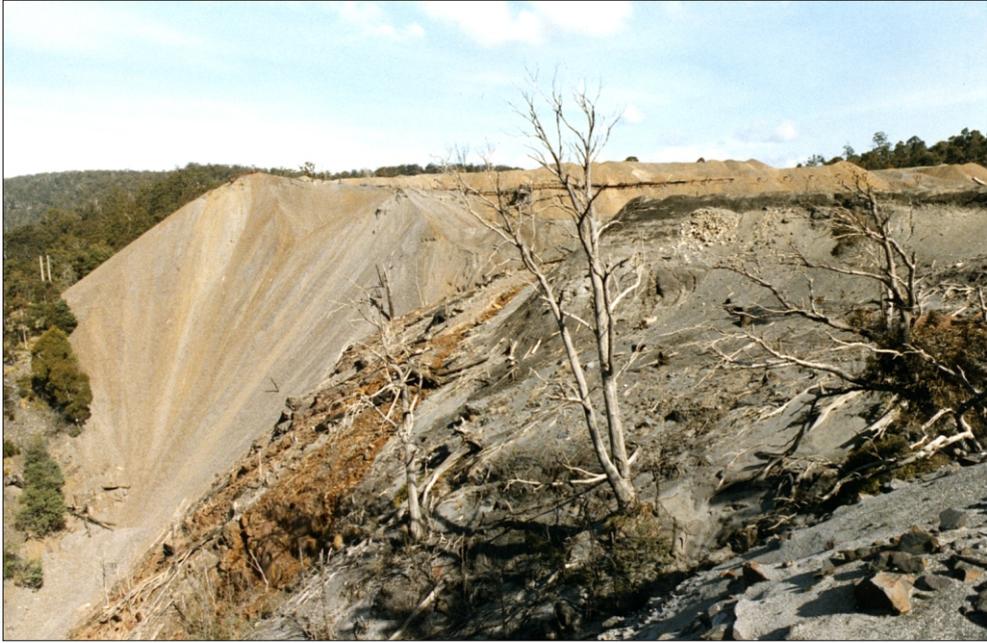
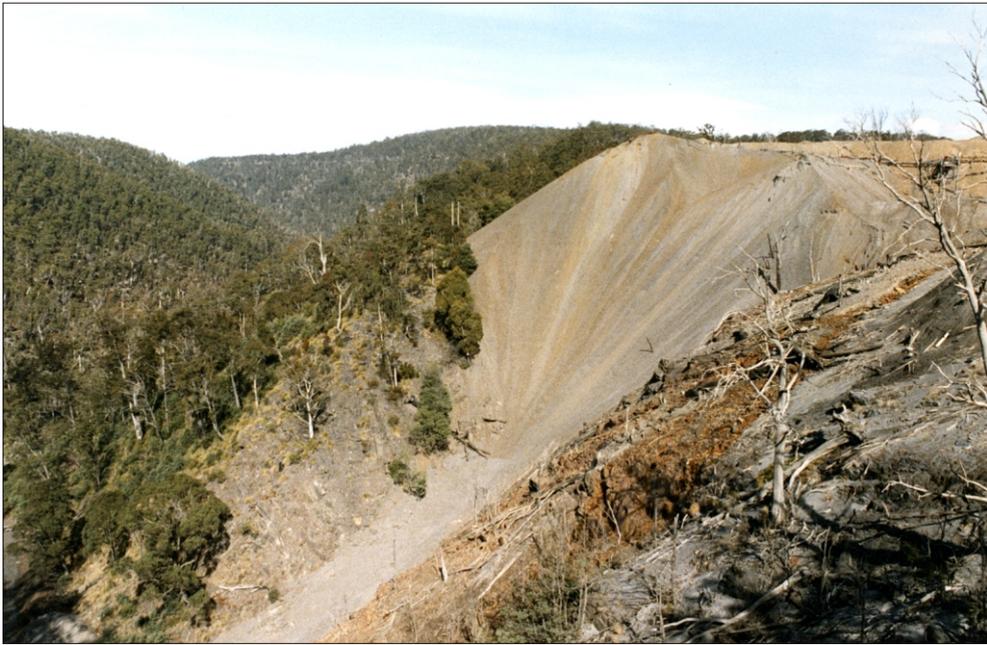
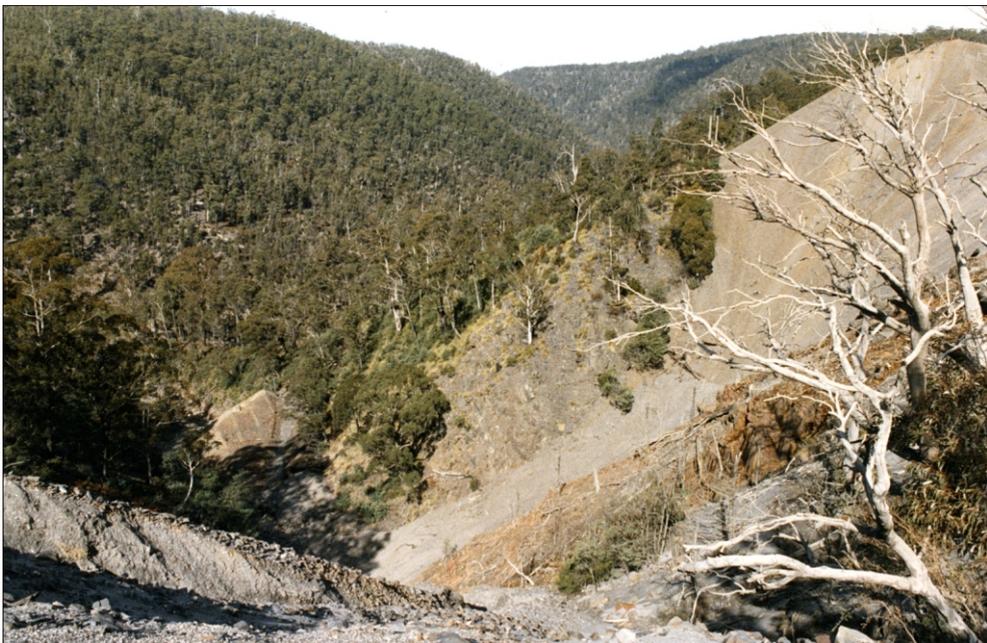
Plates 23, 24 and 25 illustrate a problem for the future as the old, large fraction tailings 'migrate' towards Aberfoyle Creek.
