UR1986-31

1986/31. Erosion problems at a proposed subdivision at Shannuk Drive, West Hobart.

W. L. Matthews

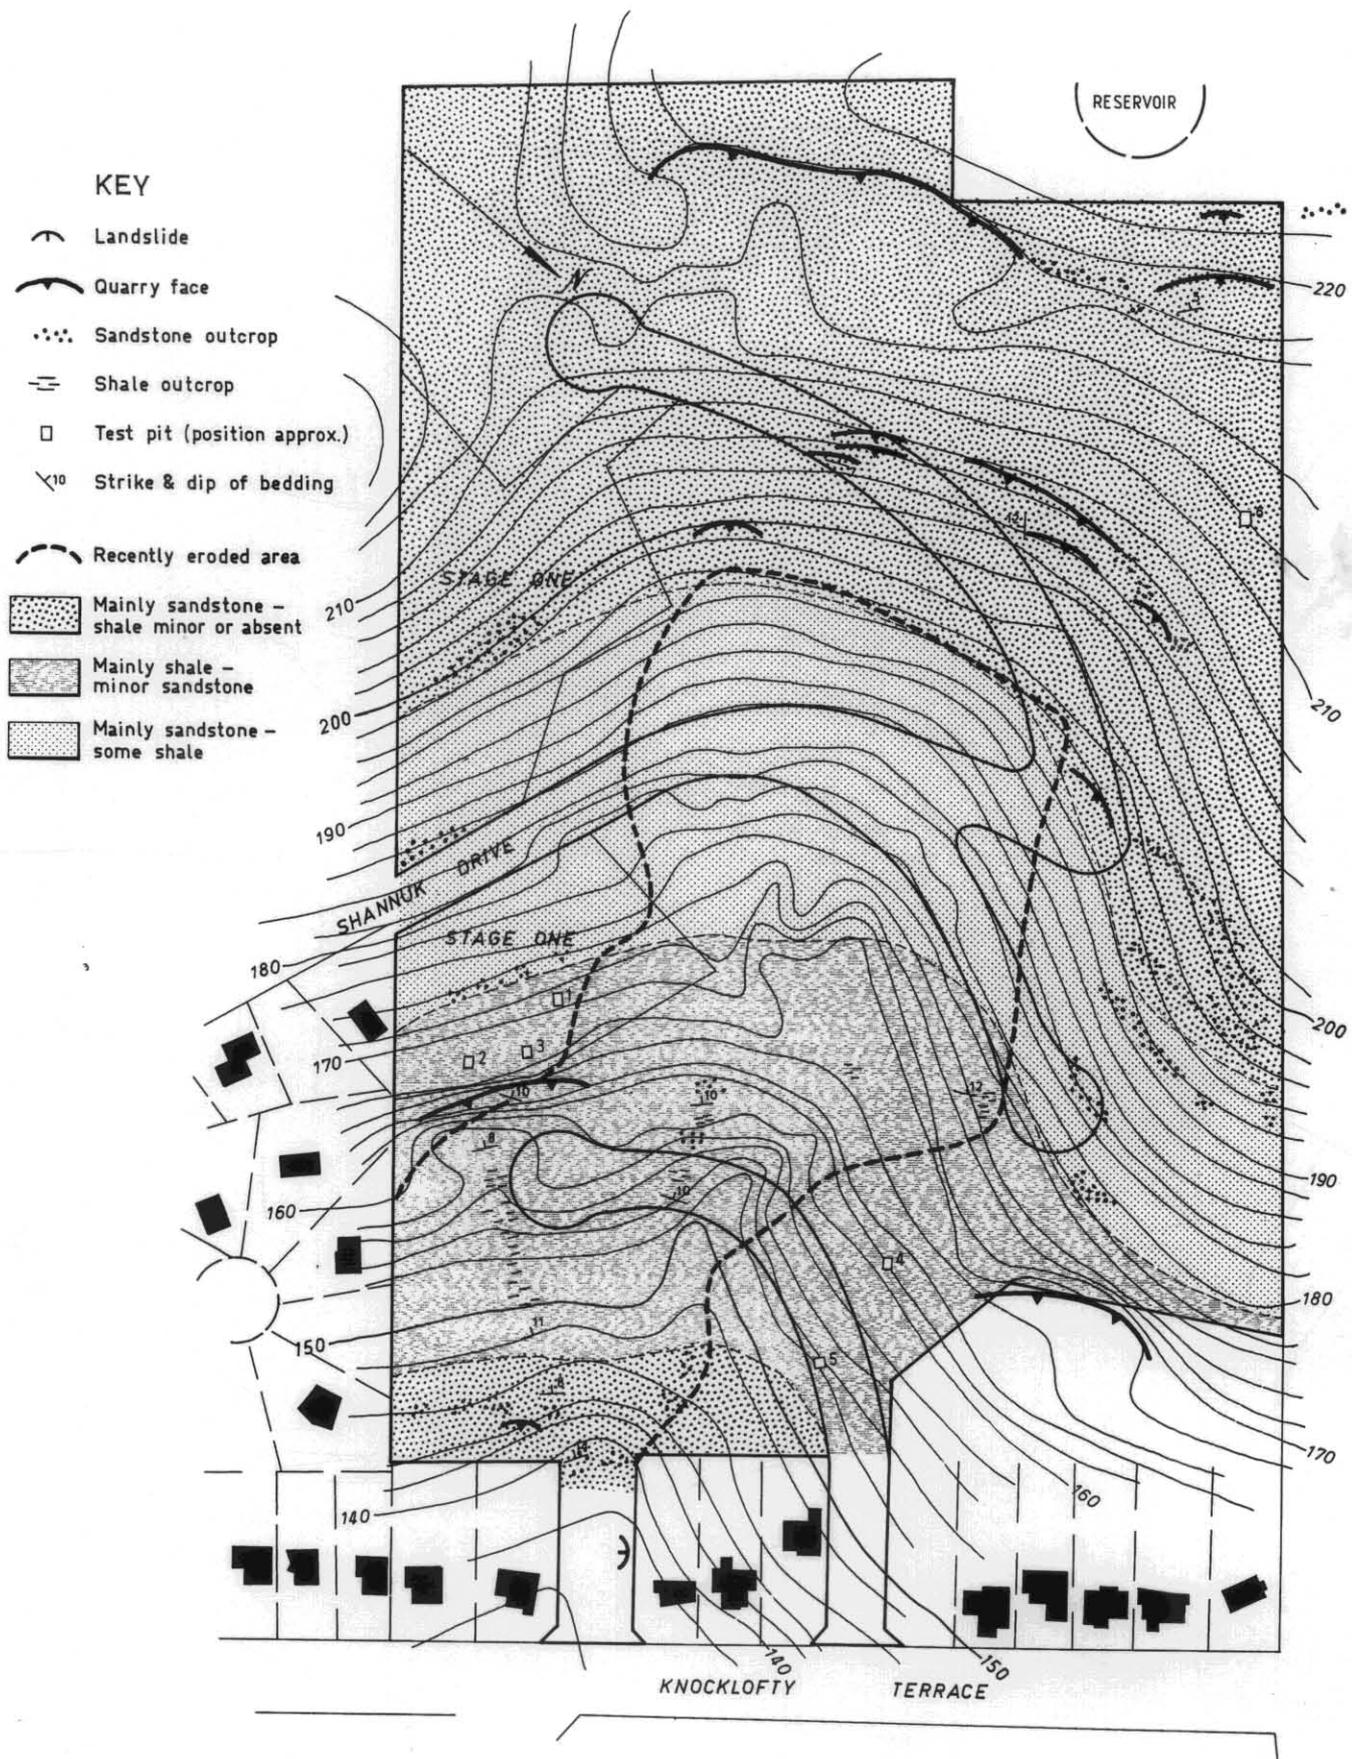
Recent erosion covers roughly one third of the area proposed for subdivision, as shown on Figure 1. This plan shows only an approximate outline, as the area has not been surveyed. Outside this area, the nature of the land surface indicates that erosion has affected other areas in the past but has been stabilised by vegetation. There is little obvious sign of mass movement as in landslip, except for a small slump on a steep bank of the valley on the vacant lot extending the property to Knocklofty Terrace. The major part of the erosion is due to tunnel erosion, vertical collapses into the tunnels, and gully erosion. In and near the centre of the valley the gullying has extended some three to four metres below the normal surface level.

In situ bedrock was encountered in all of the test pits at depths of one metre or more. In Pits 4 and 5 the bedrock was about one metre below the surface, in Pits 2, 3 and 6 about 1.5 m, while in Pit 1 it is over two metres below the surface.

Figure 1. Location map, showing test pits and geology.
