UR1986...32

1986/32. Subsurface investigation of a cracked house at Packham Street, Launceston

W.R. Moore

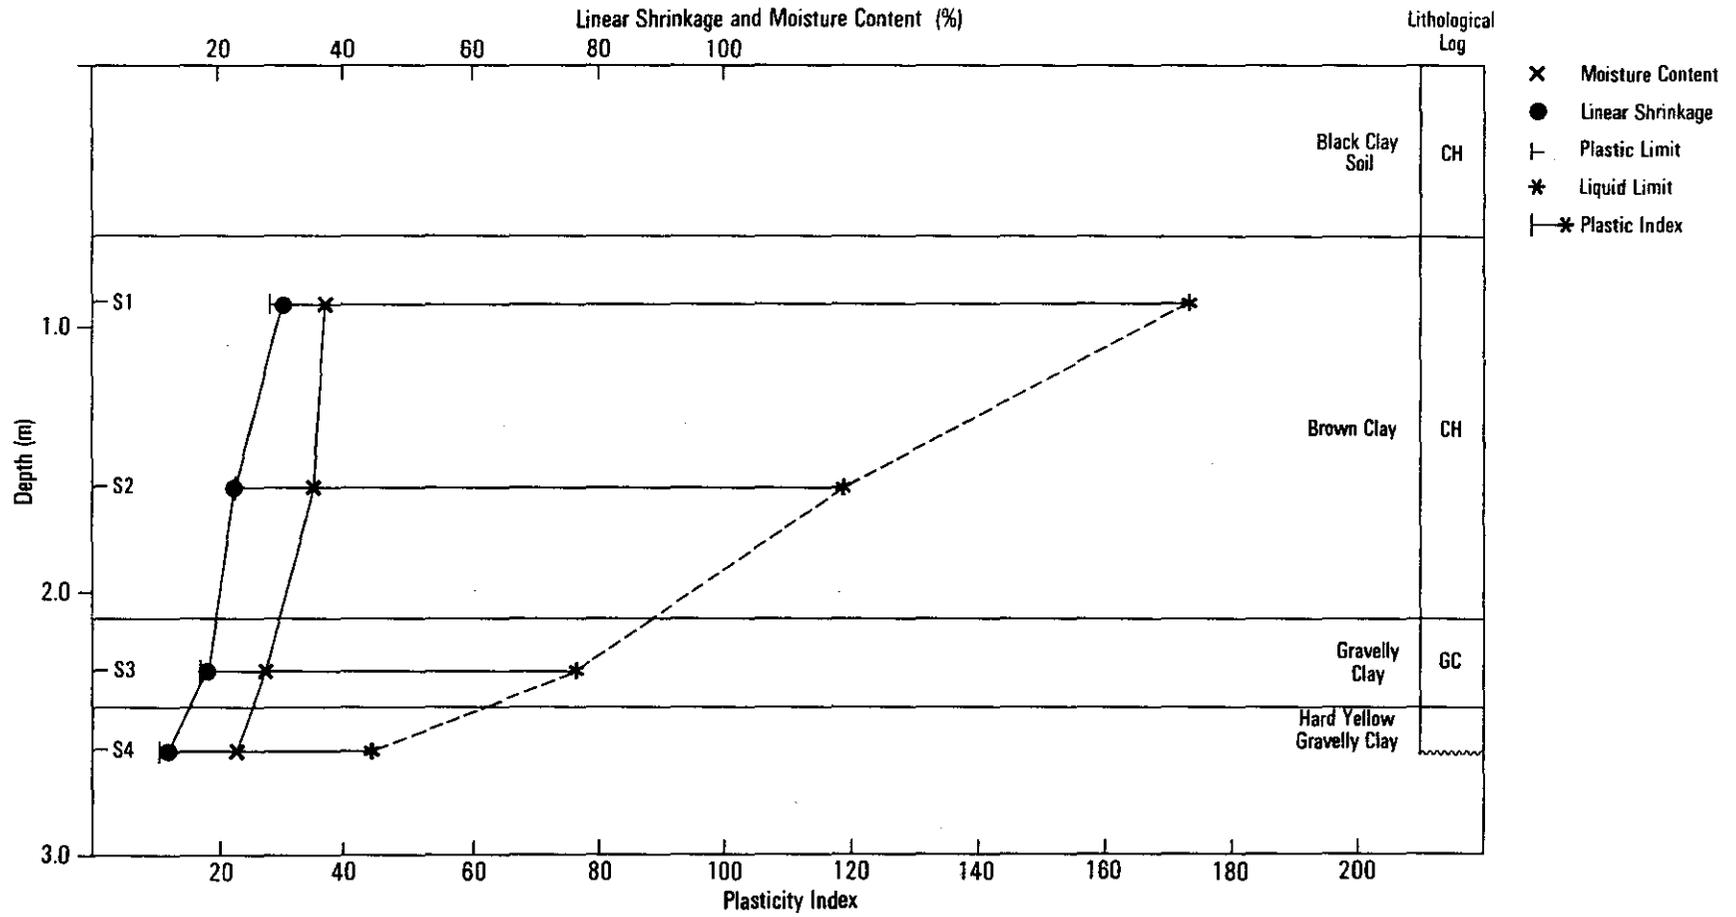
Figure 1. Soil testing results and log, Hole 1

From the exceptionally high liquid limit value of 174 of sample 1 at 0.9 m depth in Hole 1, the samples collected lower at 1.6, 2.3 and 2.6 m depths gave the following results; the liquid limit declined rapidly and constantly with depth with values of 119, 77 and 45; the plastic limit and linear shrinkage showed smaller but constant declines in values with depth (fig. 1).

- (2) It is fortunate that the high plasticity and expansiveness declines rapidly with depth in Hole 1 (fig. 1). It is likely that similar reductions occur in Hole 2 but these samples have not been tested to date.

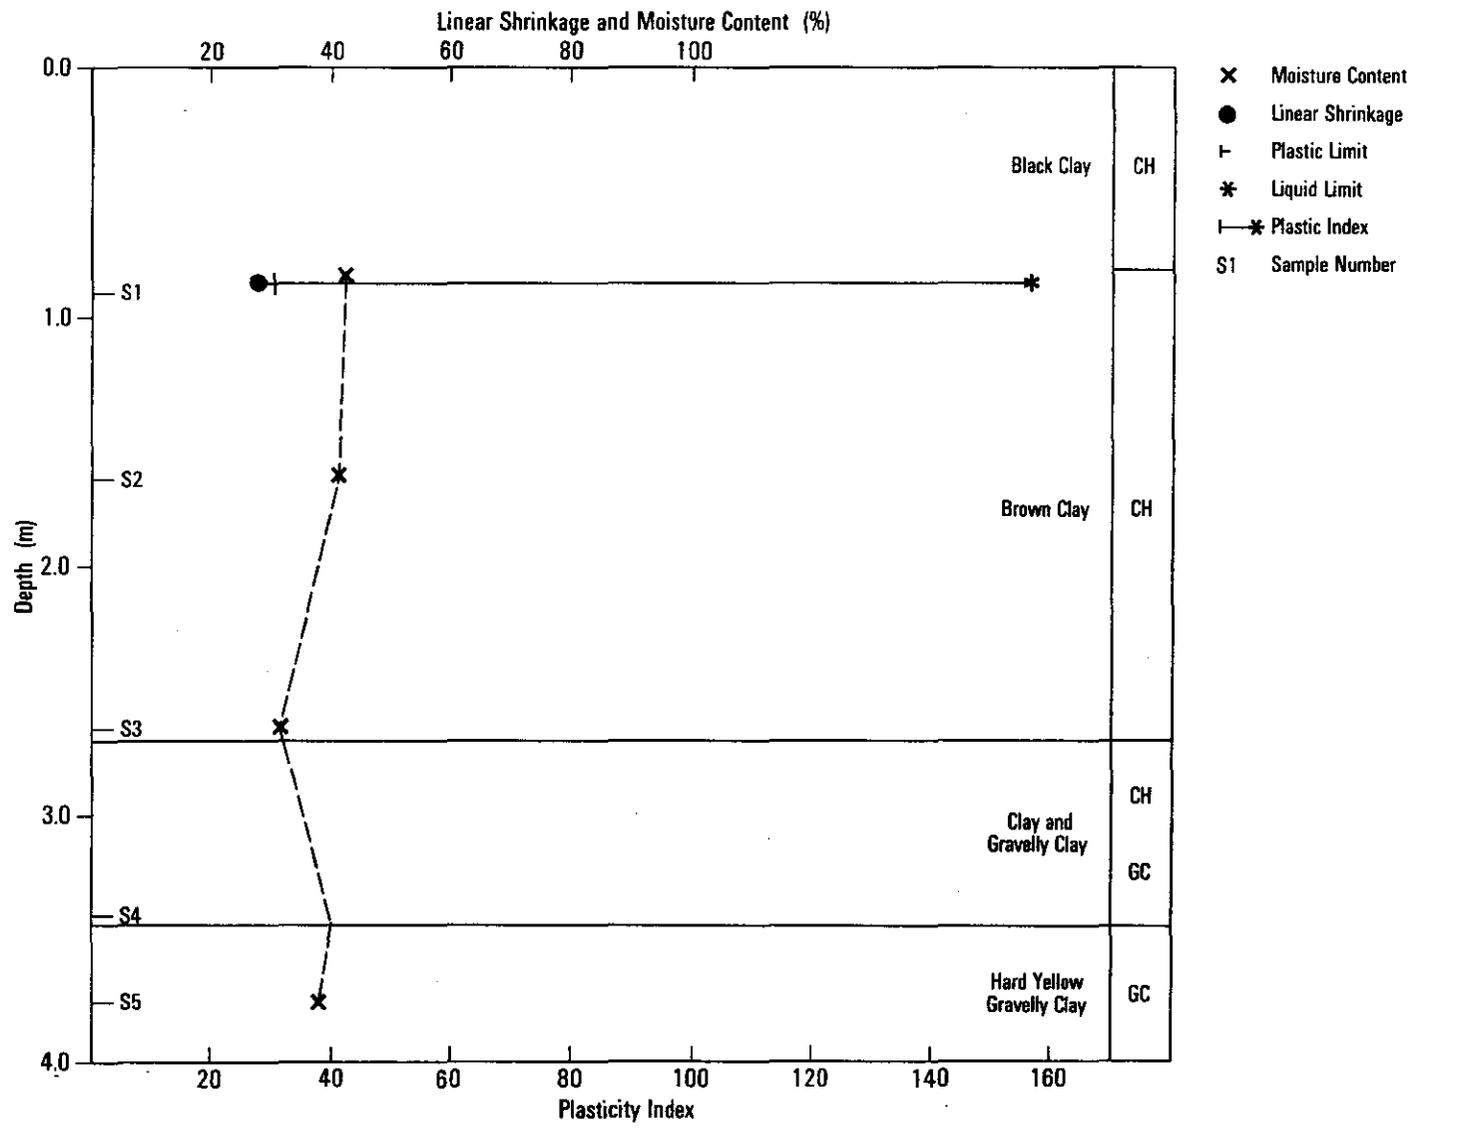
Figure 2. Soil testing results and log, Hole 2.

The moisture content of the samples from Hole 1 are high but with a constant decline from 38% to 23% with depth (fig. 2). Hole 2 moisture contents are equally as high (42%) but show little general decline, only minor irregularities (fig. 2).

- (5) A difference in moisture content profiles occurs between Hole 1 and Hole 2. No obvious explanation for the difference was seen, although the nearby pit dug by the owner and exposing the clay was full of water when Hole 2 was drilled.

- (1) The house cracking should continue to be monitored by the owner.
- (2) The remaining samples of Hole 2 be tested for Atterberg limits, linear shrinkage etc. This is to confirm that the rapid decline of plasticity and linear shrinkage found in Hole 1 occurs in Hole 2 as presumed in this report.

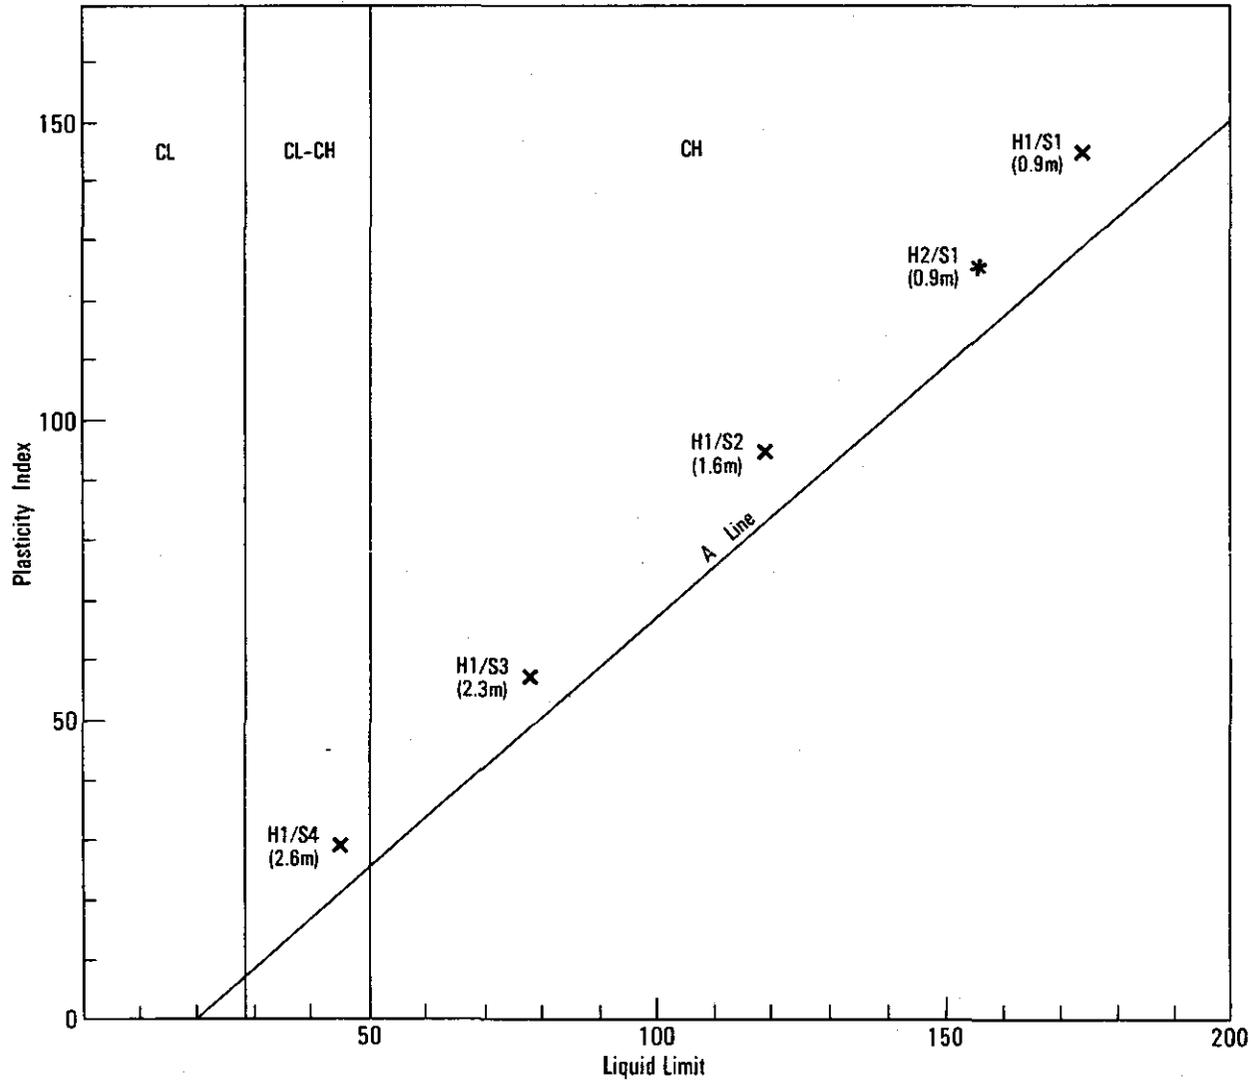
Figure 3. Clay classification diagram

This decline in plasticity with depth is shown by use of the laboratory criteria of the International Soil Classification system. Sample 1 from 0,9 m has an extremely high plasticity; and sample 4 from 2.6 m is medium, or transitional from low to high plasticity (fig. 3).
