1986/41. Investigation of a cracked house at Alanvale Road,
Newnham, Launceston

W. R. Moore

Abstract

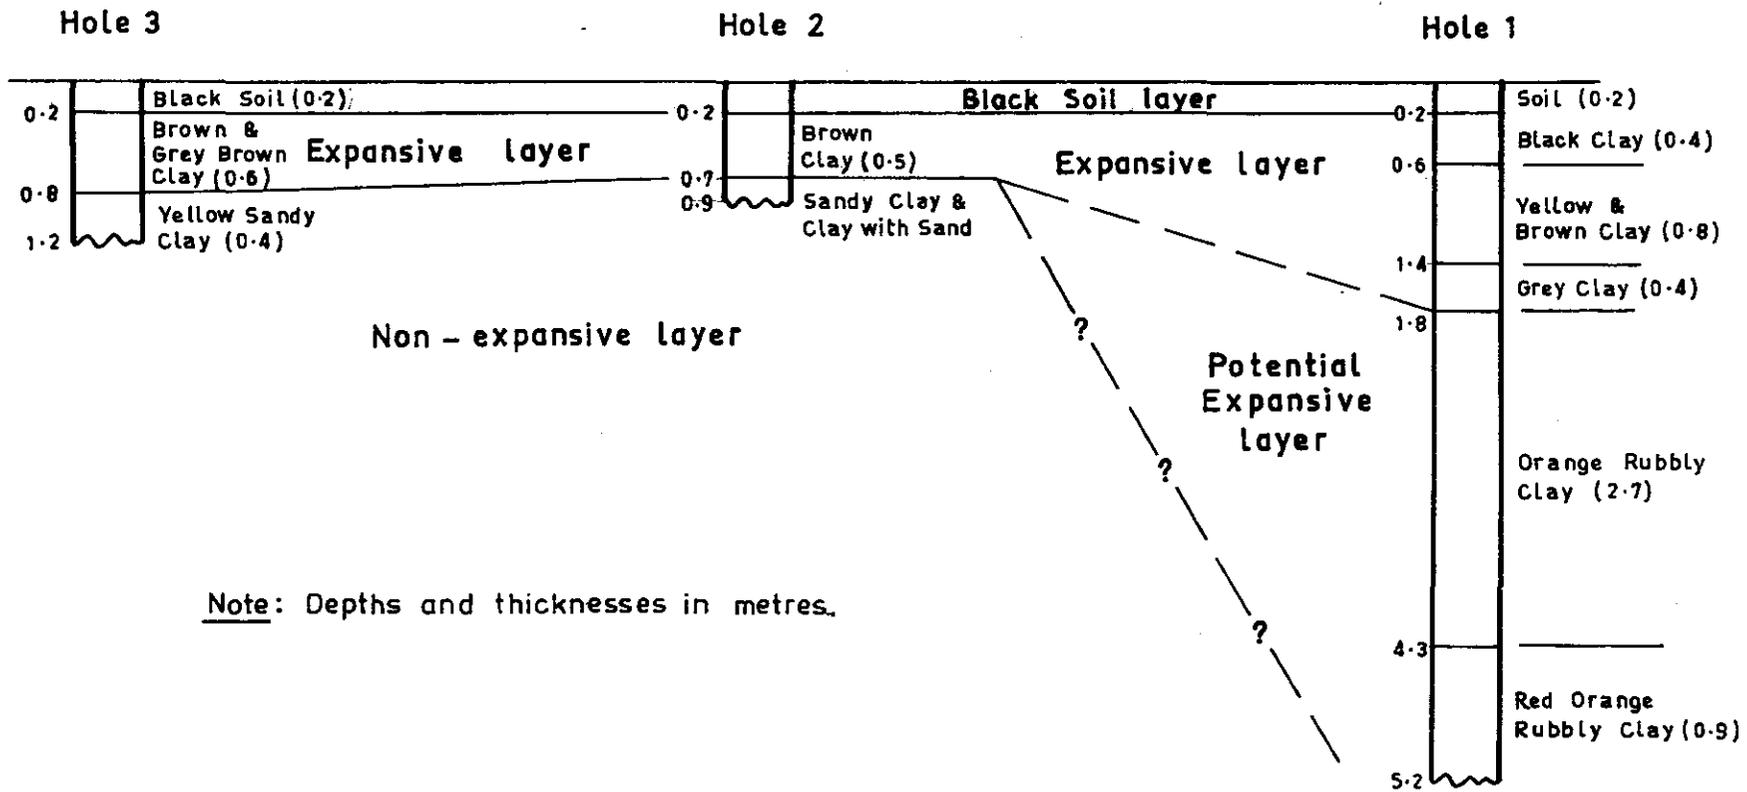
Figure 1. Section showing expansive and non-expansive layers.

In the only thick sequence of clay drilled (hole 1) the plasticity of the clay increases with depth from the surface to a grey clay layered at a depth of 1.4-1.6 m, with the plasticity index rising from 111 to 143 and the liquid limit rising from 140 to 176 both peaking in the grey clay. Below 1.6 m the plasticity of the clay declines and the liquid limit falls from 105 to 93 and the plasticity index falls to 65 in sample 5 at a depth of 4.3 m (fig. 1).

The moisture content in samples collected from hole 1 showed similar changes with depth. The range of difference in the moisture contents is very small, increasing from 41 to 47% at 1.4 m depth and then declining to 38% at 4.3 m (fig. 1).

- (1) The severity of cracking of Stevens' house would appear to be directly related to the thickness of the expansive clay at the south-east corner of the house.
- (2) Cracking is less severe along the front of the house, where the expansive clay is thin (0.7 m). This thin clay layer is underlain by yellow cemented sandy clay and sand layer. Unfortunately the foundations along the front of the house did not reach this distinctive horizon according to Mr Stevens.
- (3) Even though the moisture content of the clay when tested was constant throughout the entire depth of hole 1 at the south-east corner seasonal fluctuations of the moisture content are considered likely to occur around the outside foundations of the house. Larger scale fluctuations are most likely to occur in long drought periods such as 1982-1984.

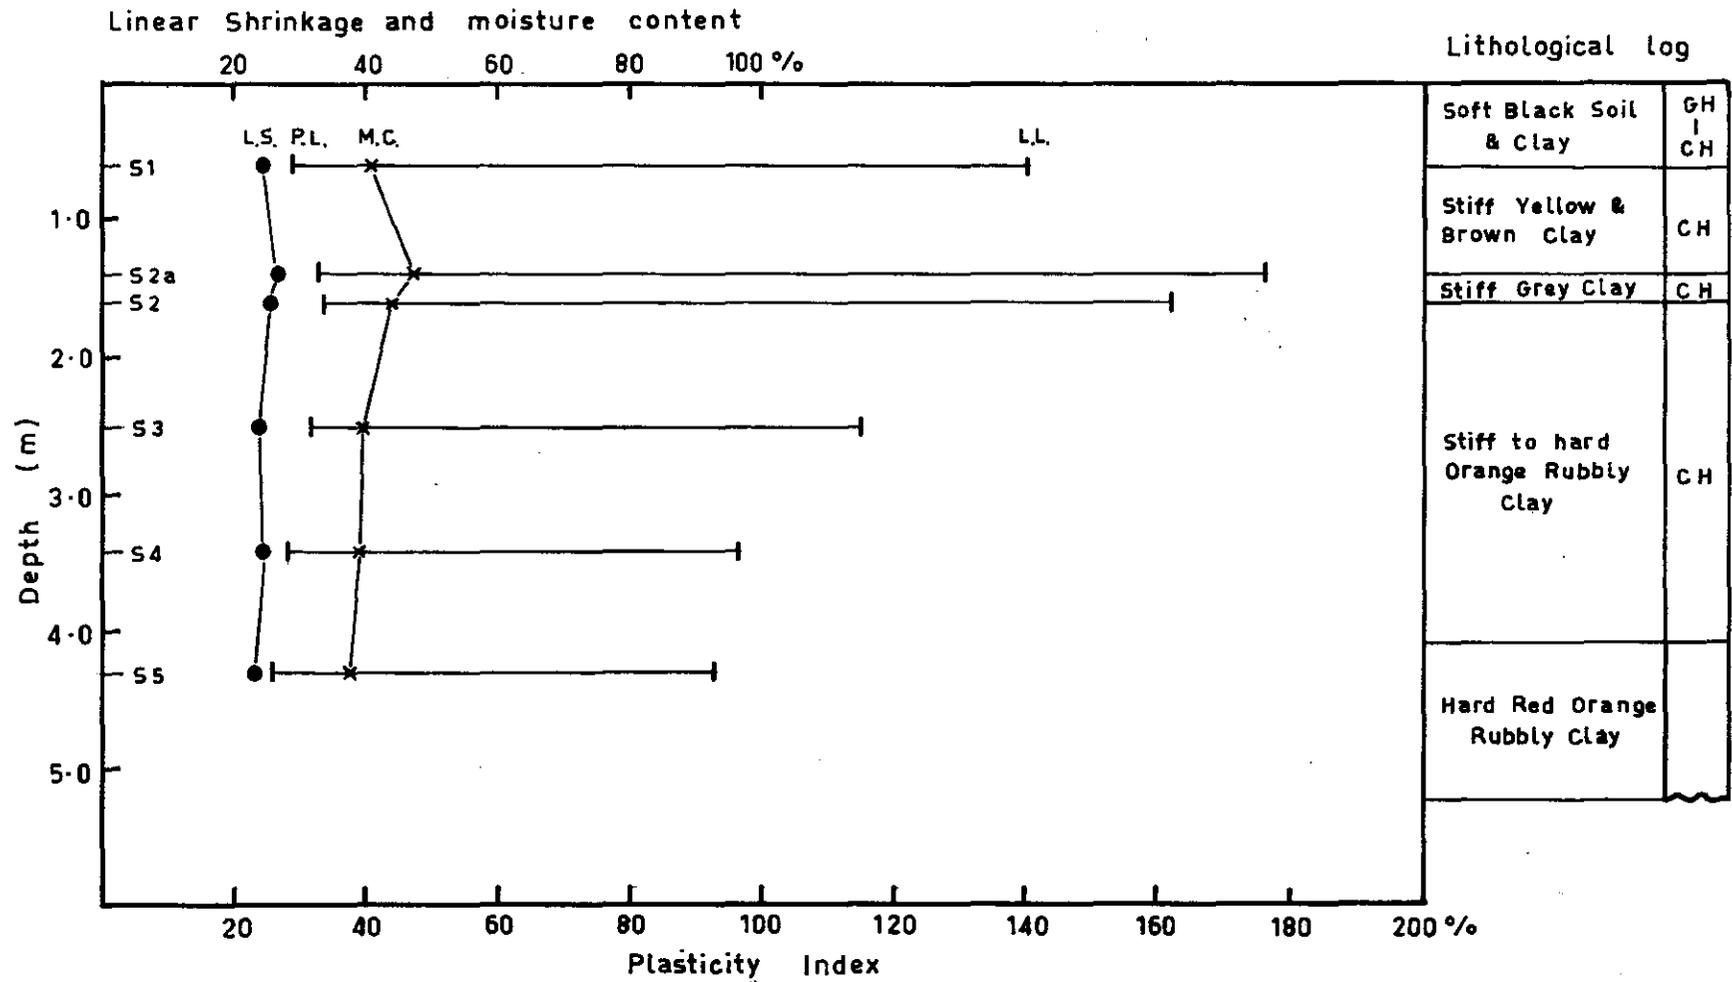
Figure 2. Soil testing results and log of hole 1.

- (1) The clay at 194 Alanvale Road is highly expansive and has the potential to cause movement in the house foundations.
- (2) Drilling shows a considerable variation in the thickness of the clay between holes 1, at the rear of the house, compared with holes 2 and 3 in front of the house (fig. 2).

- (3) A cemented hard sandy clay and clayey sand lens underlies the front of the house (holes 2 and 3). This layer does not occur at the south-east corner of the house (hole 1). The position where this layer lenses out beneath the house is unknown and can only be ascertained by further drilling along the northern and southern walls of the house.
