UR1986\_48

**1986/48. Subsurface investigation of three proposed house sites at Wulf's subdivision at Karoola.**

W. R. Moore

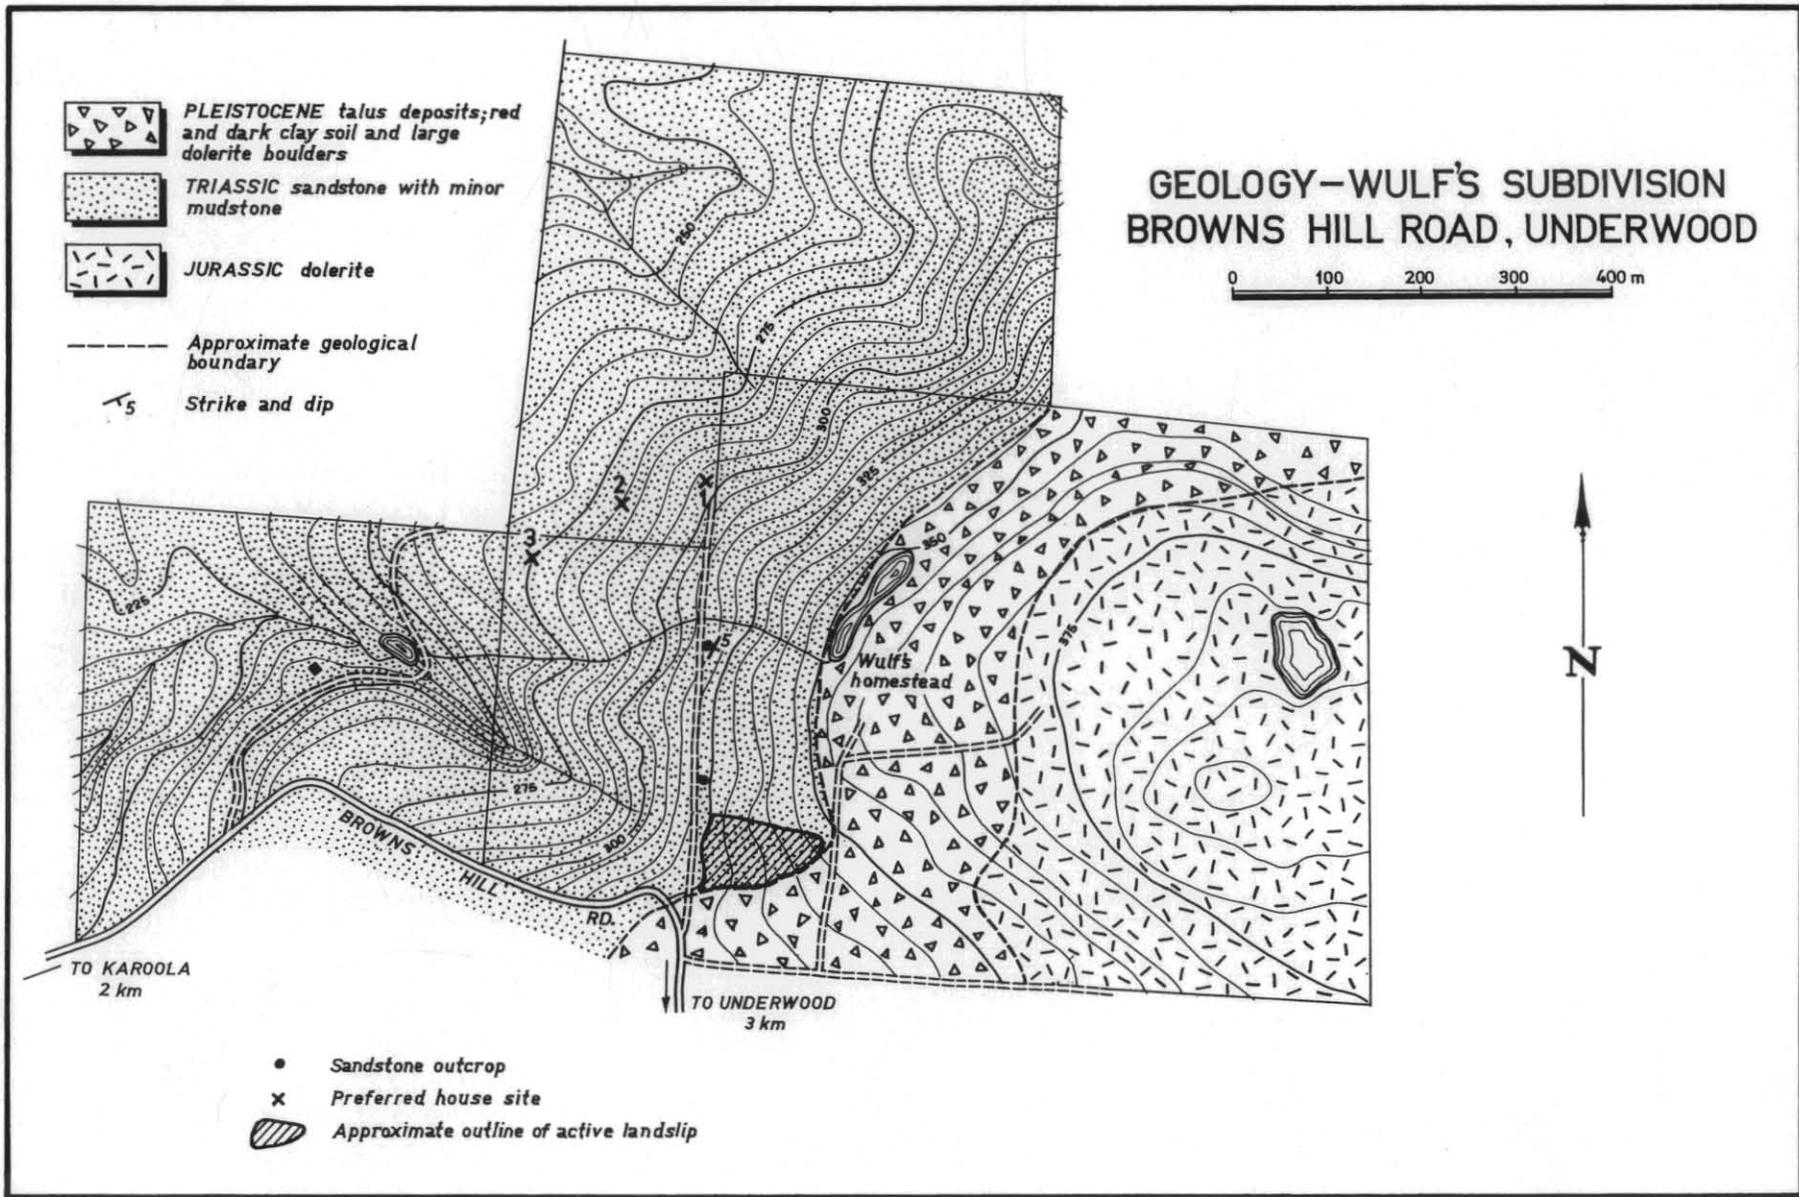
Figure 1

Site 3 is on a flatter area at the foot of a long 11°-12° slope (fig. 1). The actual site has a slope of 7° and is situated on a bench-like spur which is well drained and is in the Zone I landslide risk area and is considered not to be subject to landslides. The risk at this site is that any failure on the slope behind could move down onto a house built here.

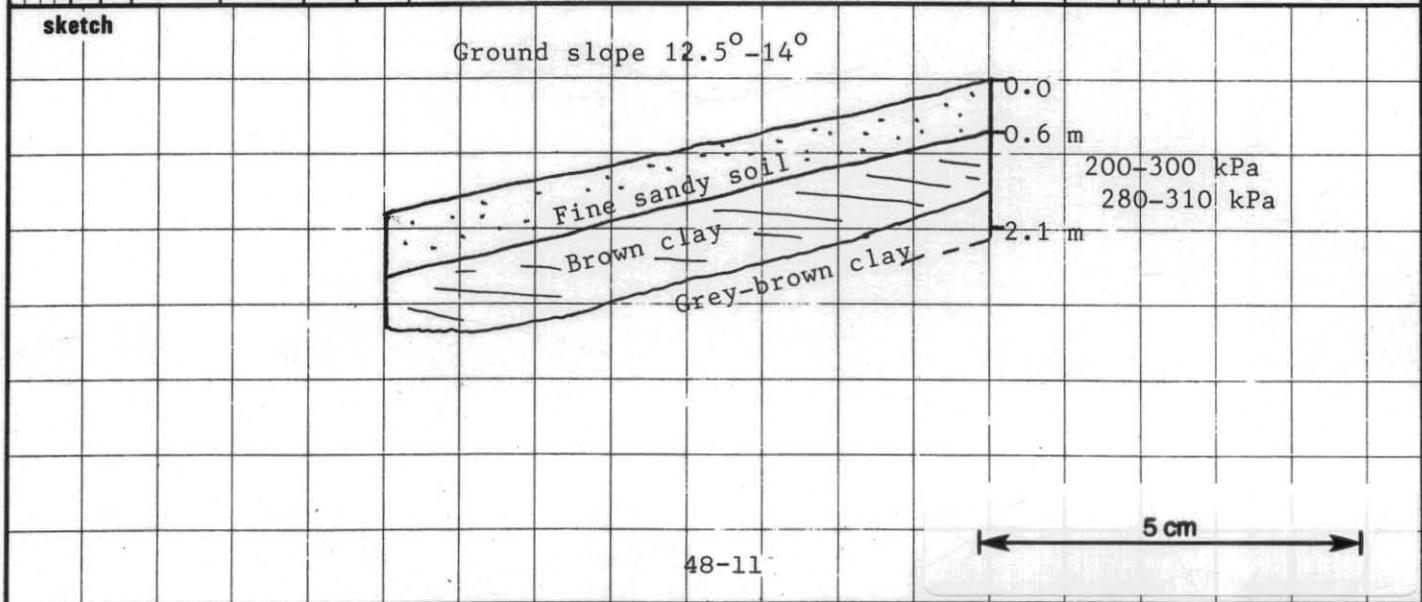
excavation no. 1

No sandstone was found below the 0.6 m thick sandy soil in Pit 1, although it was anticipated to occur because the site is along strike from and close to the above sandstone outcrop. Clay was present to a depth of 2.1 m below the top sandy soil. Even though the clay at the bottom of the trench retained the bedded structure of the mudstone it was still obviously clay.

This was confirmed by the laboratory tests on the clay which showed liquid limits to be in excess of 100 and plasticity index values of 74 at 1.1 m depth, 81 at 1.6 m, and 86 at 2.0 m depth. The clay was dominantly kaolinite (55-65%) but the montmorillonite percentage was high in all three samples (15-20%). This is reflected in the high linear shrinkage of the clay (23-24%). The moisture content of clay in this trench is constantly high (37-38%) for the entire depth (Table 1).

With no sandstone present at Site 1, and being situated on a long slope of 14° underlain by highly plastic clay and with a highly permeable sandy soil cover, the potential risk for landslide appears high. Therefore Site 1 was not recommended to the McLeod's on this field evidence when the site was investigated.

penetration 1 2 3	support water	notes samples, tests	metres		graphic log	classification symbol	material soil type: plasticity or particle characteristics, colour secondary and minor components	moisture condition	consistency density index	hand penetr- ometer kPa 25 50 100 200 400	structure, geology
			R.L.	depth							
	None	None				SP	SAND. Dark grey, silty sand. Poorly graded, organic. Sharp transition	D	L		Soil
		S1	1.0			CH	CLAY. Brown, highly plastic.	M	V		Clay
		S2					CLAY. Grey-brown, highly plastic. Some laminar bedding seen. No shearing or shear polish.	<	St		Clay, extremely weathered mudstone
		S3	2.0					P1			
							Pit stopped, backhoe starting to slip down slope.

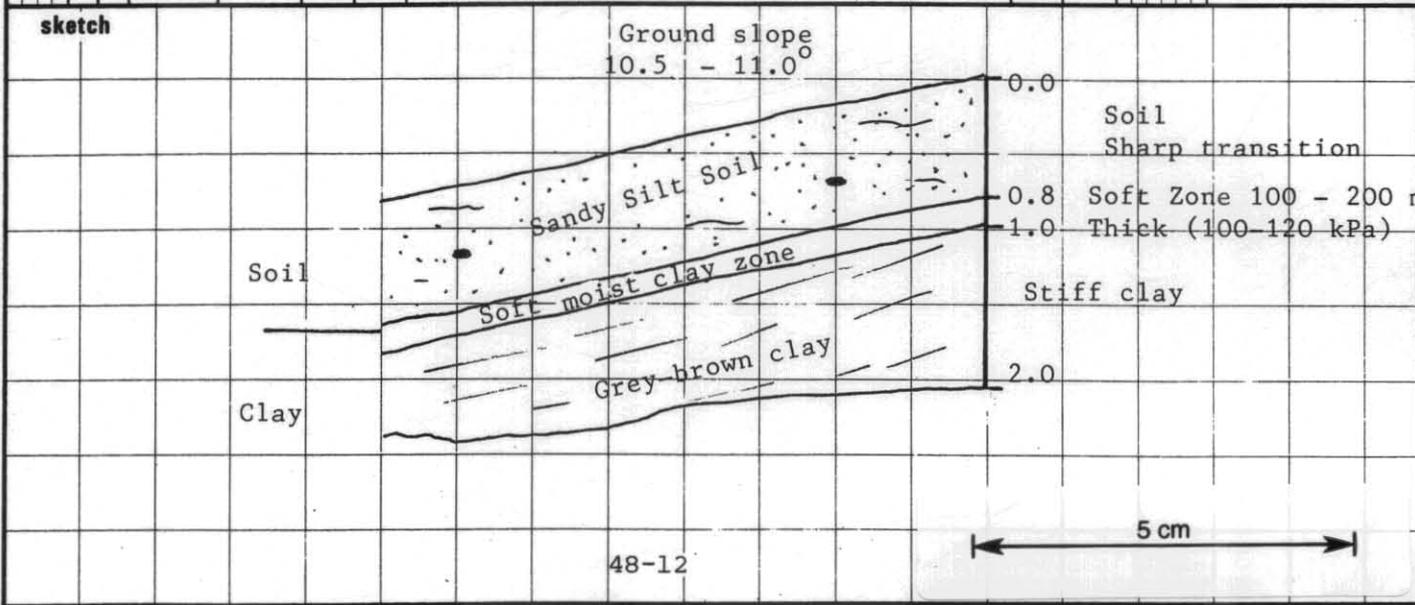
excavation no. 2  
sheet 1 of 1

A soft moist clay zone, 100-200 mm thick, was exposed at the interface of the sandy silt soil and the underlying stiff clay in Pit 2. As the clay in this soft moist zone was near its liquid limit, a shallow translational slide is considered a potential danger even on this slope of  $10^\circ$ - $11^\circ$ .

This site was only considered marginal, on field evidence, on the day of the investigation. The overall dampness of this site was confirmed in the laboratory, with the moisture contents of the clay from Pit 2 being consistently high (40% at 0.8 m depth, 41% at 1.0 m depth and 45% at 1.8 m depth; Table 1). This increase in moisture content with depth indicates that the moisture in the clay is not only derived from water collecting in the surface soil in the area of the small depression in which Site 2 is situated but has moved down the slope behind the site, at depth, within the clay.

With the high moisture contents in the clay and the presence of a soft, moist zone at the top of the clay, Site 2 was not recommended because of the potential slope instability.

penetration 1 2 3	support water	notes samples, tests	metres R.L. depth	graphic log	classification symbol	material soil type: plasticity or particle characteristics, colour secondary and minor components	moisture condition	consistency density index	hand penetr- ometer kPa	structure, geology
					ML	SANDY SILT. Fine, dark grey, poorly-graded, organic. Some sandstone boulders.	V M	L		Soil
	None		S1 S2 1.0		CH	CLAY. Grey-brown. Highly plastic	M=P M < Pl	St V St		Soft Moist Zone  Clay
	None		S3 2.0			Backhoe stopped - required depth reached.

Remedial drainage at this site, as suggested by the engineer, is considered likely to be effective only in the top sandy soil. The effectiveness of any drainage in the underlying clay is considered to be limited.

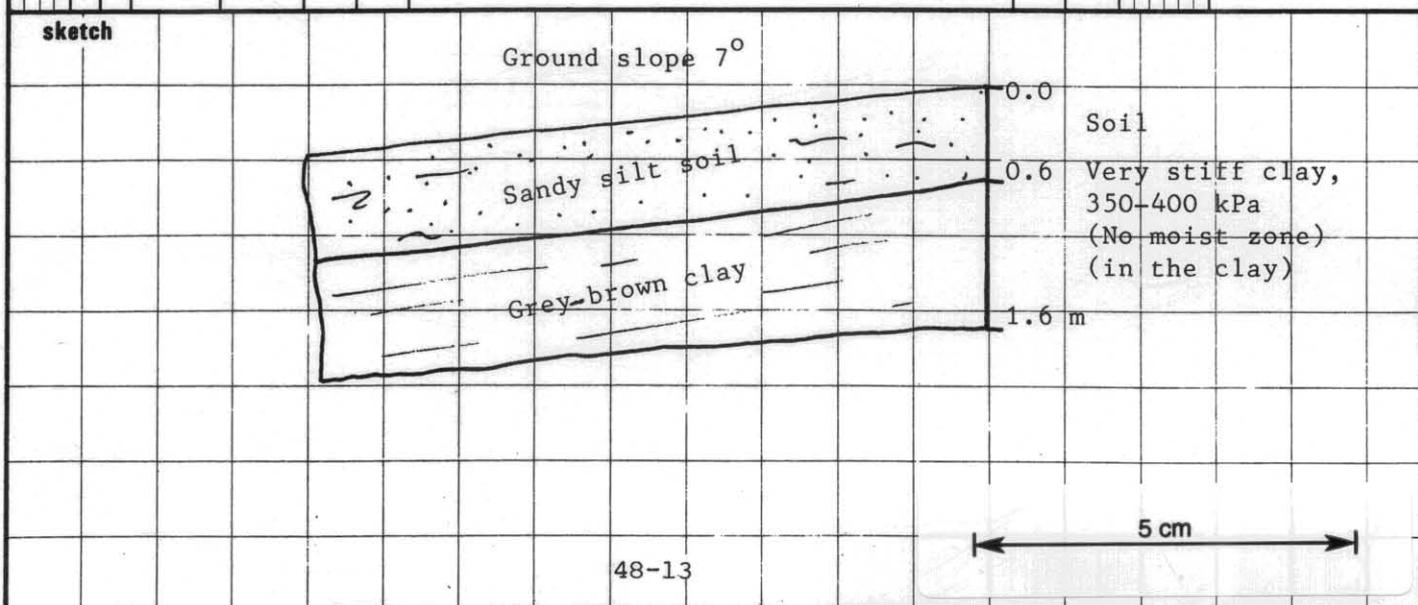
excavation no. 3  
sheet 1 of 1

The sandy silt soil is 0.6 m thick and overlies a grey-brown clay with some sand. The clay has similar field properties to the clay of the other two pits. This was confirmed by the composition of the clay, although it had a slightly high percentage of quartz. The clay at this site, although highly plastic, has a lower liquid limit (83) and plastic index (59), compared with clay samples from Pit 1 (Table 1). Significantly the moisture content of this clay was low (29%) compared with the clay from the other two pits.

With a low slope of  $7^\circ$ , absence of any soft zones in the clay and with a low moisture content, Site 3 is considered to have the lowest potential for slope failure of the three sites investigated. The only potential

(3) The clay underlying the 0.6 m of dark grey sandy silt soil in Pit 3 is expansive, with a linear shrinkage of 21%.

penetration 1 2 3	support water	notes samples, tests	metres R.L. depth	graphic log	classification symbol	material soil type: plasticity or particle characteristics, colour secondary and minor components	moisture condition	consistency density index	hand penetr- ometer kPa	structure, geology
					ML	SANDY SILT. Dark grey, poorly graded. Organic.	M	L		Soil
	None	S1	1.0		CH	CLAY. Grey-brown, highly plastic	M < Pl	V St		Clay
						Backhoe stopped - required material seen.

(3) With expansive clay underlying this site, the foundations of the house should be designed and built to withstand or accommodate seasonal movements to avoid future house cracking. The foundations should be designed, and when constructed supervised by a foundation engineer or his agent.
