1986/53. Investigation of a cracked house at Sorell Street, George Town.

W. R. Moore

Abstract

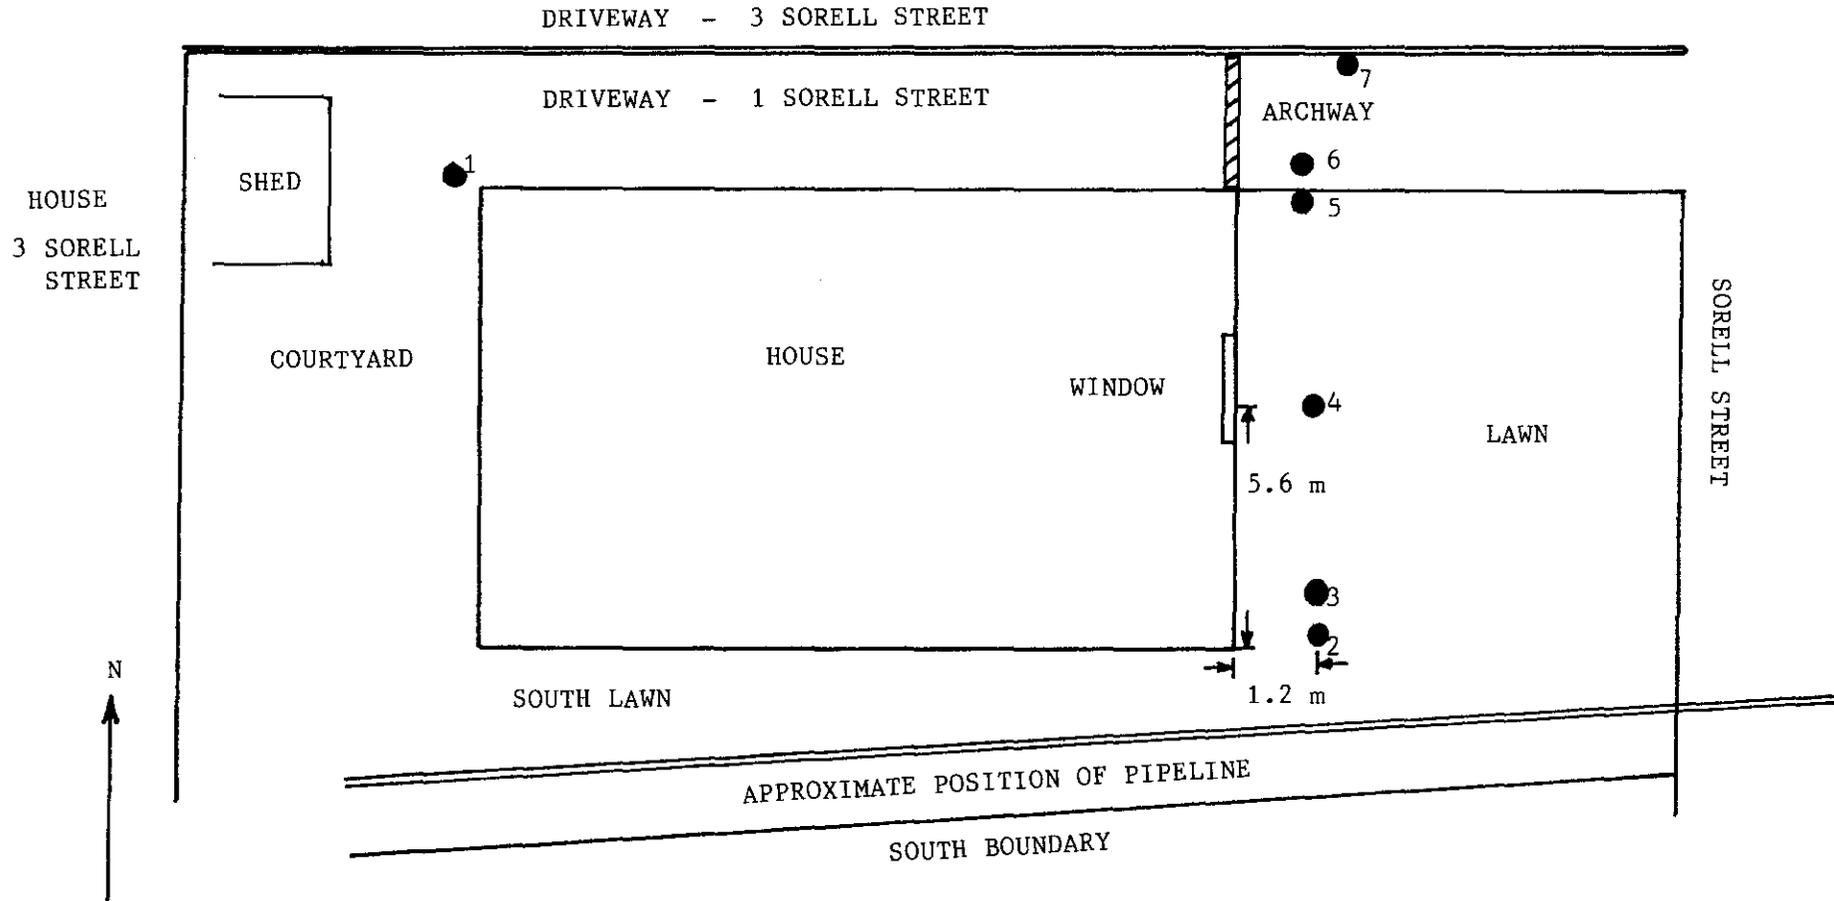
Figure 1. Sketch plan showing location of drill holes

The subsurface investigation was only partially successful because of the difficulty of access and lack of penetrating power of the drill in the gravel. Seven holes were drilled; their locations are shown on Figure 1. The lithological logs of these holes are given in Appendix 1.

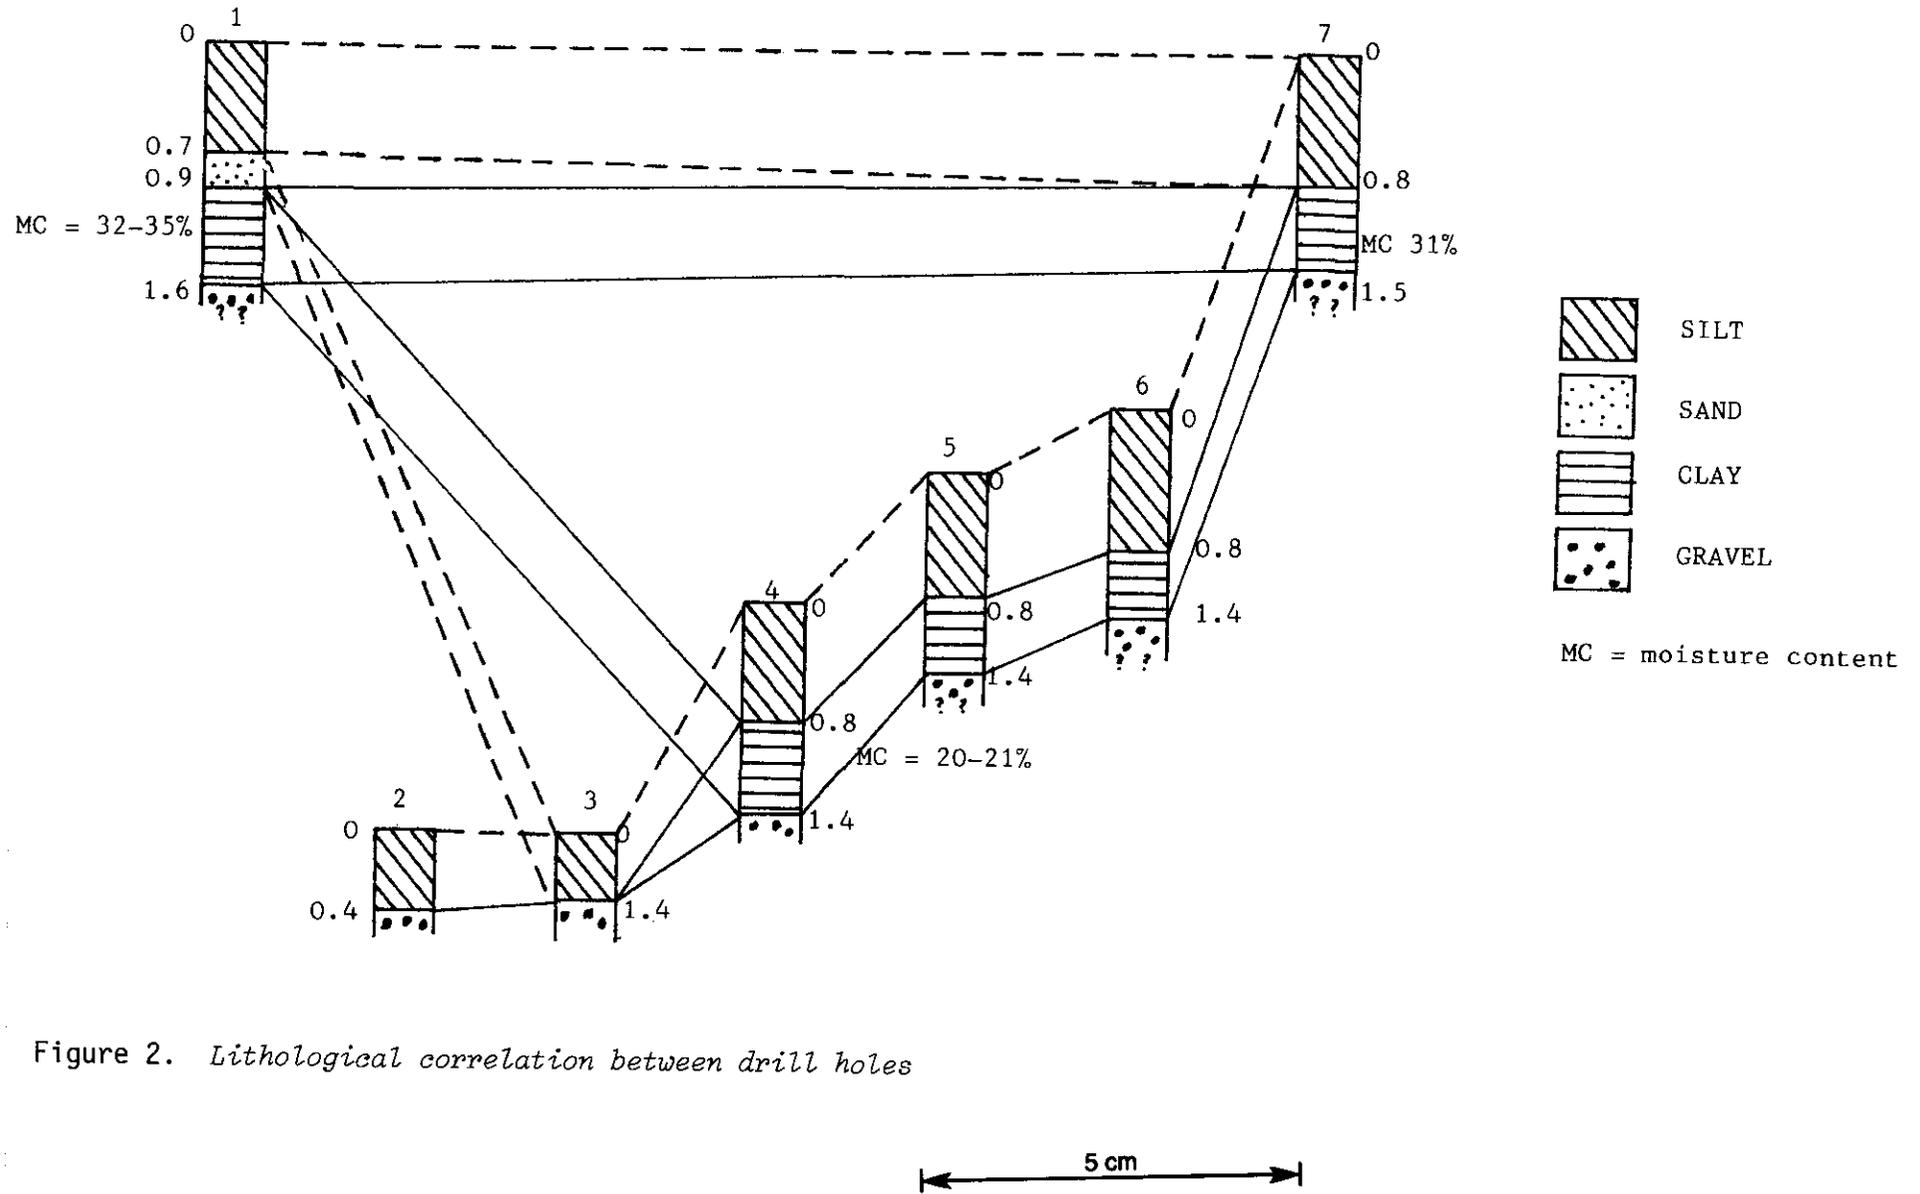
Figure 2. Lithological correlation between drill holes

All the holes drilled through the clay stopped at approximately the same depth (1.4-1.6 m, fig. 2). This conformity of depth at which the drill stopped suggests to the writer that this surface is similar to the rock platform covered by large basalt boulders that is exposed in York Cove. A similar rock platform is thought to underlie the low marine terrace on which 1 Sorell Street and George Town is built.
