1986/55. Stability of land at Glenwood Road, Leichardt, Launceston.

W. L. Matthews

Abstract

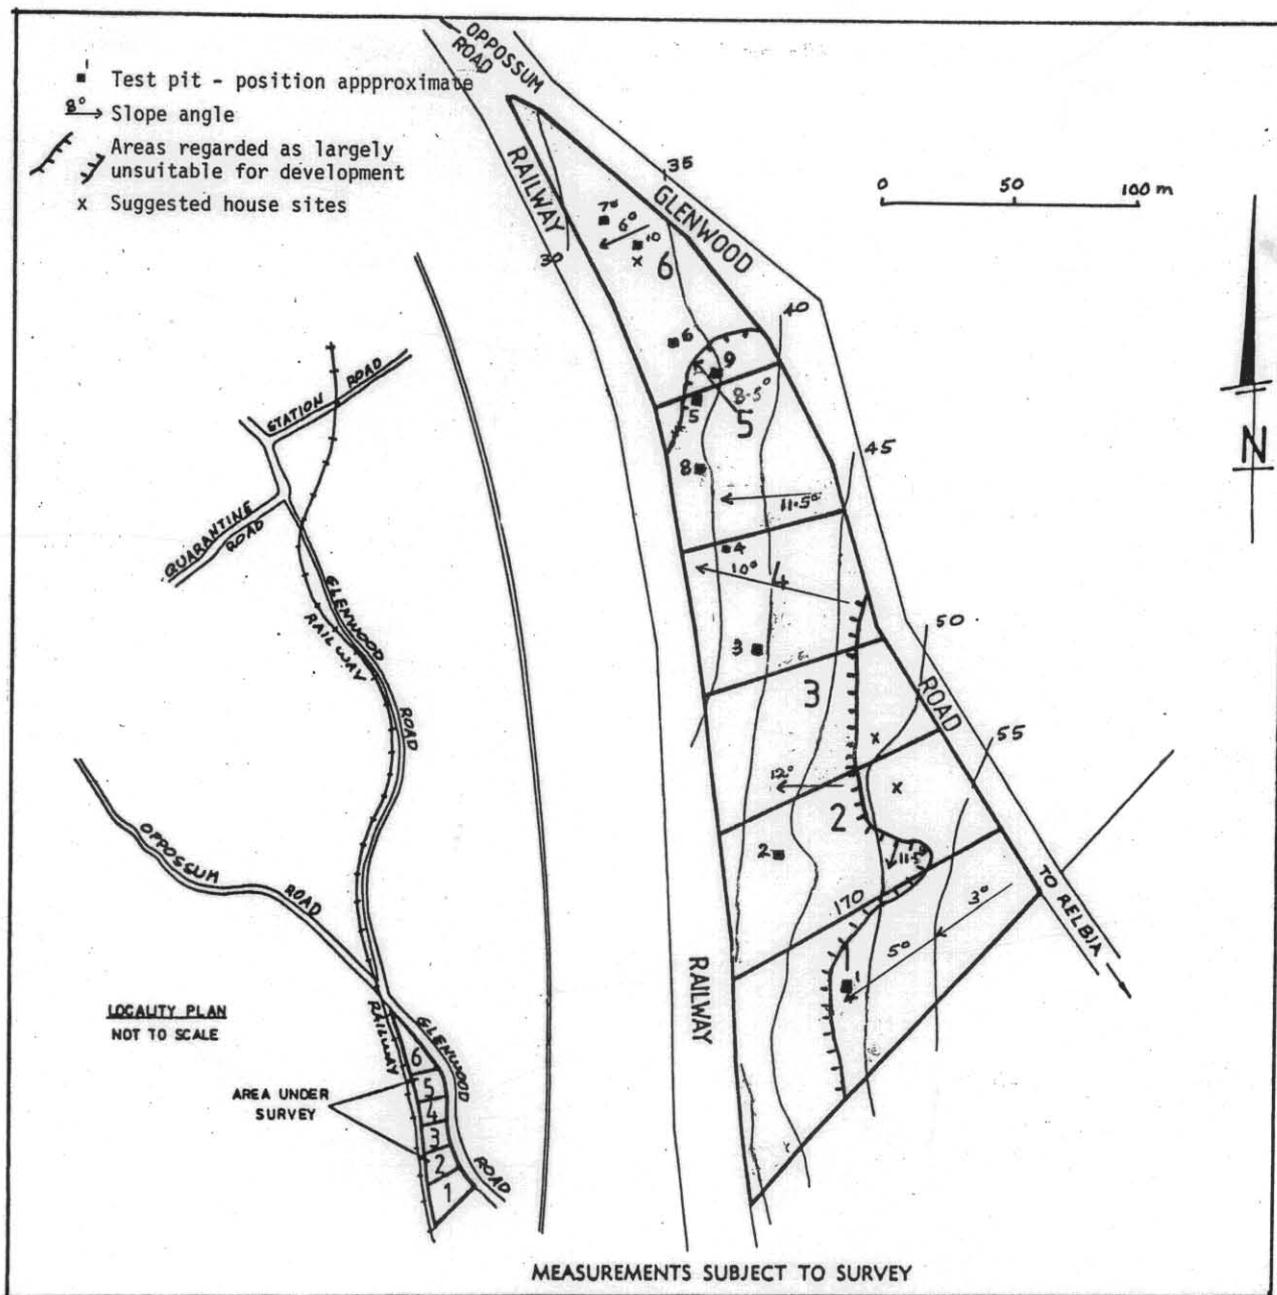
Figure 1. Sketch plan of proposed subdivision.

A proposed subdivision comprising 6 lots between Glenwood Road and the railway line [EQ157077] has been examined. Initially seven test pits were dug largely to examine the suitability of the area for septic tanks: five were only to shallow depth but two were extended to 2 m or more. A further three test pits were dug in the northern part of the proposed subdivision to depths of from 2.8 to 3.3 m and samples were collected for testing. The locations of the test pits are shown in Figure 1 and their logs are included as Appendix 1.

The major part of the proposed subdivision is in class 4 on the landslip zone map - i.e. it is an area of old landslips and adjacent areas. Because of the relatively steep slope and previous instability on most of the land, development could not be recommended without very detailed subsurface investigations (the results of which are unlikely to provide a recommendation for development). The northern part, although it has probably been subject to movement in the past has a lower slope and abuts an area west of the railway line with a long low-angle slope. Further test pits were suggested in this area to examine subsurface materials.

Only the flatter south-east portion of the land can be regarded as being relatively free from the risk of landslip. Most of the remainder of the area has been subject to landslip in the past or is moderately steep. On adjoining land recently-active slips can be seen on similar slopes. Strength tests indicate that there is low-strength silty clay in the area. Development of these steeper areas cannot be recommended.

A northern portion, although probably affected by past movements has a more gentle slope. With extreme care it should be possible to develop this without the risk of movement becoming unreasonably high.

On lots 1, 2 and 3 septic tank effluent and sullage should be dispersed on the flat area around the house sites if possible. If this is not possible (perhaps in the case of lot 3) it should be piped down the ridge and dispersed well away from the house site. Dispersal in valleys or on the sides of valley features is not favoured. Houses on these three lots should not be built on or near the edge of the steep slope to the railway line. There is wide scope to choose a site on lot 1.

In the case of lot 6 a house site should be selected near the middle of the lot where the slope is even and away from the shallow valley at the southern boundary. Septic tank effluent and sullage should be dispersed either to the north or south of the house site, some 25 m or more away, and not downslope of the house.

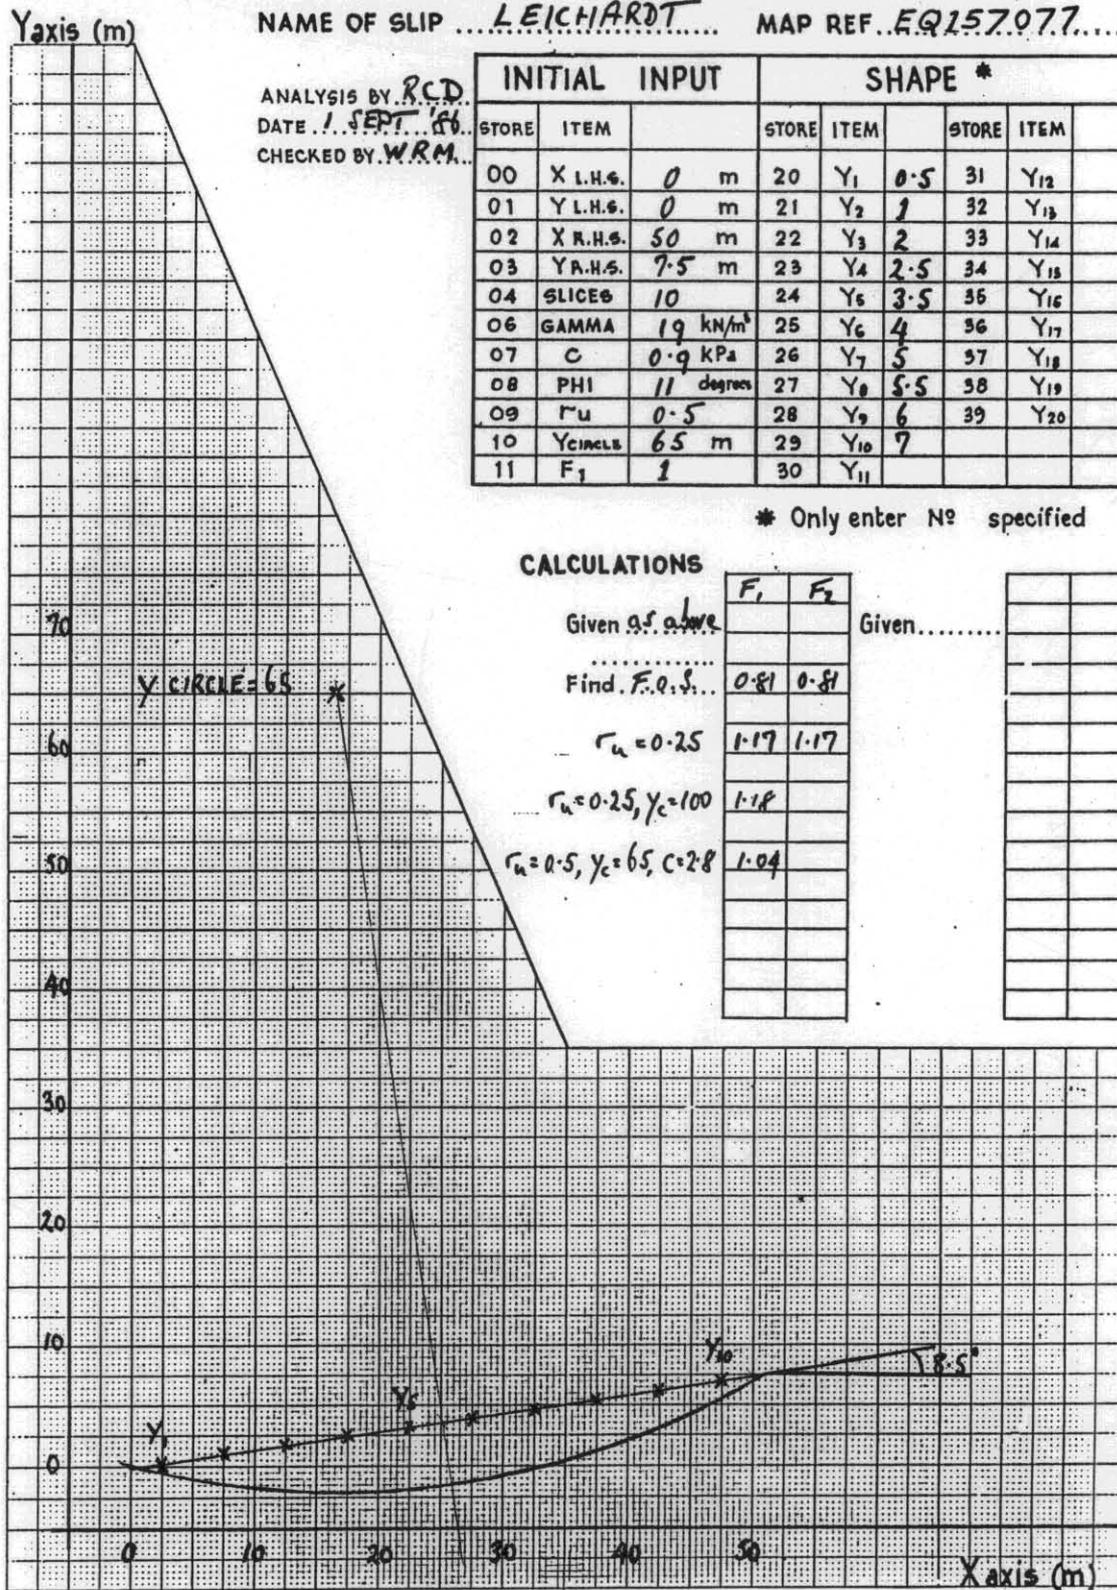
Figure 2. Slope stability analysis.

Using the strength factors determined above, stability analyses (fig. 2) indicate that the slope of 8.5° near the boundary of lots 5 and 6 could become unstable if saturation of the material underlying it approaches the surface.

Development is not recommended on this slope. Slopes of more than 10° in other parts of the proposed subdivision should be excluded from development on the same basis. This suggests that lot 4 and most if not all of lot 5 has an unacceptable risk of becoming unstable. There may be a flattish area on lot 5 near the railway line, or part of the flattish area of lot 6 could be added, where a house may be built but this is unlikely to be favoured by any purchaser.
