URI 986-68

1986/68. Preliminary report on building cracking at the Tasmanian State Institute of Technology campus at Newnham.

W. R. Moore

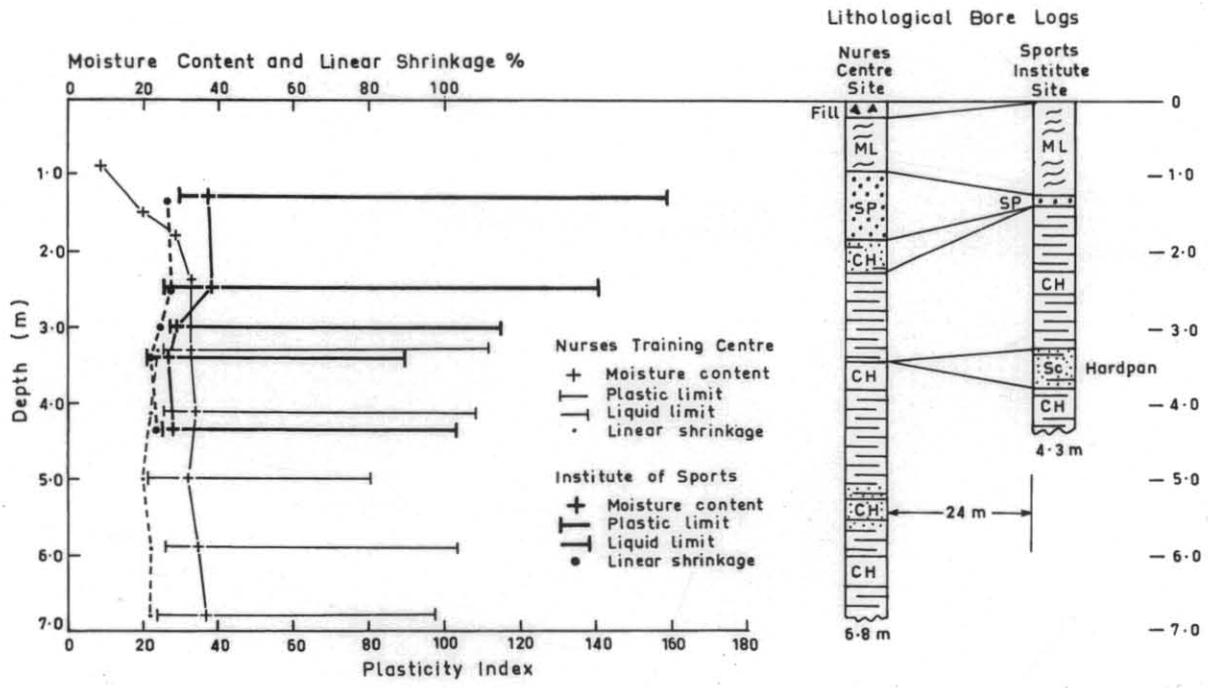
Figure 1. Soil testing results and diagrammatic logs.

Indications of the types of variations, and how quickly these changes can occur, is seen in the recent auger drilling at the T.S.I.T. (fig. 1). Even though the holes were only 24.4 m apart, the hole at the Nurses Training Centre encountered 0.2 m of fill followed by 1.6 m of river gravel and silt overlying dry clay; whereas at the Sports Institute site, 1.4 m of river gravel and silt was drilled before encountering moist clay (see drill logs Appendix 1). The clay in both holes was lithologically similar, very highly plastic, and expansive (fig. 1 and 2; Tables 1-3).

Only 2.9 m of clay was drilled at the Sports Institute site before gravel was encountered which the drill could not penetrate. In this clay a hard pan of sandy clay (0.4 m thick), which acts as a barrier for moisture penetration within the clay, was encountered (Moore, 1986). At the Nurses Training Centre site, 5.0 m of clay was drilled to a depth of 6.8 m with no hard pan layer or gravel encountered in the clay (fig. 1).

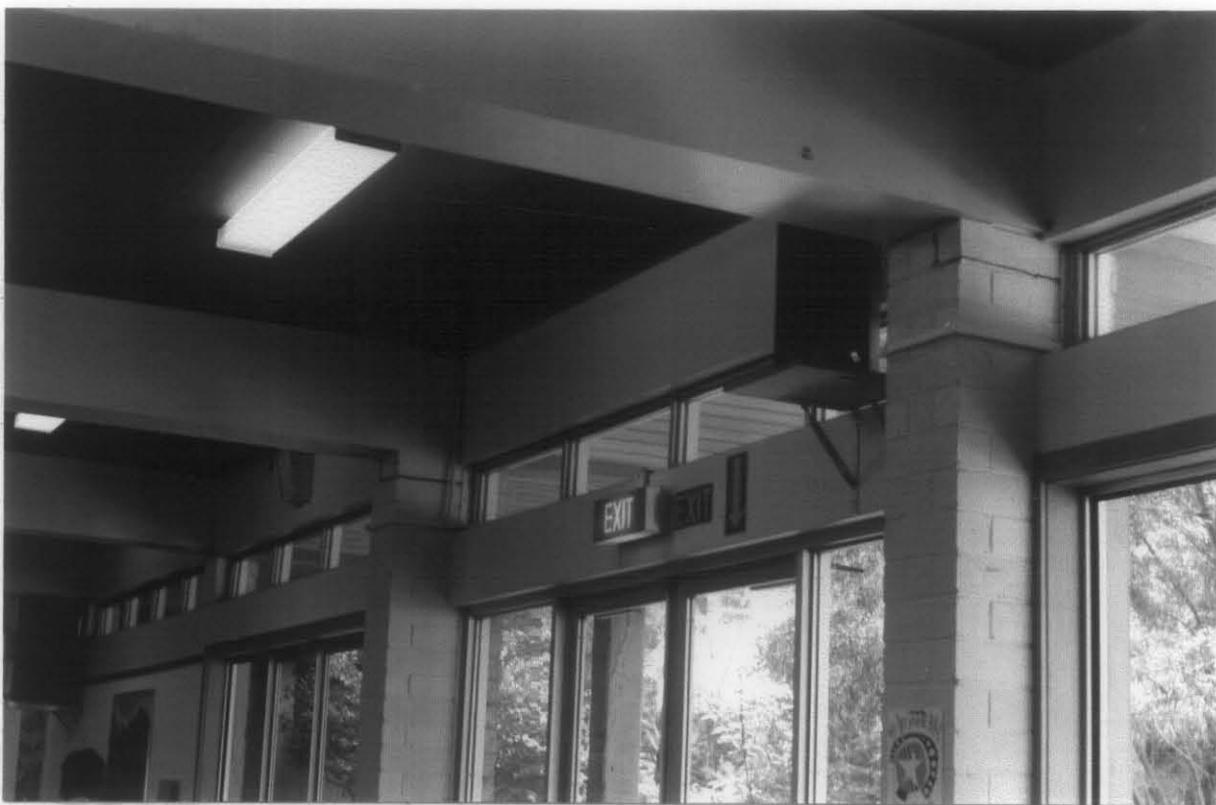
As far as can be ascertained from discussion with the building maintenance staff, the cracking started in 1982-1983 (significant drought years in Launceston), when there was low total rainfall and little or no winter rains occurring. Since then the cracking has continued, with very significant movements measured on some buildings according to Mr Taplin's measurements (plate 1).

Plate 1. *Cracking at beam/pillar joints, cafeteria, main building.*

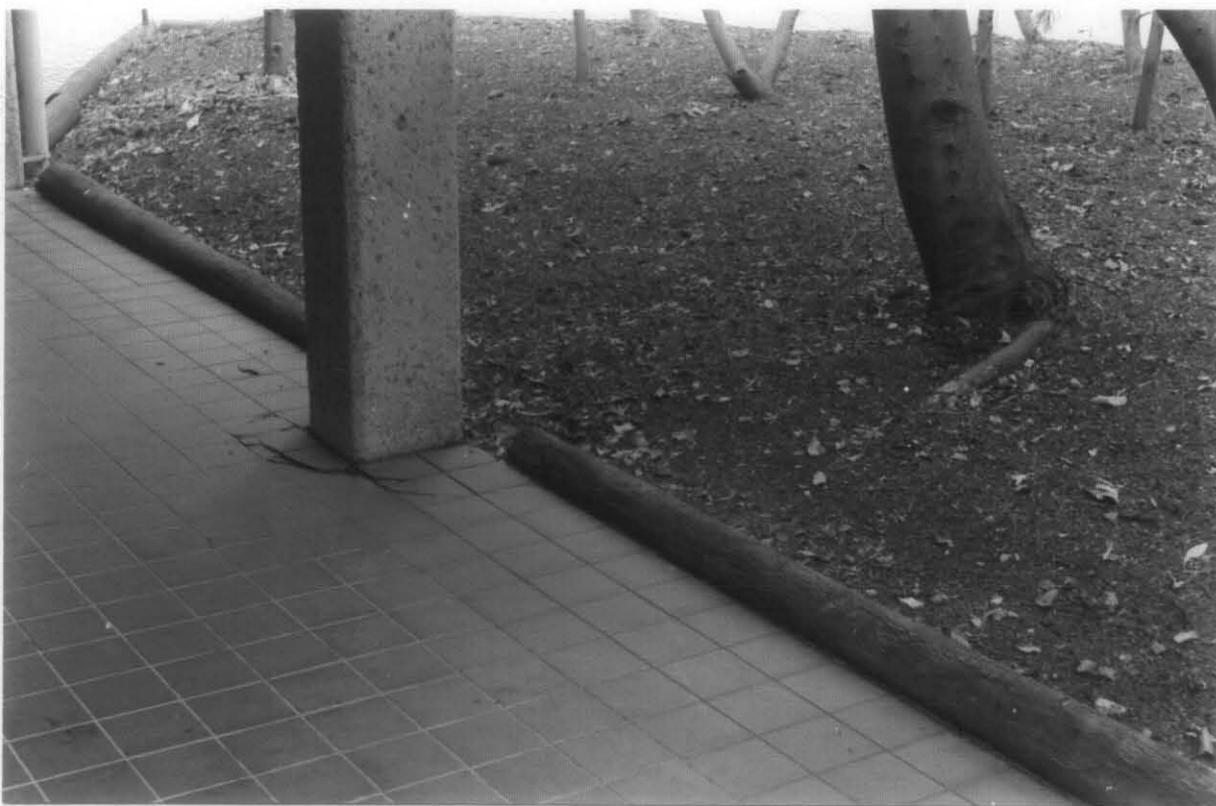
From the inspections, the cracking is thought to be related to foundation movements caused by differential ground movements from the underlying expansive clay, which responds to seasonal and longer term moisture fluctuations (plate 2).

Plate 2. *Cracking around base of pillar because of proximity of trees to building.*

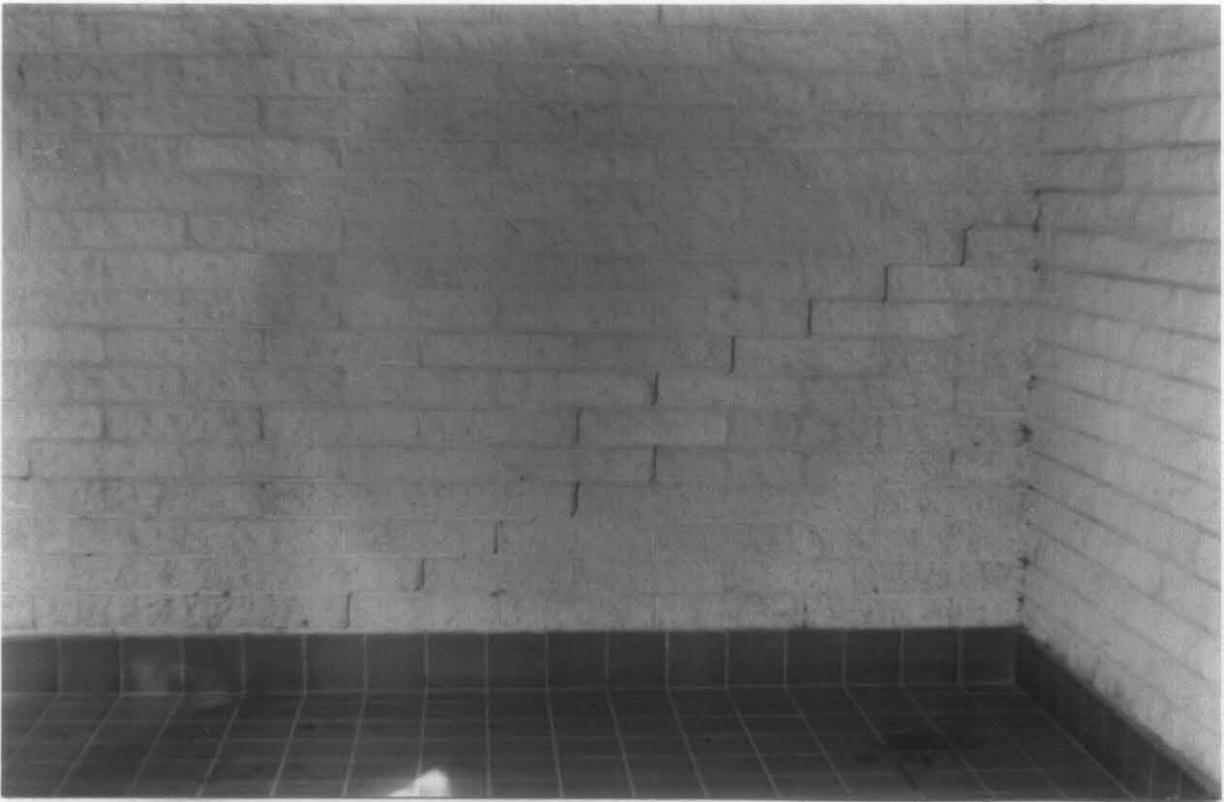
Plate 3. *Cracking in brickwork of main building, possibly caused by foundation movements.*

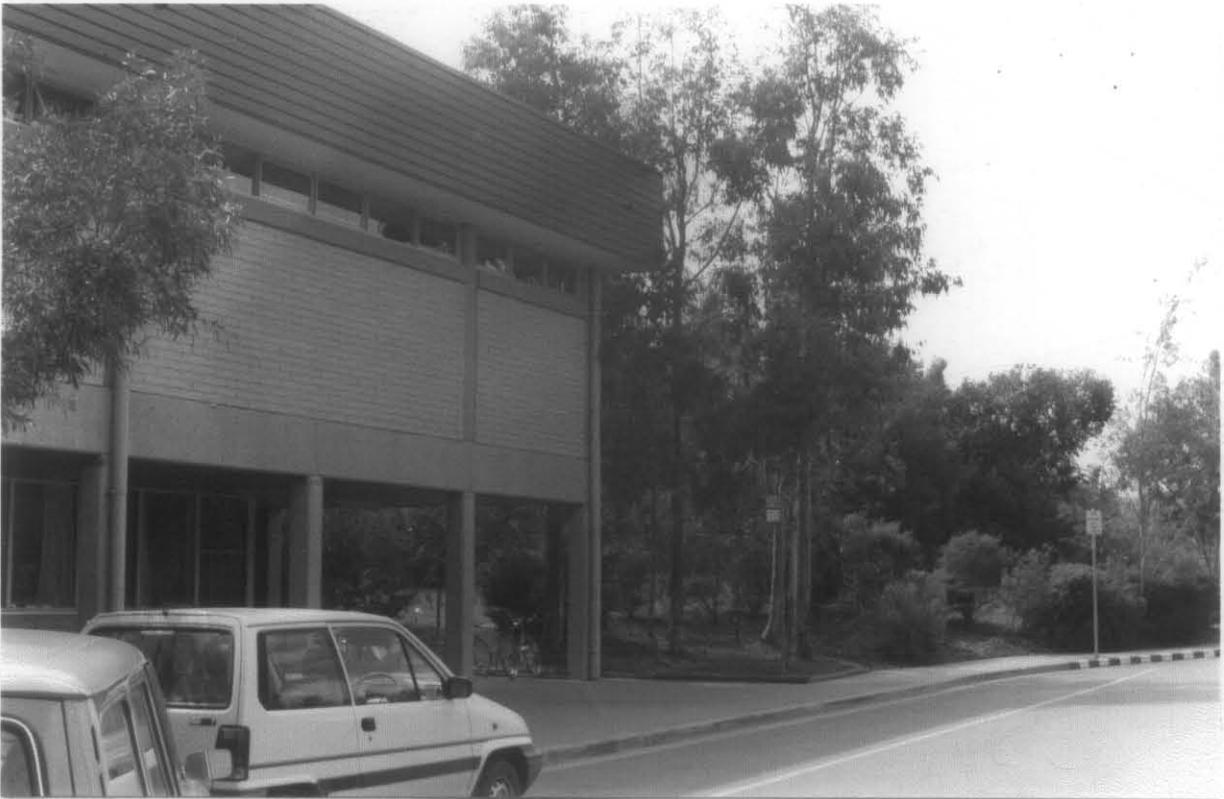
These expanding and contracting movements are possibly combined with small translational downslope movements in some buildings, related to soil creep and/or initial incipient landslide movement. These factors, combined with different design of the building's foundations and weight etc., may have added further to the problem (plate 3). The height and number of trees so close to the buildings foundations, which are desiccating the underlying clay, is likely to prove a significant factor as a cause of the cracking of many of the buildings (plate 4).

Plate 4. *Close proximity of large trees to Administration building.*

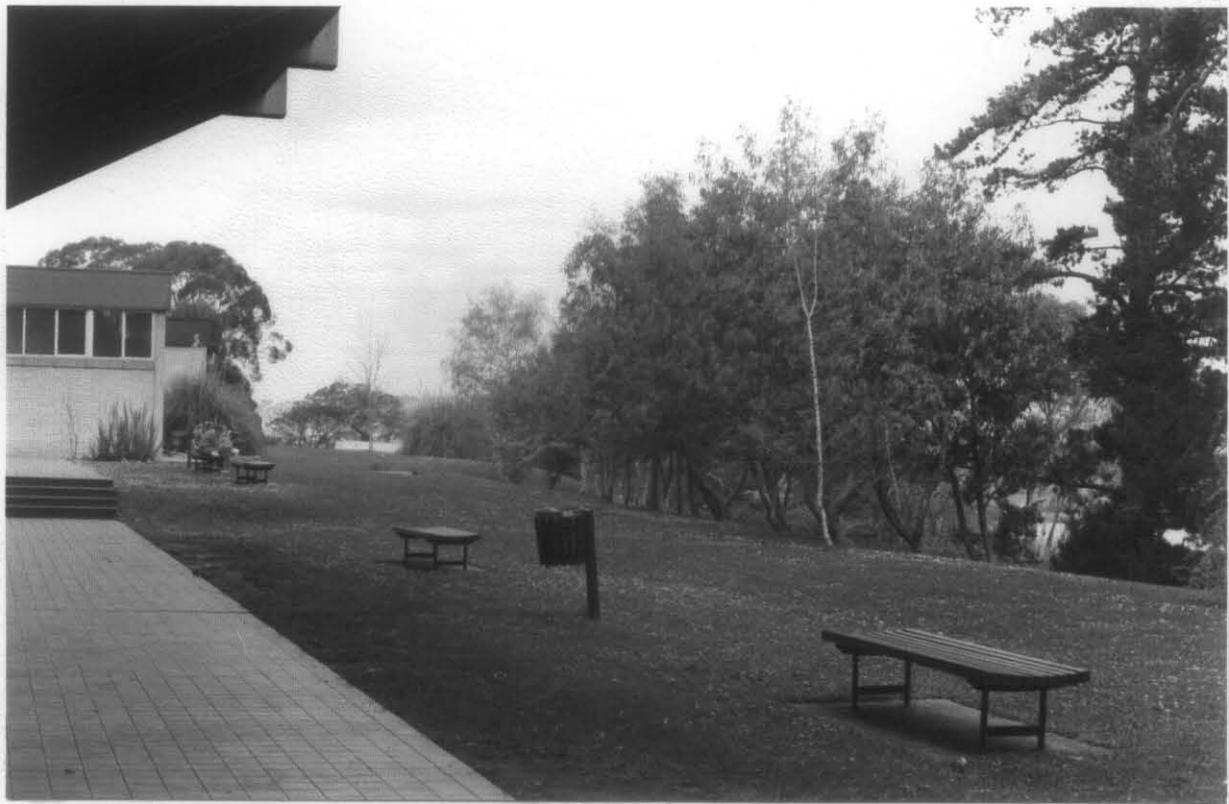
The campus of the T.S.I.T. is situated on a river terrace overlooking the flood plain of the River Tamar, with some buildings sited close to the break in slope marking the edge of this terrace (plate 5). Two recent auger holes drilled close together at the proposed building sites for the Sports Institute building (Moore, 1986) and the Nurses Training Centre Building, together with outcrops below on the highway, suggest the campus is underlain by river terrace sediments of Quaternary age overlying clay of the Launceston Beds of Tertiary age (Longman, 1964). A buried Tertiary age river valley crops out on the highway north of the Maritime College and this buried valley may extend south under the T.S.I.T. campus area.

Plate 5. *Campus buildings, showing close proximity to terrace edge on River Tamar side.*
