**1986/70. A difficult house site on steep land underlain by Permian mudstone at Powers Road, Lilydale: A case study**

W. R. Moore

*Abstract*

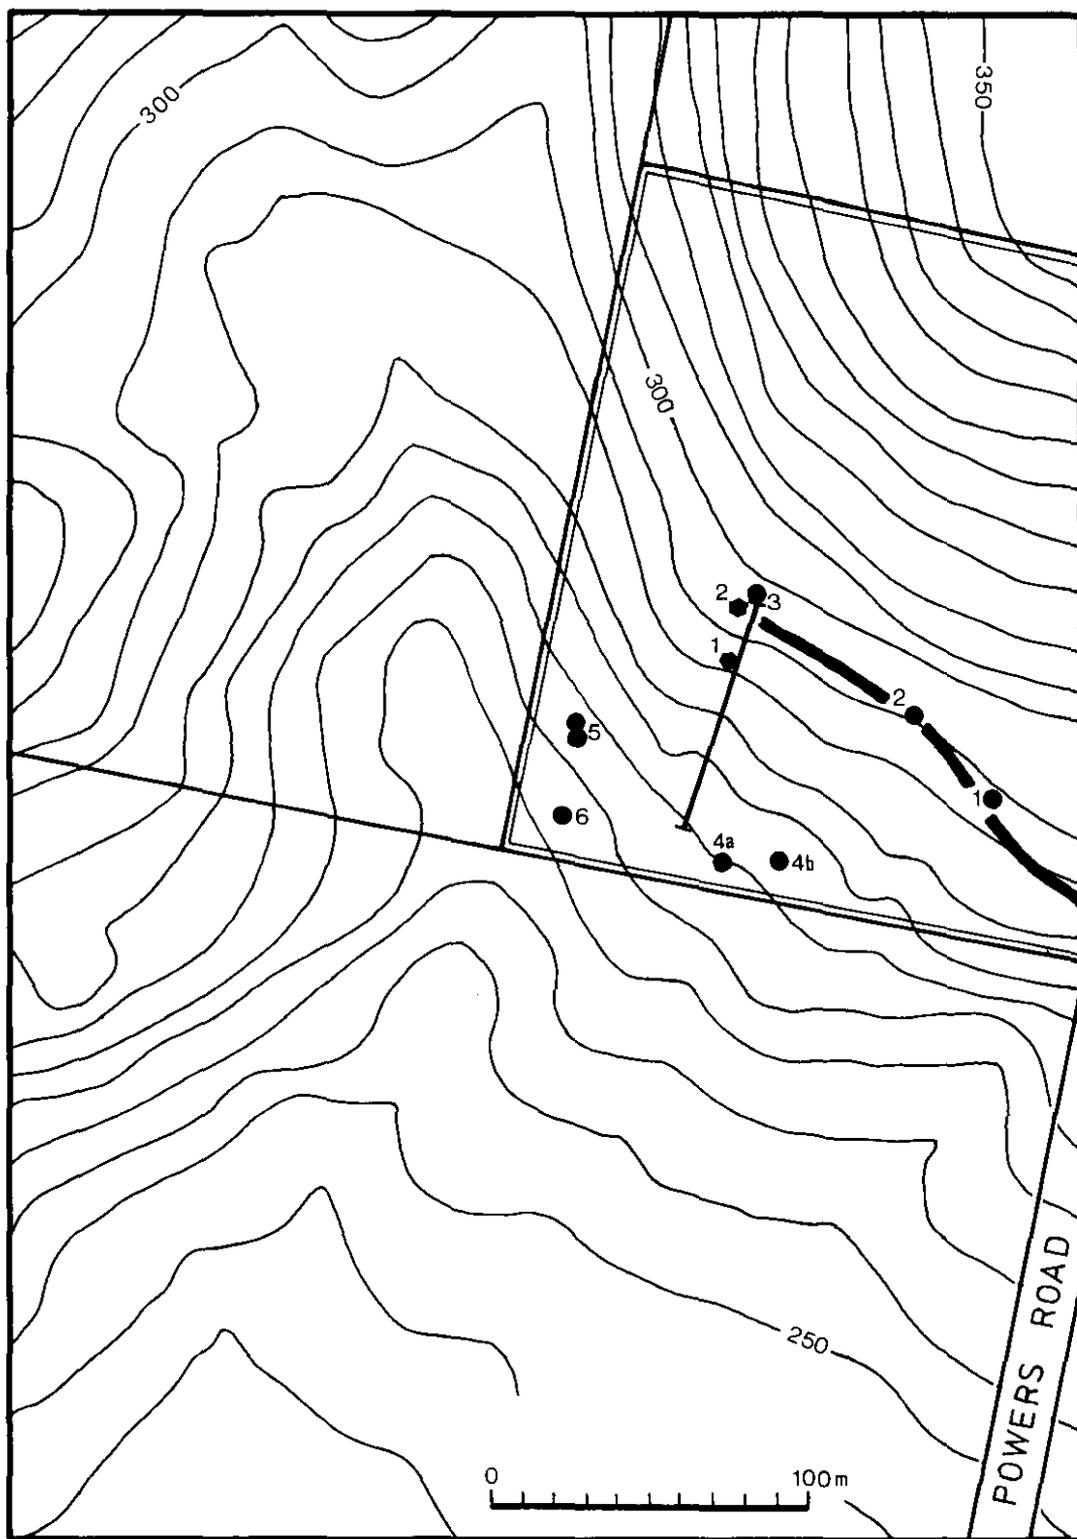
Figure 1. Buchanan's block at Powers Road, Lilydale, showing positions of drill holes and proposed house sites.

Seven sites were inspected on 11 November 1985; the locations are given on Figure 1. Of these, Sites 5a and 5b were rejected immediately by D. Baker because the overflow from the septic tank was likely to pollute the stream. Of the remaining sites, with the exception of Site 1, all had slope stability and/or drainage problems, and required subsurface investigations (Appendix 2).

- (2) There is evidence for such localised failures occurring on Buchanan's block at some of the previously investigated house sites (Hawes site b, Appendix 1).

- (3) Trenching and drilling show that there is an adequate thickness of clay present on the slope in front of Site 3 for slope failure to occur.
- (4) No soft or moist zones were seen in either of the two auger holes and neither hole made water.

- (1) Site 3 cannot be recommended for a house with conventional foundations. The foundations for the site will have to be piers dug or drilled down to the hard bedded mudstone at least 2.5 m deep, as indicated from the drilling on the site. The owner must be convinced that all the piers on which the poles for the house will be situated are into this rock. As the owner was informed verbally, if he has any doubts determining the correct material, an inspection of the foundation holes should be requested from the engineering geology section of the Mines Department. Water must not be allowed to run down the poles and collect on the surface and infiltrate down the pier sockets. A light concrete apron beneath the house would be advantageous in keeping this area dry.

- (2) Strictly on slope stability considerations, Site 1 is the preferred site by the writer. It has a lower landslide risk and would be suitable for a house with conventional foundations.

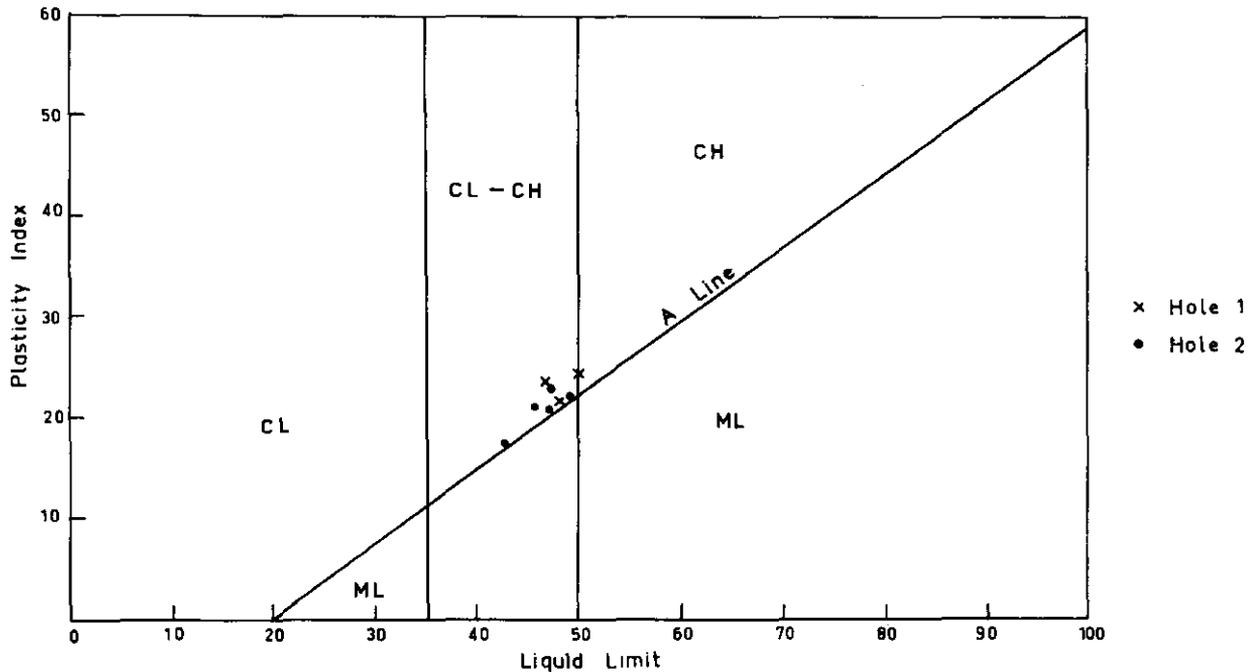
Figure 2. Clay classification diagram, with samples of clay from Holes 1 and 2 marked.

The clay, when tested, showed a medium plasticity and, when plotted, is in the low to high range of the International System of Soil Classification. The highest plastic index of the samples tested was 24, with a liquid limit of 50 (fig. 2).

The tested properties of the Lilydale clay derived from the weathering of the Lower Permian mudstone are noticeably different to the properties of clay from the Launceston Beds of Tertiary age of the Tamar Valley. The plasticity is much lower (fig. 2) and the angle of friction is higher and cohesion lower.
