1986/80. High groundwater levels along Shark Point Road, Penna.

B. D. Weldon

Abstract

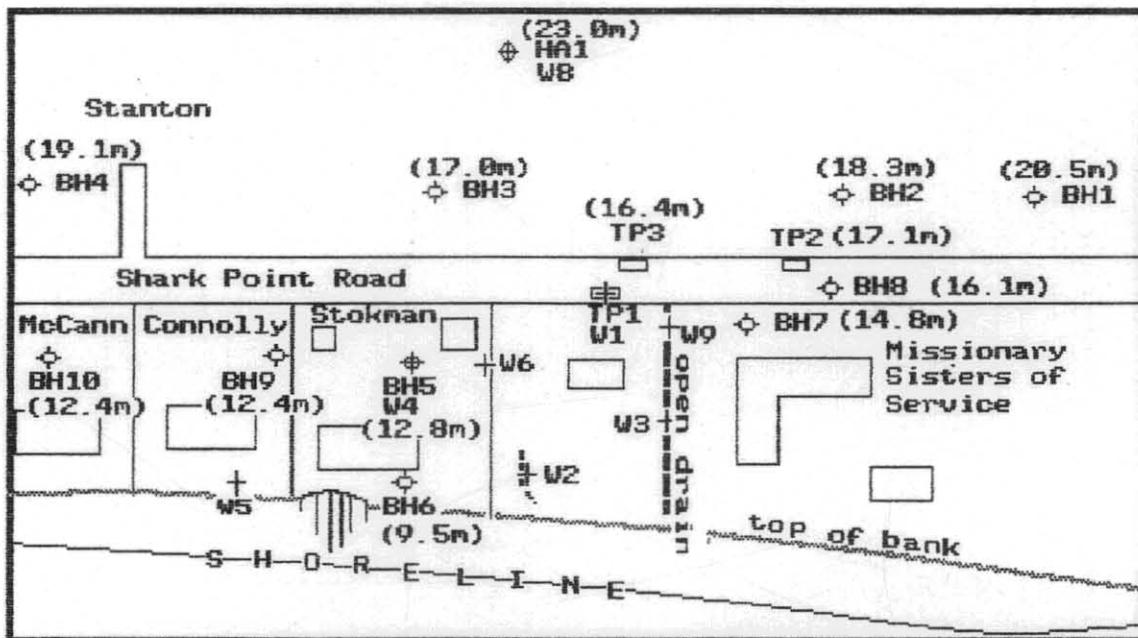
Fig. 1. Investigation of high groundwater levels, Penna Not to Scale (Schematic only)

The sequence encountered by the test pits and the boreholes are summarised in Table 1. The various sites are shown schematically in Figure 1.

The Department of Mines results, because of turbidity in the samples and the relatively narrow sensitivity band for the colorimetric test, should be regarded with caution. The locations of the various samples are given schematically on Figure 1.

The Government Analysts results do, however, suggest some mixing of naturally occurring groundwater (as typified by sample W8) and treated domestic water supplies (as typified by sample W7). Samples W1-W4 contain roughly 75-100% more fluorine than that in the natural groundwater control sample (W8). Again, caution must be exercised. Samples W2 and W3 were obtained downslope from the outfall of septic tanks and may be contaminated from these sources. In the past there has been a leak in the supply line. Fluorine in the water at this time may have been absorbed by clay particles within the sand. The fluorine detected by the analyses could be from this source. Alternatively, the line might have a fresh leak.
