1986/83. Investigation of cracking of S. Pickett's house, Windermere Road, Windermere.

W. R. Moore

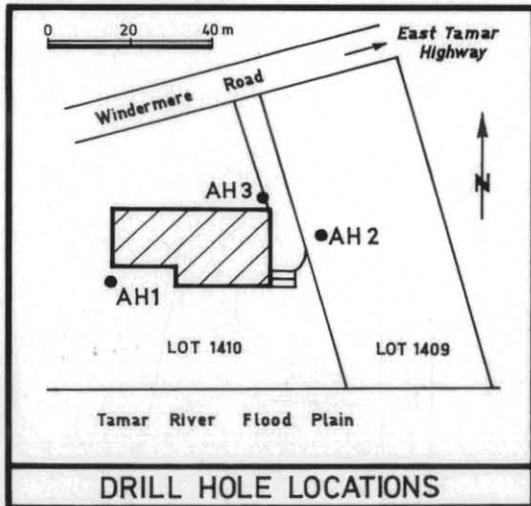
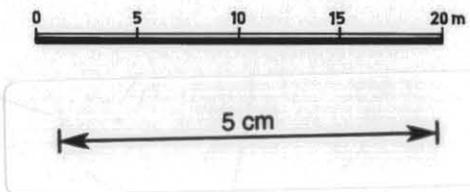
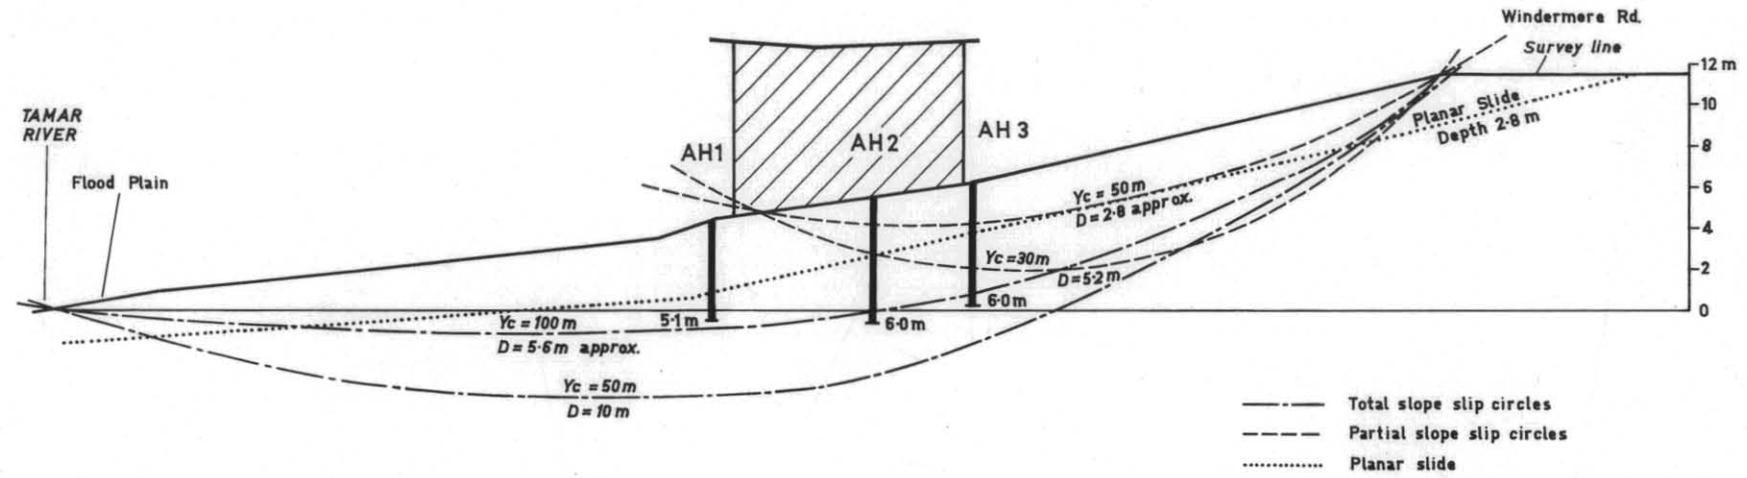
Figure 1.

The house is situated on the northern lot of this double block. The southern lot is mainly in lawn with trees. On the western boundary of the house lot, slopes of 12° occur which flatten to 7° from the south-west corner of the house to the river bank. On the east side of the house lot the driveway slopes down from 14° to 12°, flattening to 6° on the fill near the underhouse garage. The slope then flattens to 6° on the flood plain. This higher flood plain comprises most of the lower southern block which has slopes of 5° flattening to 3° (fig. 1).

SLIP CIRCLES FOR STABILITY ANALYSIS PICKETT'S HOUSE - WINDERMERE

The steeper section of Pickett's block was modelled in this analysis. Two potential failure circles were used with radii of 30 - 50 m, giving the maximum depth to these surfaces of 5.2 m and 2.8 m (fig. 1).

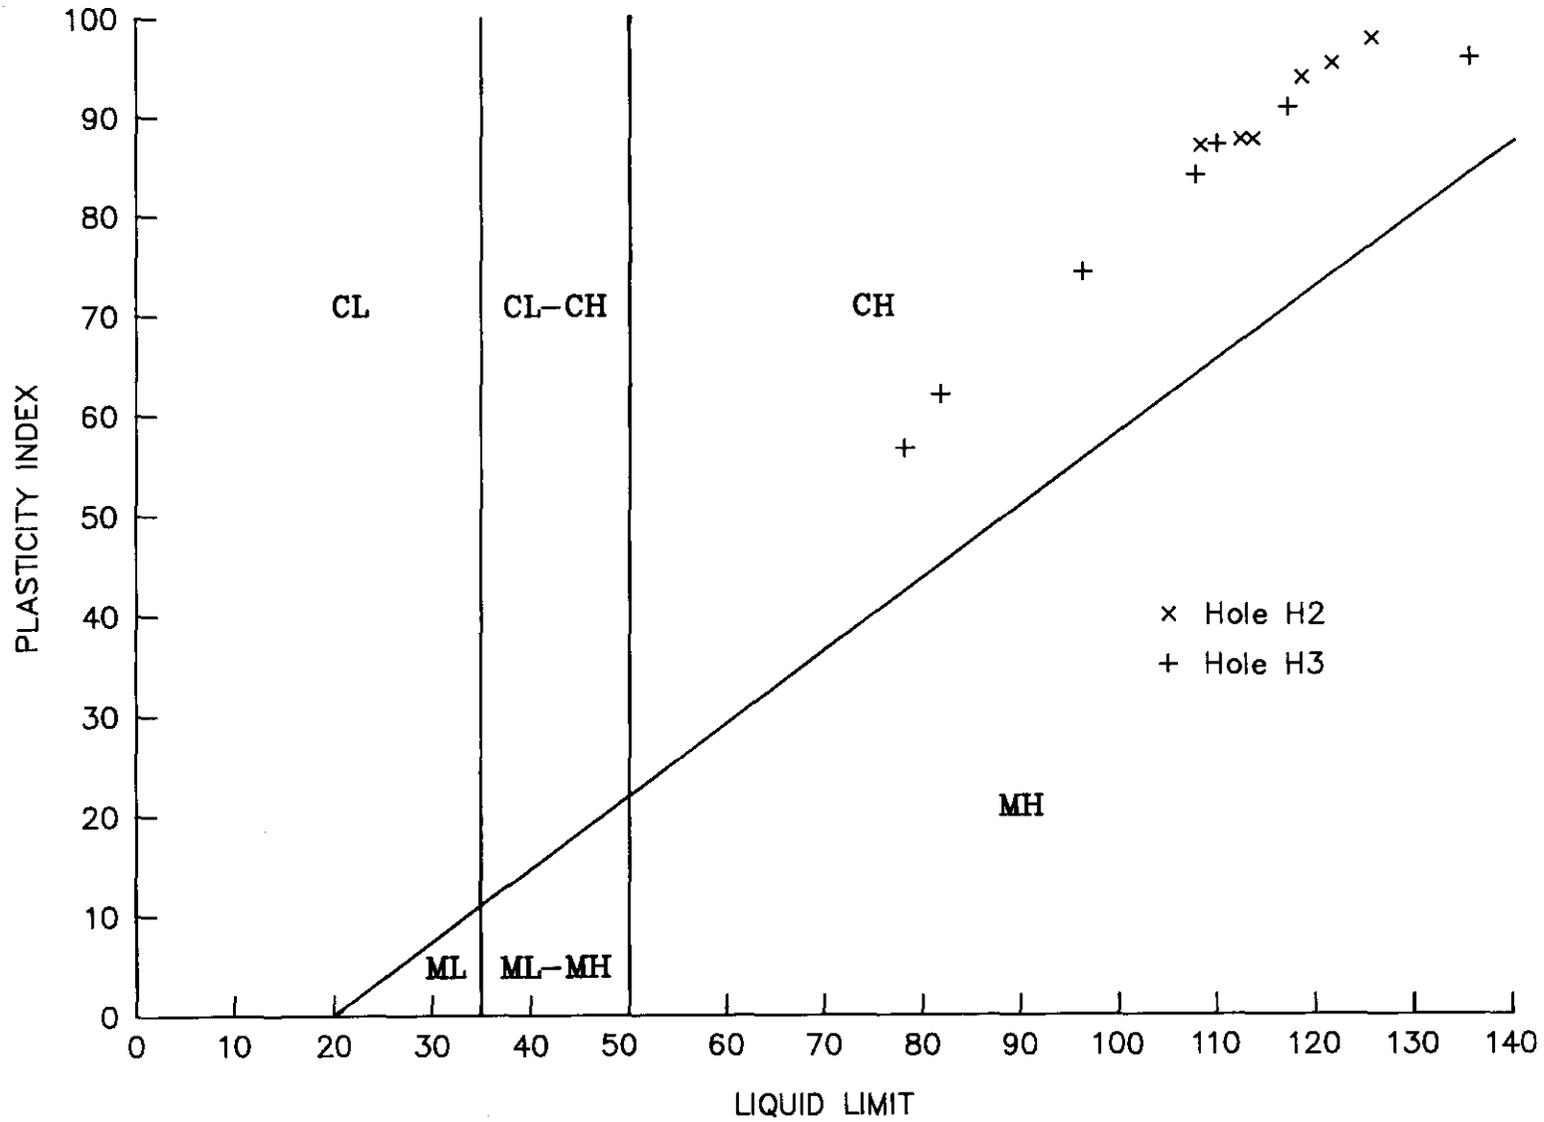
Figure 2. Soil laboratory classification of clays

All of the clays sampled were highly plastic with a wide range of liquid limits from 78 to 125 (fig. 2). In Hole H2 the plasticity indices range from 87 to 98 whereas in Hole H3 they range from 57 to 96. In Hole H3 the highest value was near the surface at 0.6 m and lowest at 1.5 m. From this depth the plasticity index increases with depth from 62 at 2.4 m to 92 at 6.0 m depth (fig. 3a). The linear shrinkage shows a similar pattern with depth and varies from 20-26%. Hole H2 shows little of this variation and the liquid limits are higher (fig. 3b).

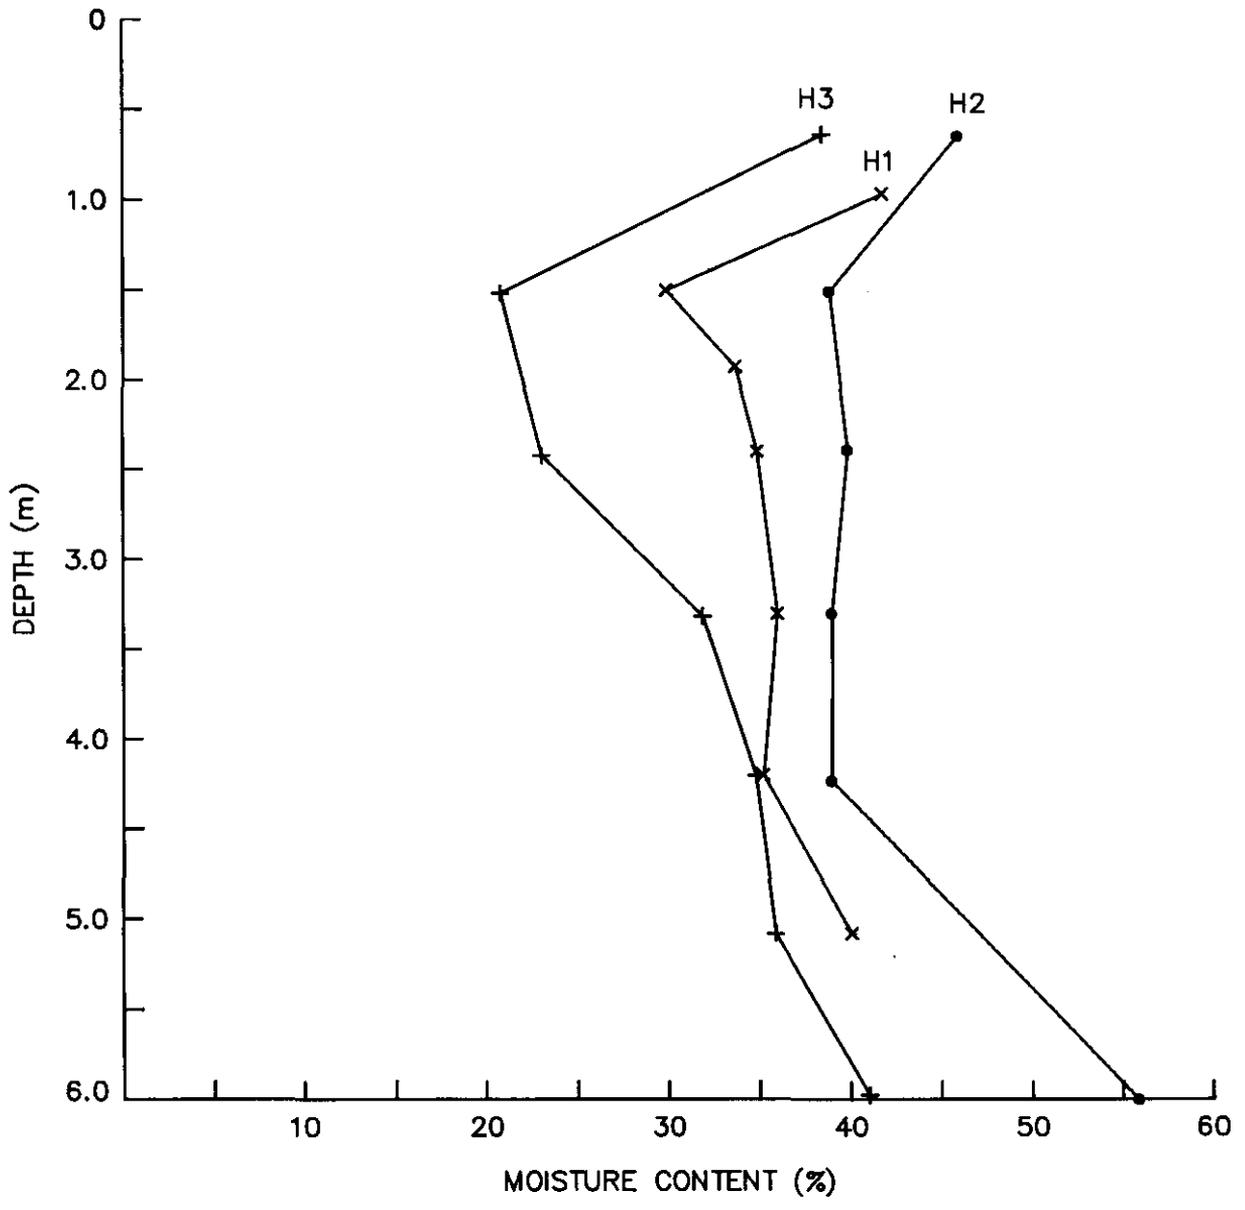
Figure 4. Moisture content profiles, holes H1 to H3.

The moisture content profile of Hole H3 shows a very moist surface layer of 38% at 0.6 m depth, which declines considerably to 21% at 1.5 m depth. Then, with increasing depth, the moisture content increases constantly to 41% at 6 m depth (fig. 4). In Hole H2, drilled on the higher flood plain level on the east side of the house, the clays have very high moisture contents of 39% to 57%. Near the surface, at 0.6 m depth, the moisture content is 46%. This declines to 39% at 1.5 m depth and remains at this level with a consistent 39 - 40% between 1.5 m and 4.2 m depth. Below this depth there is a steep rise to 57% at 6.0 m depth which is below river level (fig. 1).

In Hole H1, drilled at the south-west corner of the house (on the shady side of the house), the moisture content profile is intermediate between Holes H2 and H3. It has a high surface moisture content, 42% at 0.9 m depth, which declines to 30% at 1.5 m and increases to 34% at 1.9 m and remains between 35% and 36% to 4.2 m. It then increases rapidly to 40% at 5.1 m, which is also below the water level of the river flood plain.
