**TASMANIA DEPARTMENT OF MINES  
UNPUBLISHED REPORT 1986/92**

## **Test pits on Hill's subdivision, Windermere**

*by W. L. Matthews*

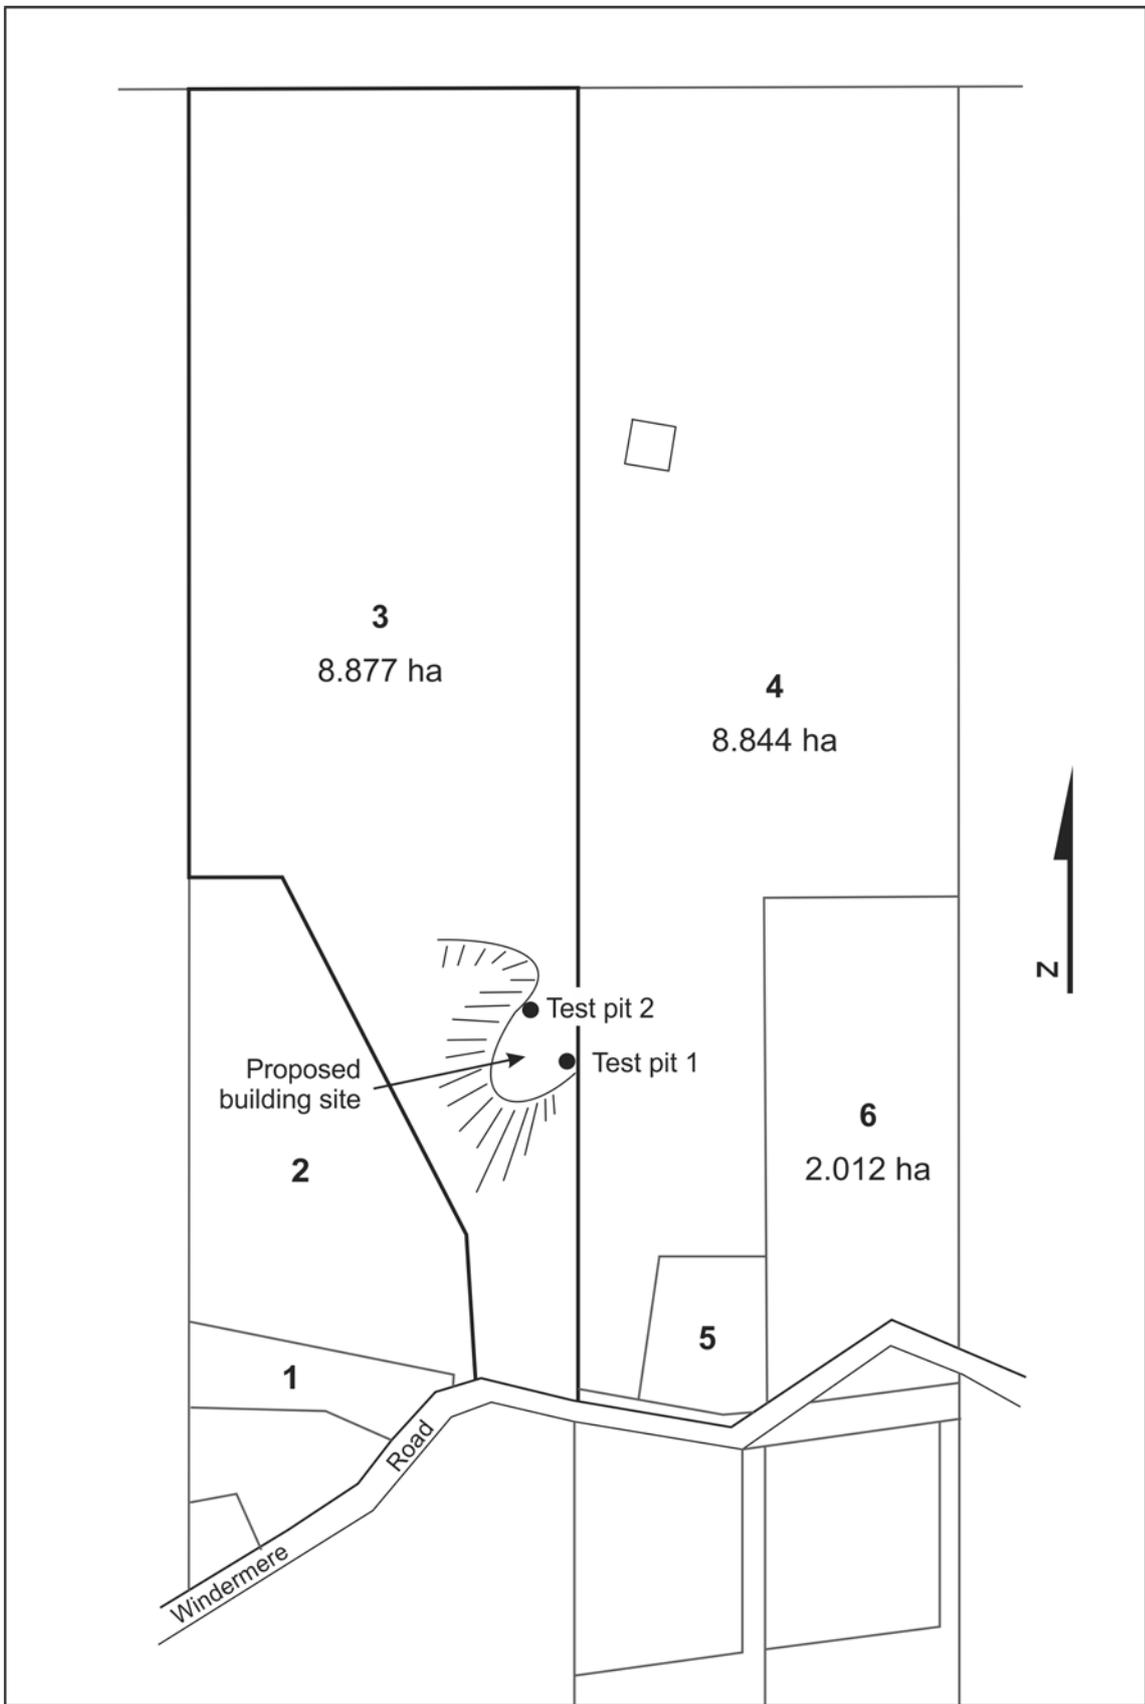
Following a request for advice on Lot 3 at Hill's subdivision, Windermere, two test pits have been examined at the site where it was planned to build a house (fig. 1).

The house site selected is a relatively small flat area on the end of a narrow ridge in a Class 3 area. Because of the topography test pits were dug to examine subsurface materials and groundwater conditions. The logs of these test pits are attached (Appendix 1).
