1987/06. Engineering geology report on five subdivisions at the Blackstone Heights Project, Launceston.

W. R. Moore

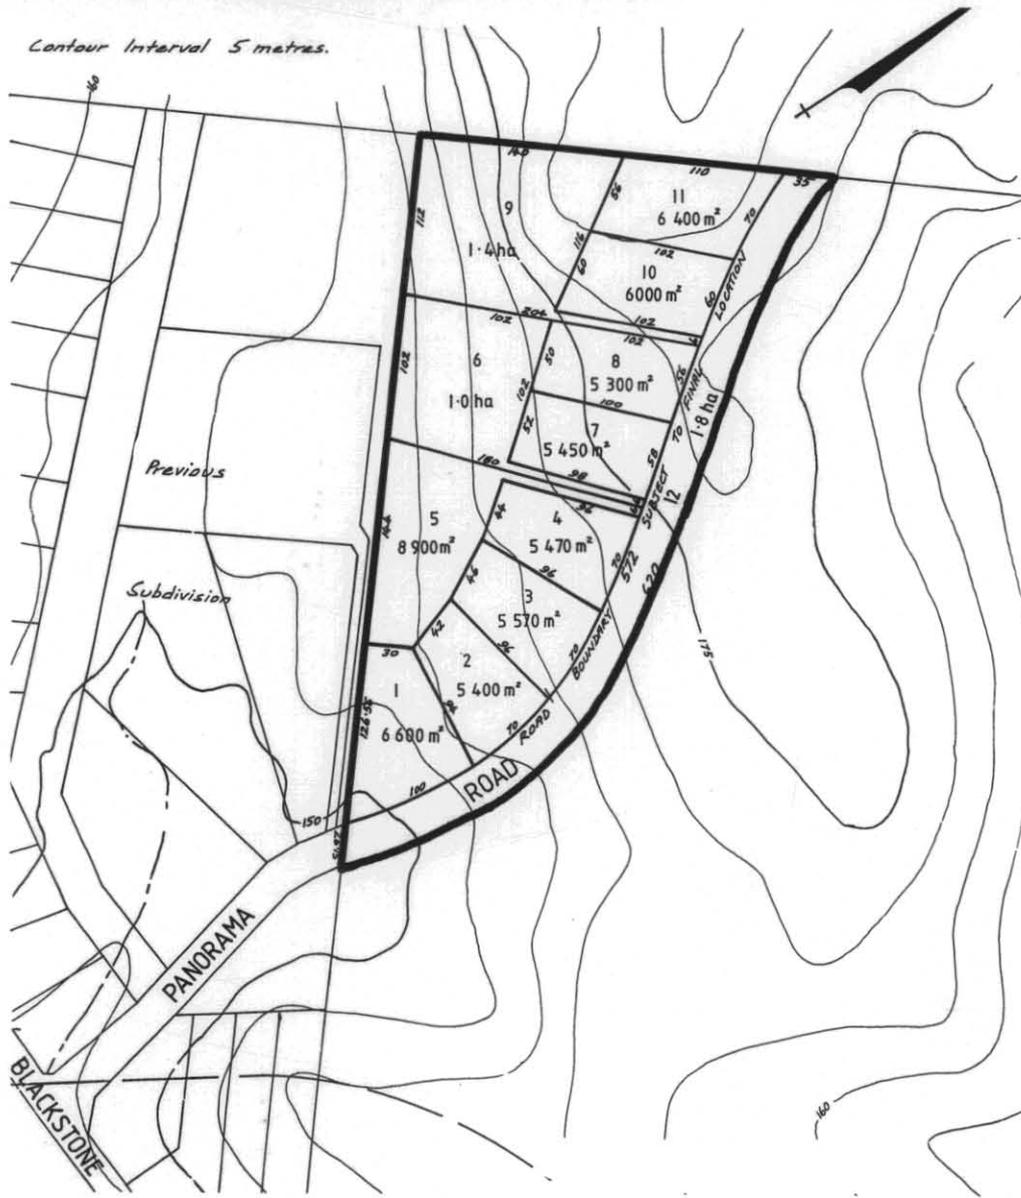
Figure 2. Panorama Road subdivision

The east-west ridge which forms the highest section of the proposed subdivision is capped by outcropping dolerite. The rock forms a series of stepped ledge outcrops followed by long slopes down to the valley floor. The highest measured slope on the subdivision was 7° with most slopes 5° or less. These slopes are gentle and even, and should give no stability problems even if a thick mantle of clay is present.

The lack of soil cover on the highest blocks in the rock outcrop area would make it difficult for soakage drains and septic tank overflow pits to function. In this area some drains may even require blasting.

There are localised moist areas, which are probably formed by pockets of clay, which will require drainage. Any house site founded on clay should have the expansive properties of the clay tested.

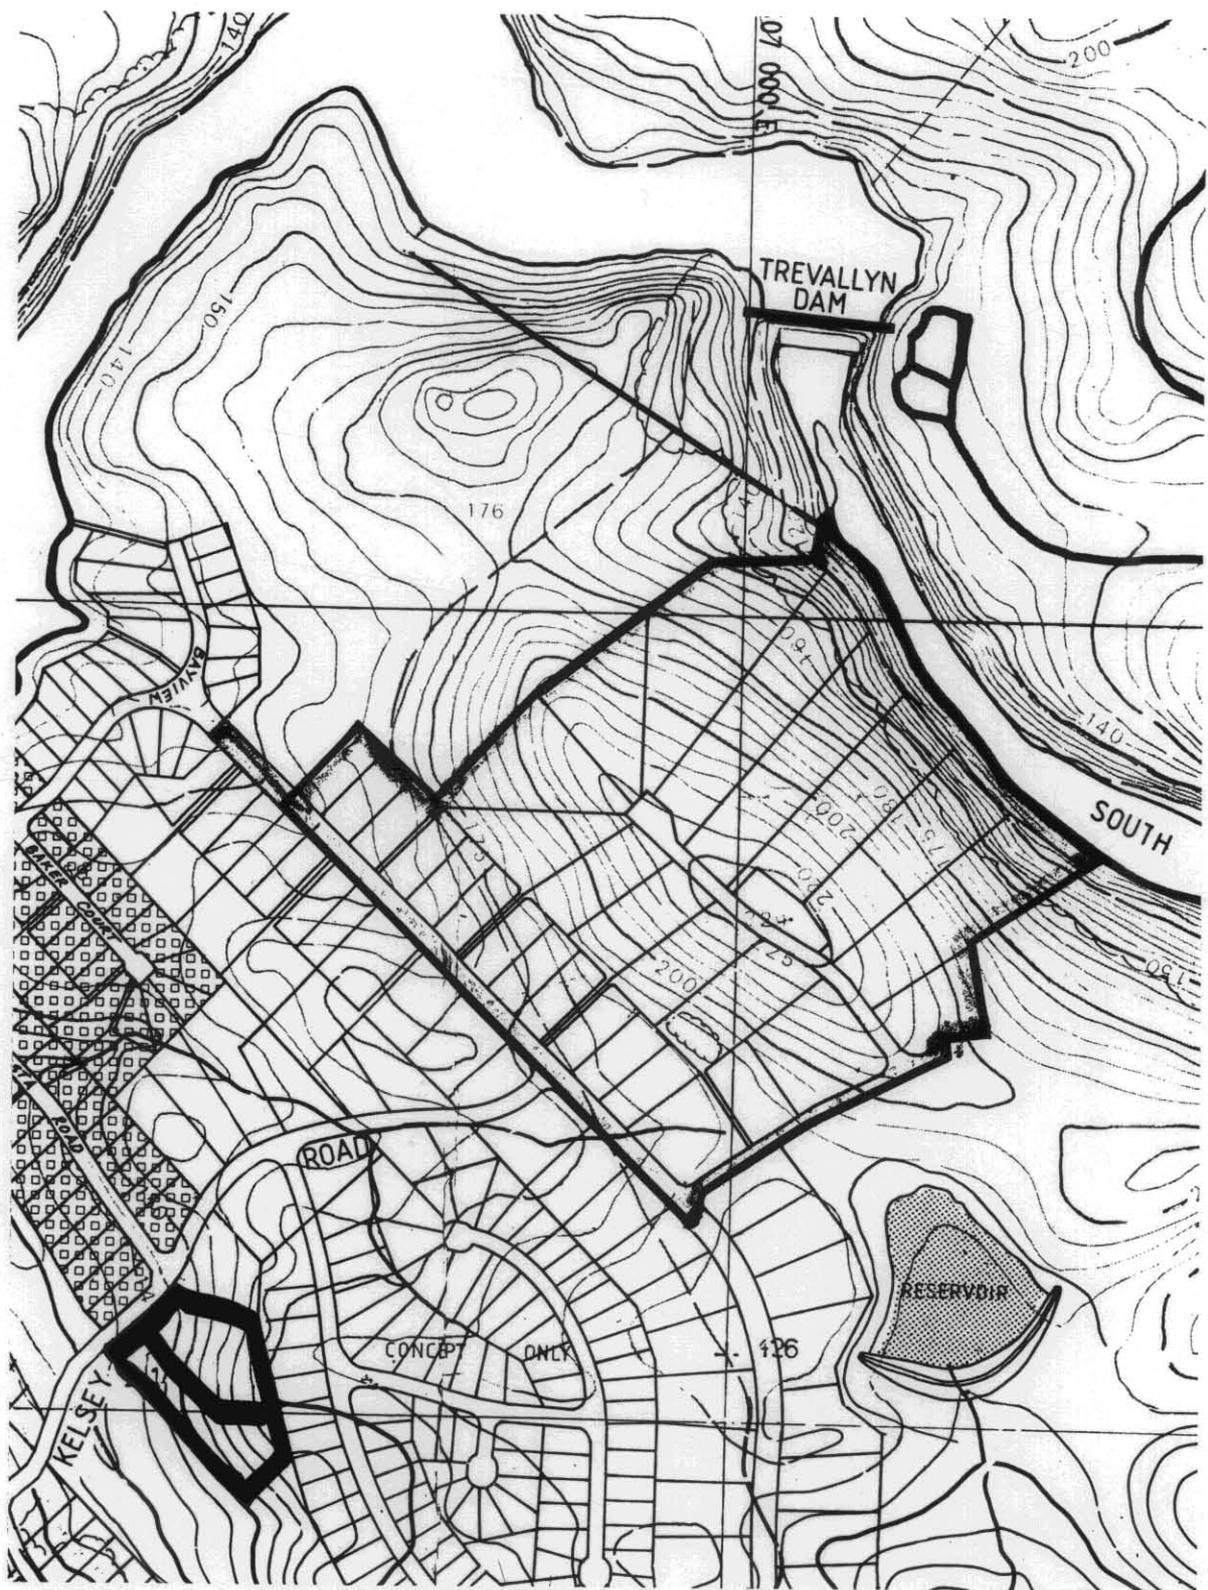
Figure 3. South Esk subdivision.

This large subdivision was not examined in any great detail, as it is only in the preliminary planning stage. The area comprises a rock-capped ridge overlooking the South Esk River to the north and Panorama Road valley to the south. From Panorama Road, the slopes of 3° and 5° of the valley flats steepen rapidly to 10°, then to greater than 15° below the rock ledge along the top of the hill on the south side.

In the shallow reservoir excavations immediately south of the subdivision, clay-like sediments, possibly of Tertiary age, and suspected basanite or Tertiary-age dolerite boulders were found.

If a similar sequence of basanite underlain by soft Tertiary-age sediments forms the ridge and steeper slopes of the ridge of this subdivision, rather than Jurassic dolerite, then the landslide risk on this hill section is going to be higher. Clearly this subdivision requires more investigation and should be zoned for landslide risk followed by redistribution of the blocks. In the existing concept plan the access road occupies the most stable zone along the rock ridge.

The seismic and magnetometer work indicate that the hill forming the major part of this subdivision is capped with a thick and very hard (high seismic velocity) layer of rock, thought, from surface mapping, to be all Jurassic dolerite. The layer is thick and extends well down the slope on the south-east face, as indicated from what is thought to be outcrops and from the magnetometer traverse. If this capping happens to be basanite (Tertiary basalt lava with the physical appearance and mineralogical composition of dolerite) then any Tertiary sediments underlying this thick capping are likely to be very thin. The magnetometer traverse indicates that these sediments (clays) are likely to be located near the foot of the slopes at approximately the same level as the reservoir to the south-east. On such low slopes (<13°) such a thickness of clay is unlikely to give any future landslide problems.

It is estimated that the field work for this mapping would be between 5-6 hours followed by some seismic work and possibly trenching. Most of this recommended work was carried out on 14-15 January when the slope and geological mapping was completed, three seismic spreads fired, and one magnetometer traverse completed.

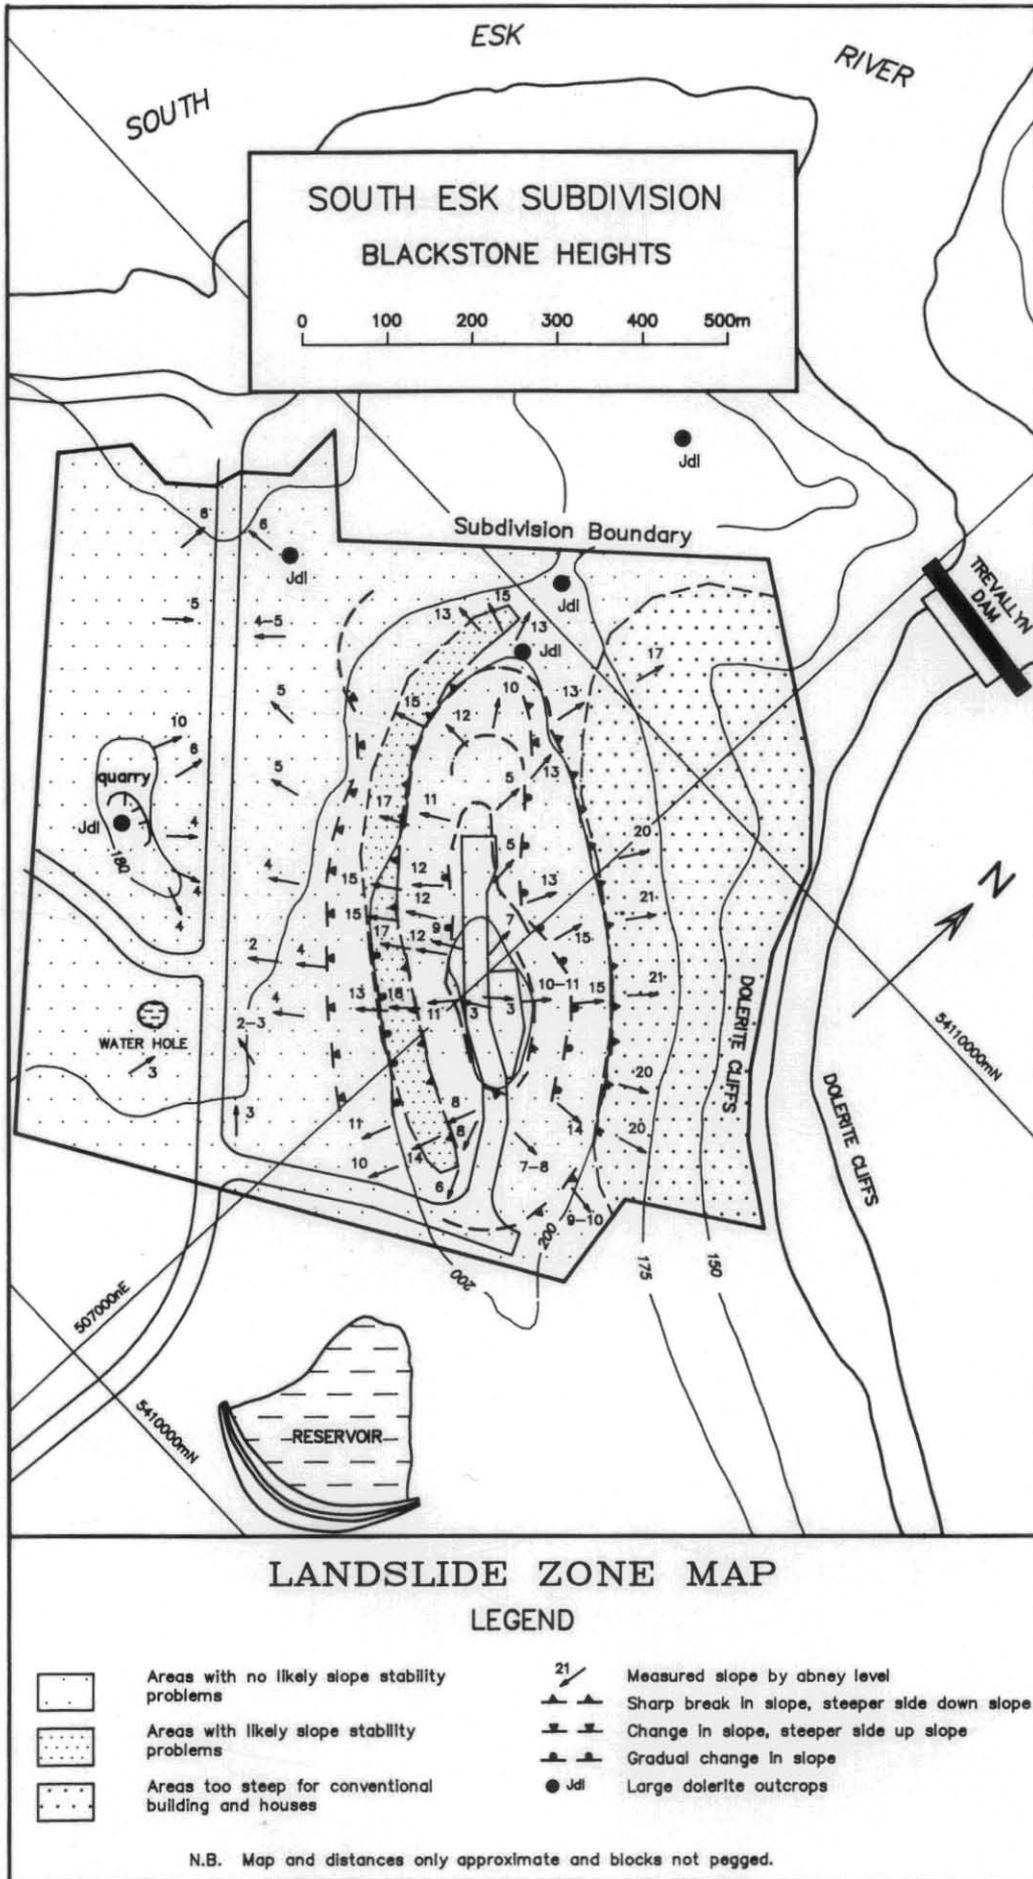
Figure 4.

This subdivision has now been mapped for landslide risk on the classification outlined previously in this report (fig. 4). The details of the above investigation will be forwarded as a separate report.

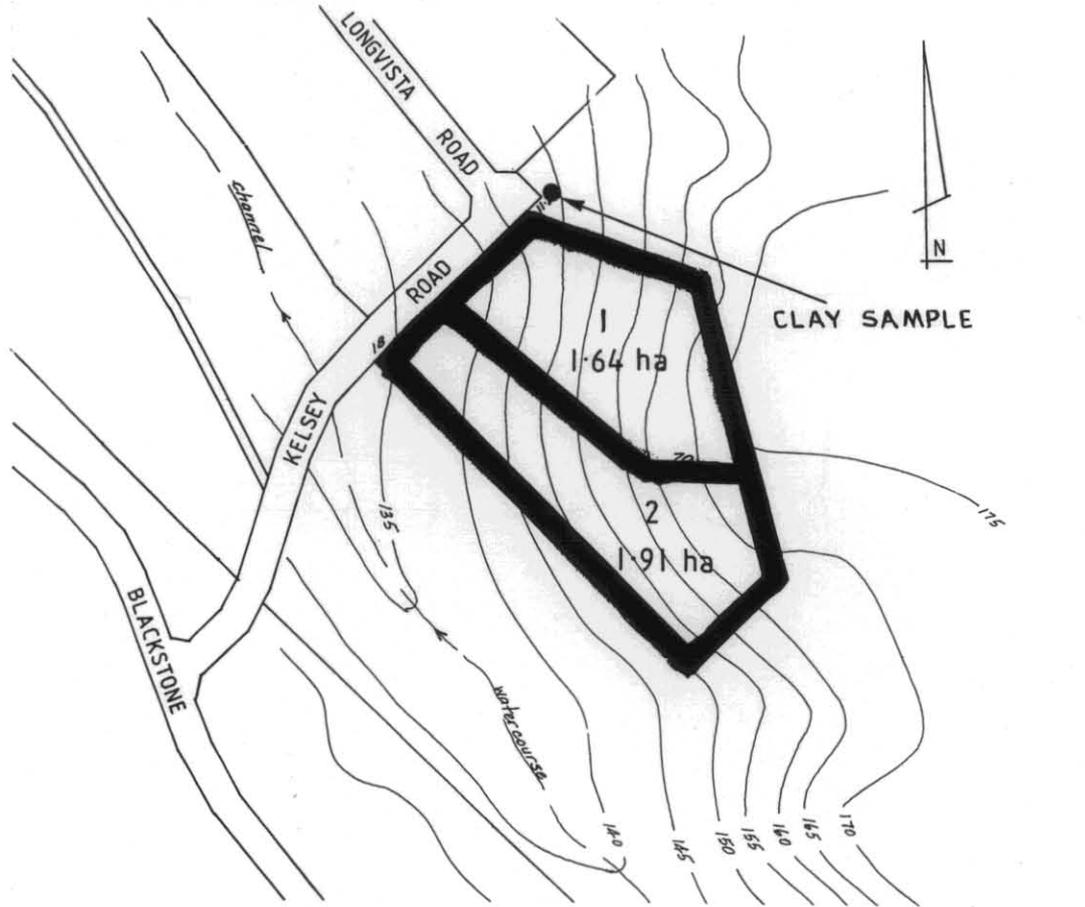
Figure 5. Kelsey Road subdivision

The precise boundaries of these two blocks could not be found on the ground. From the survey pegs located, the dolerite outcrops on the ridge are outside this subdivision's boundaries. The high eastern section of the two blocks is underlain by dolerite talus, with dolerite boulders covering most of the ground surface. Scattered dolerite boulders are present over the remaining lower area.

The slopes on the block are long and average 10°, with 11-12° slopes in the higher section and 8-9° close to Kelsey Road. There are large moist areas below the talus. Brown clay is exposed in a freshly dug drain up the slope on the northern extension of Kelsey Road. This clay with dolerite boulders is thought to underlie the even slopes of the block below the talus. It is in this steeper area that houses are likely to be sited in order to obtain a view of Lake Trevallyn.

In a freshly dug drainage pit at the junction of Kelsey and Longvista Roads is a 1.5 m deep exposure of clay. The brown clay below a thin black clay soil with dolerite boulders overlies a yellow-green clay showing an igneous rock texture. Two clay samples were collected from this pit for testing in the soil mechanics laboratory of the Department. On the opposite side of the road, 15 m distance from the above pit, is a 1.5 m high outcrop of dolerite which is so completely unweathered that it had to be blasted for the road construction.

With slopes of only 9-11° there is little risk of landslide but with the possibility of clay of a considerable thickness, and the variation of rock types occurring within such short distances, each house site should be investigated. The samples collected at road level at this subdivision (fig. 5) show the clay to be expansive (22-24%), highly plastic, with liquid limits of 89-103, and dominantly montmorillonite (90%) in composition. Shear box testing showed the angle of friction to be reasonably high (20°) but the effective cohesion was low (1.9 kPa).

A backhoe pit on each preferred house site, when selected, should be examined by an engineering geologist and, if required, the clay tested. This work will allow the engineer to design foundations and drainage suitable to each site.

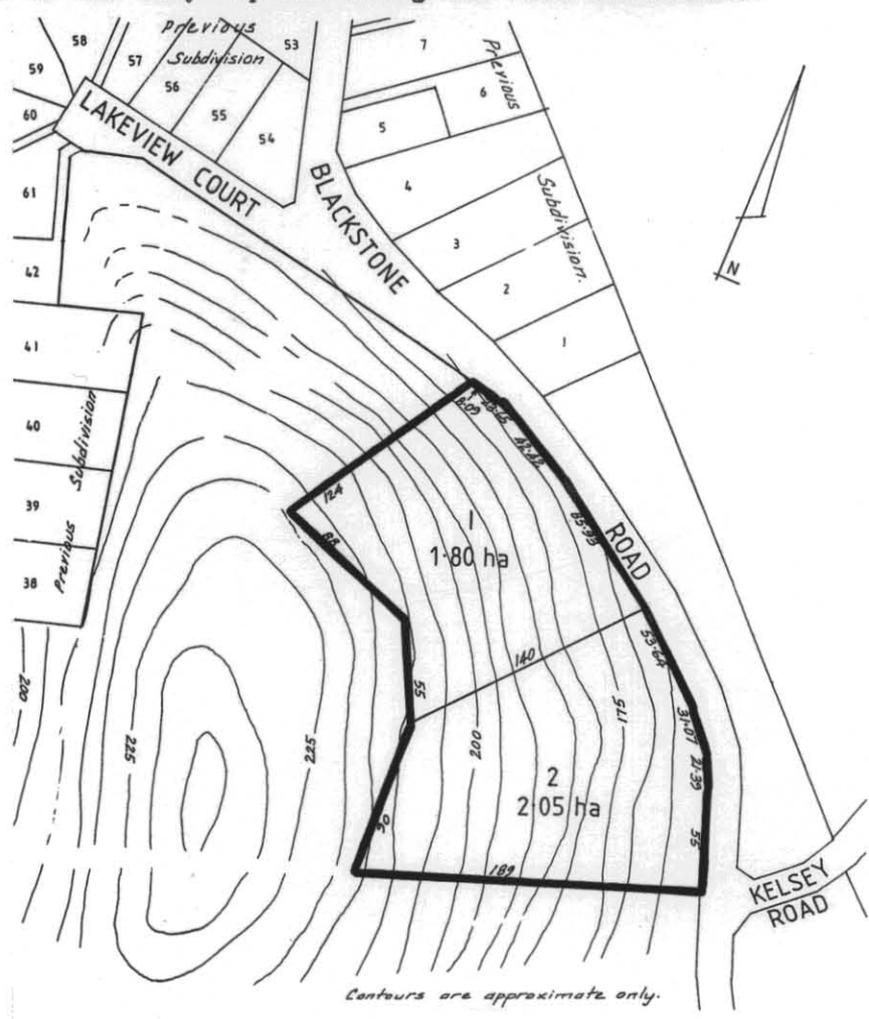
Figure 6.

This subdivision contains two large blocks on the upslope side of Blackstone Road (Plate 7). On both blocks the slopes are very steep (22°). Exposed on the ground surface are talus deposits of dolerite, possibly with some outcrops of dolerite.

The lower boundary of the subdivision is a road embankment some 2.0-2.8 m high. On this bank is a thin surface soil of talus and dolerite boulders underlain by one metre of brown clay, which is underlain by 1.5 m of yellow and white clay of extremely to highly weathered dolerite. In the yellow clay are some unweathered kernels of large dolerite boulders surrounded by clay formed by concentric weathering. Pinnacles of unweathered dolerite of the bedrock profile protrude up into the clay. Some of this unweathered dolerite has been blasted to cut the embankment. As the road climbs higher towards Lakeview Court the depth of weathering becomes marginally less deep.

On slopes as steep as 22° it is preferable that the house foundations be tied to unweathered or slightly weathered dolerite rock. To cut into such a steep bank and level a house site by pushing the material cut out as fill, over the existing slope and vegetation, is considered a very dangerous practice. The risk of a future slope failure and consolidation movements is considered to be too high. These blocks require a full site investigation with soil testing of the material, and slope stability analysis etc., to be followed by correct site preparation, adequate consolidation and permanent drainage installation if the material encountered is the clay exposed along the road embankment.

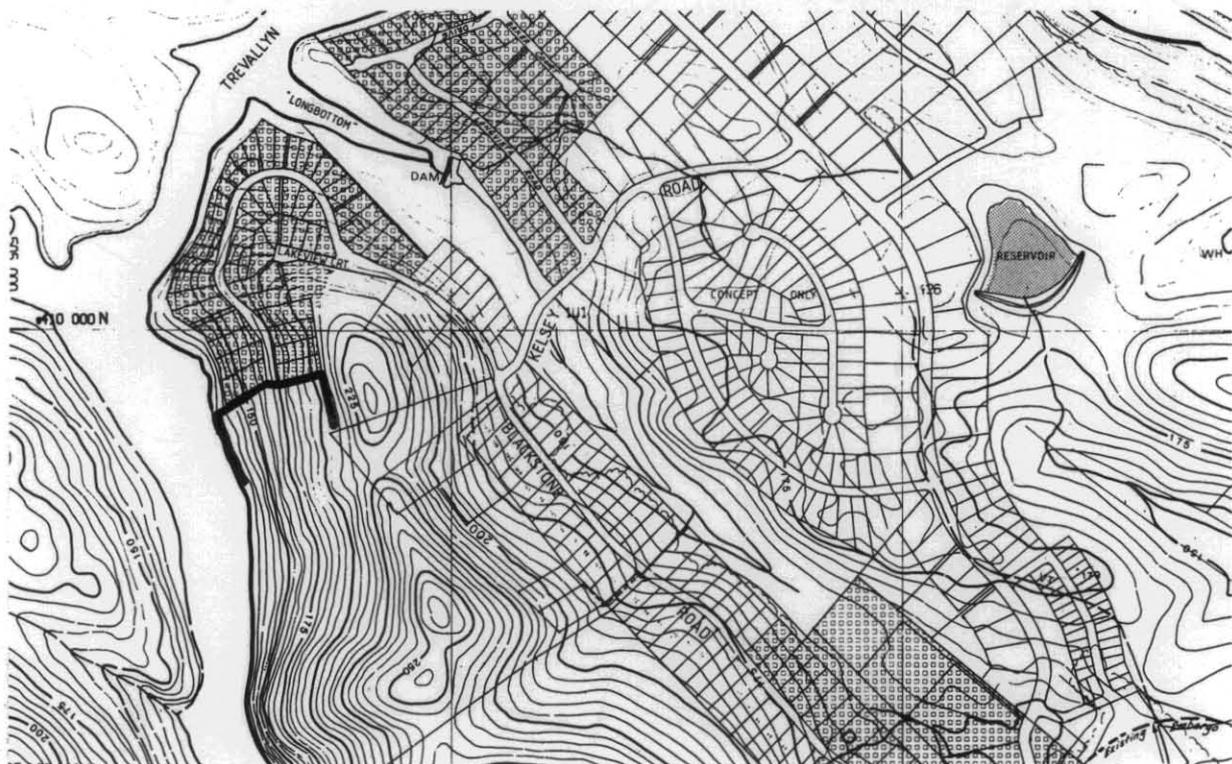
Figure 7.

The road has been cut into the slope and the fill pushed over the slope. The road cutting gives continuous exposures of dolerite and dolerite-derived clay, approximately 2.0-2.5 m high. The extremely weathered dolerite forms a 16 m long exposure which ends in unweathered dolerite at the south end of the road.

The slope above the road is 22° and south of the road, the natural slope below the road level is $32-35^\circ$. The slope is mainly covered by dolerite boulders, some large. Flat and stepped outcrops or near-outcrops are visible from the road. The depth to dolerite does not appear great, but this can only be established by further investigation.

Serious thought should be given by the Westbury Council as to the suitability of these sites for housing because of the high potential risk from slope failure and boulder toppling. Further subdivision southwards should be dependent upon the results of detailed geological analysis.

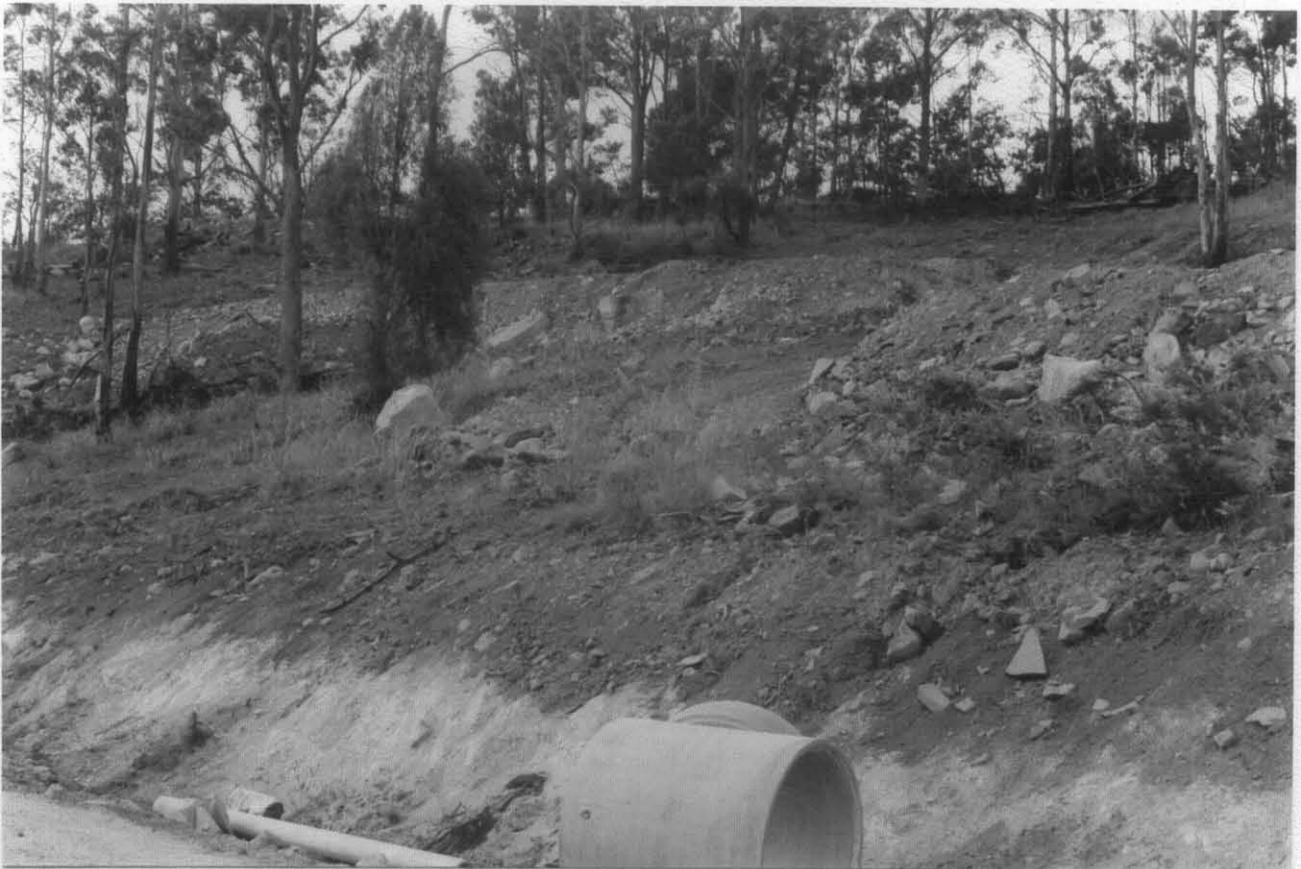
Plate 2. *Yellow clay retaining igneous texture, exposed in a drain.*

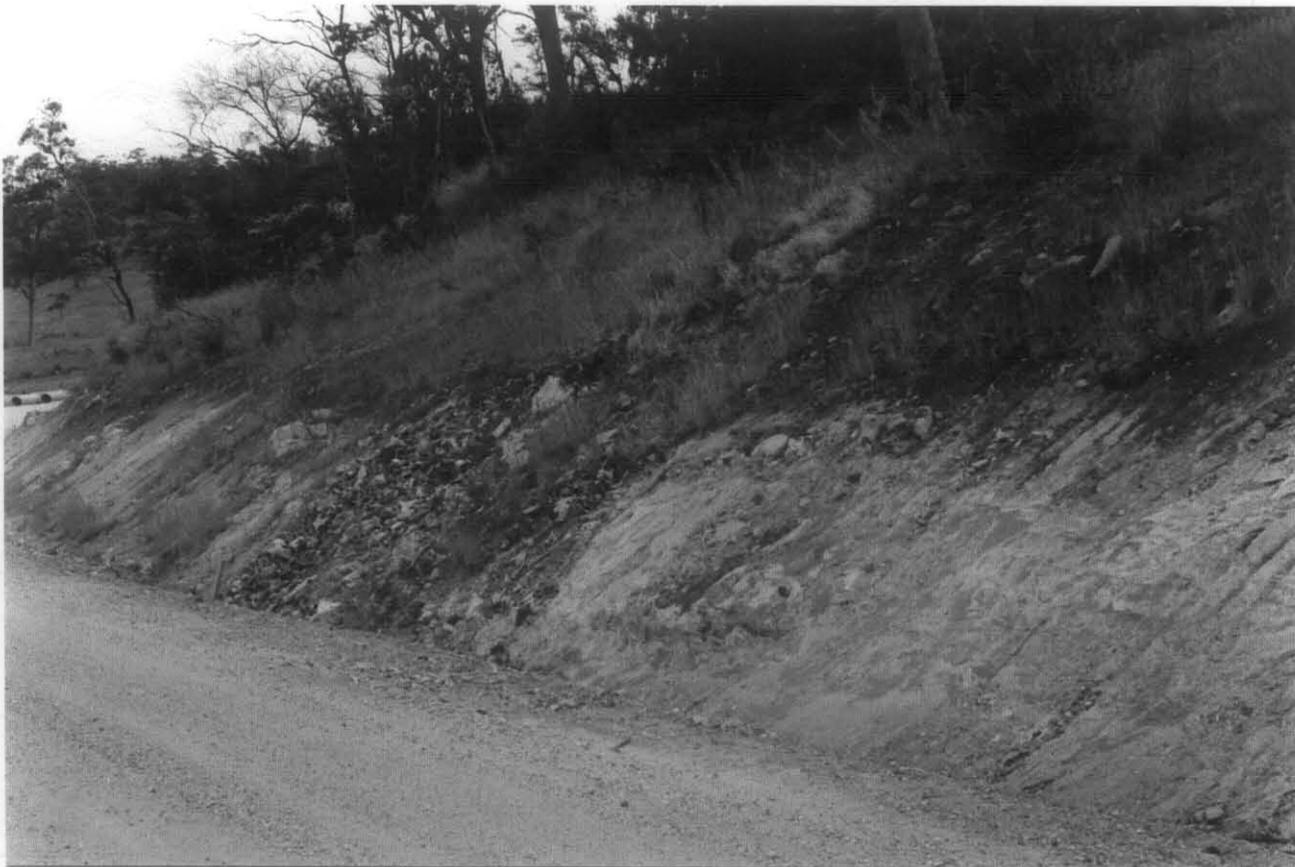
Plate 3. *Fresh dolerite rock bounded by yellow clay.*

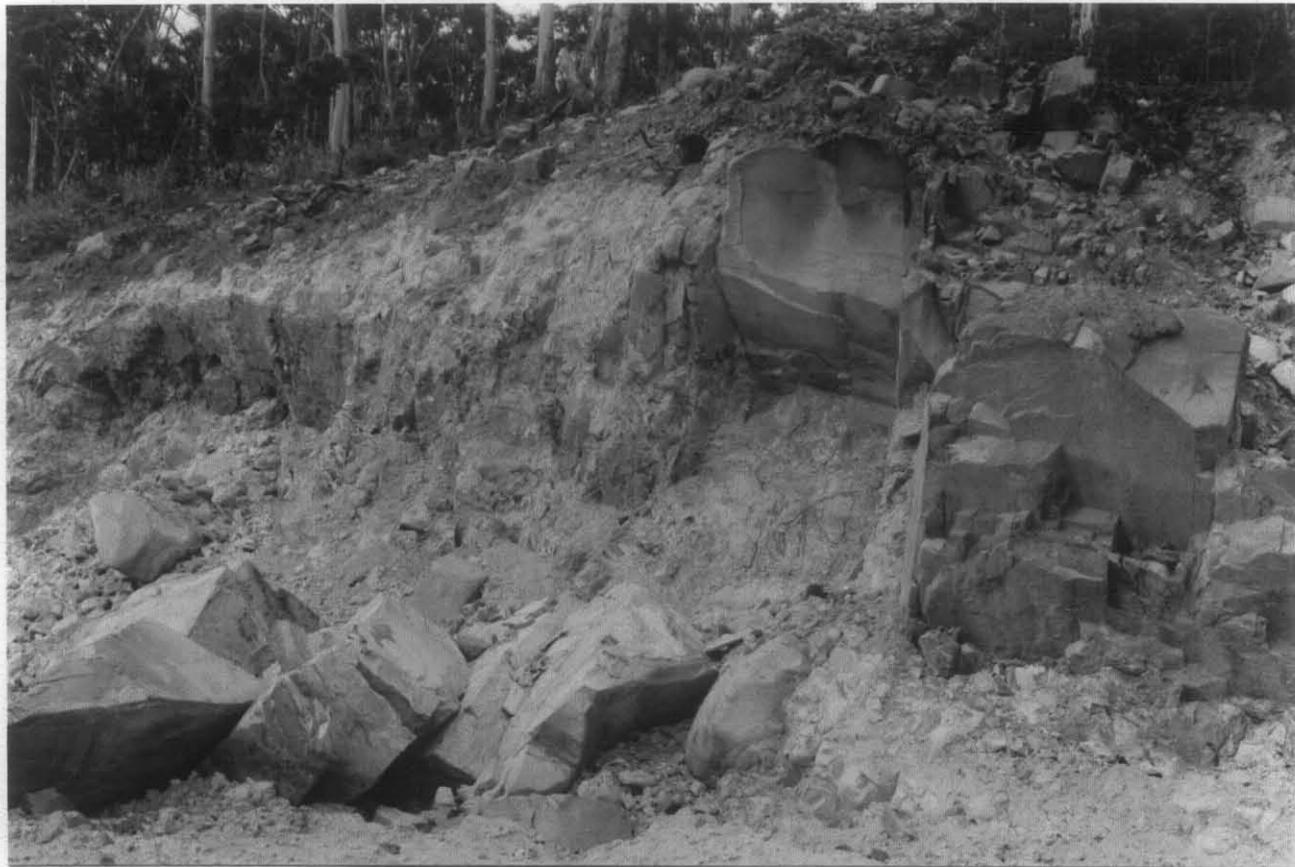
The profiles between the extremely weathered to highly weathered dolerite (clay) and unweathered to slightly weathered dolerite (rock) are irregular, both in shape and depth. Some areas show deep concentric weathering with kernels of unweathered large dolerite boulders surrounded by clay (Plate 4). In other exposures the change is abrupt from unweathered dolerite to clay (Plate 5). This latter change appears to be the result of metasomatic alteration due to the extrusion of fluids possibly associated with Tertiary faulting in the dolerite. This alteration and weathering is thought to be re-exposed weathering of Tertiary age and not associated with present day weathering.

Plate 4. *Kernels of unweathered large dolerite boulders surrounded by clay.*

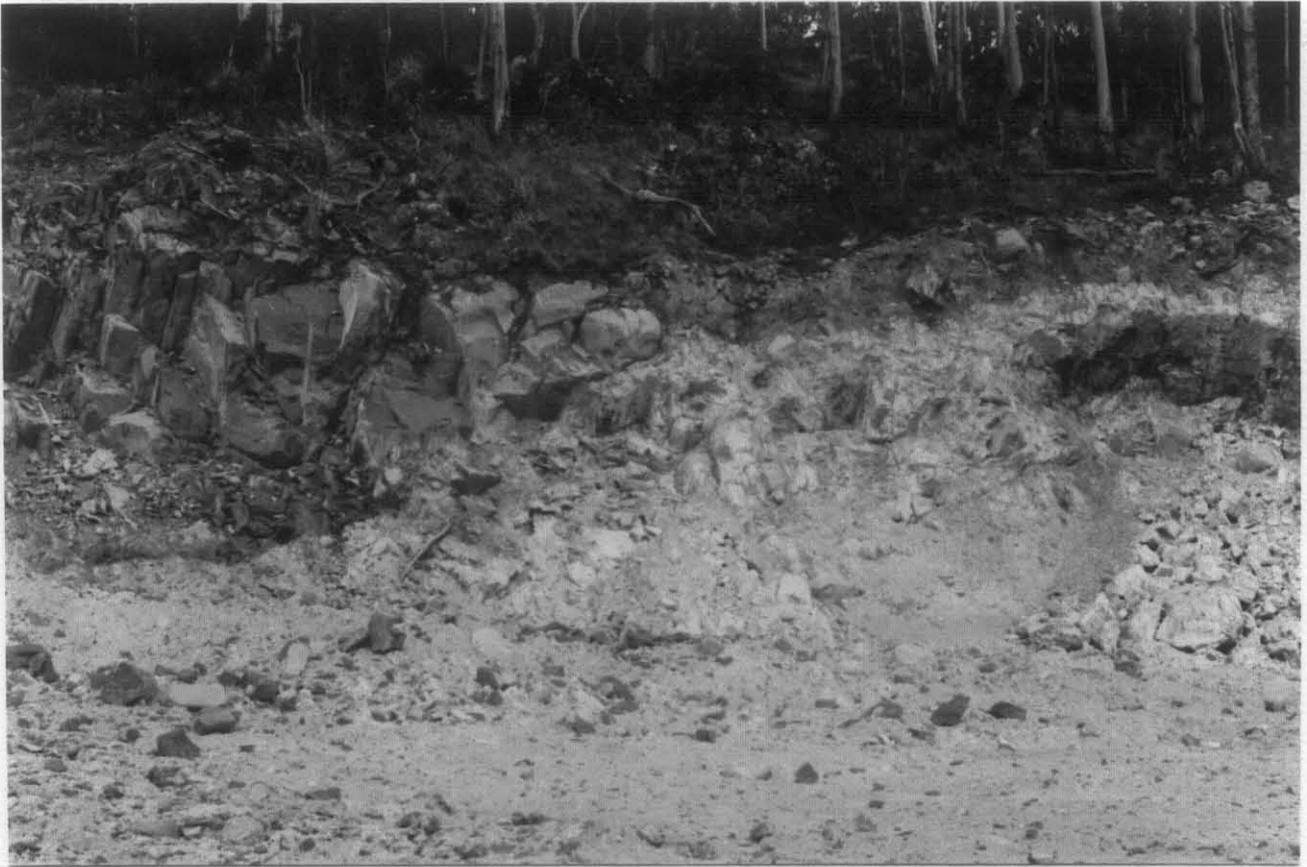
Plate 5. *Exposure showing abrupt change from fresh dolerite to clay.*

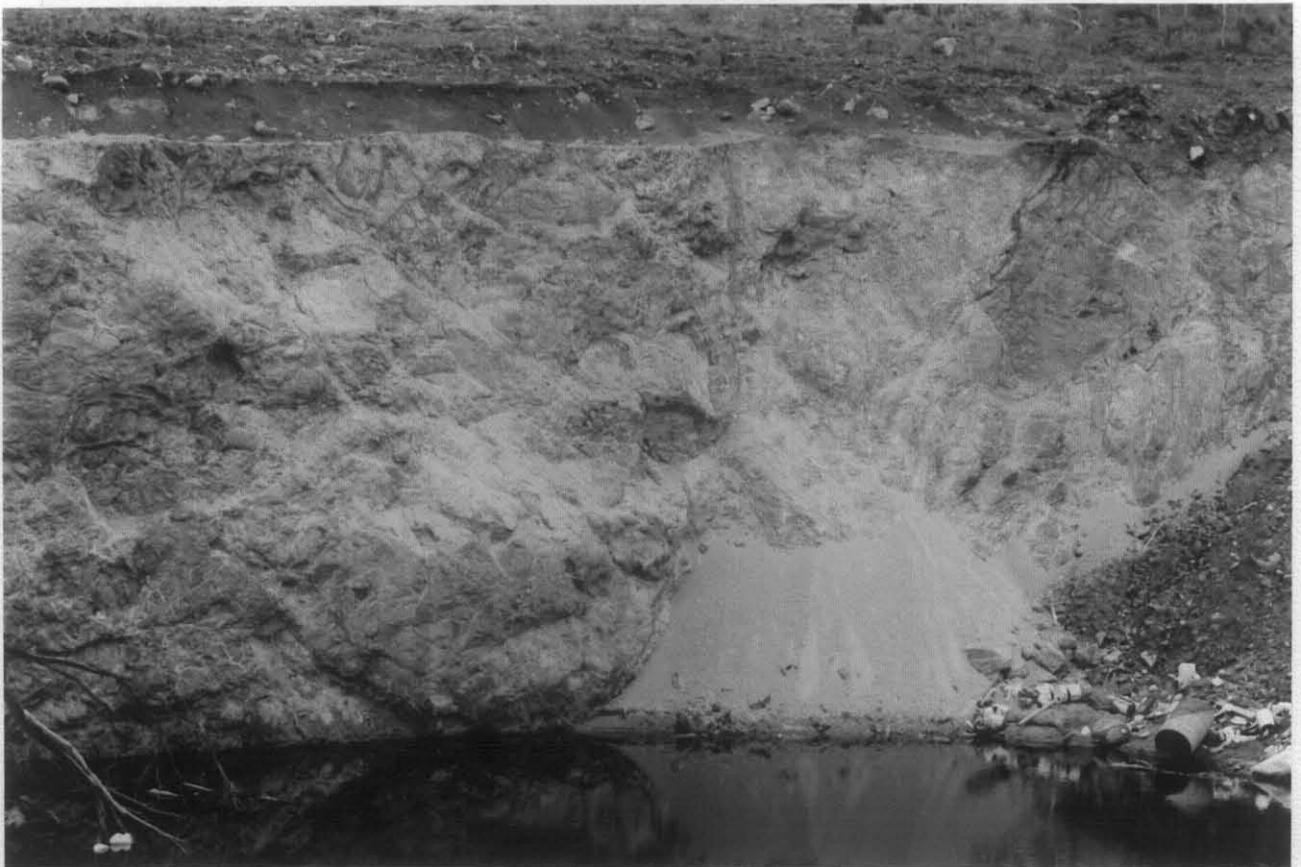
From the limited amount of work done to date, outcrop of dolerite rock appears to be confined to the ridge and hill tops, and to the lower slopes bordering Lake Trevallyn and the South Esk River. On the higher levels of the slopes are talus deposits of large dolerite boulders and clay, with boulders appearing to cover a high percentage of the ground surface, whereas on the remainder of the slopes the clay appears to dominate. The thickness of the clay and the depth to the unweathered or slightly weathered dolerite is unknown but appears considerable and variable in the borrow pits examined (Plate 6).

Plate 6. *Exposure in borrow pit, showing depth of weathering in dolerite.*

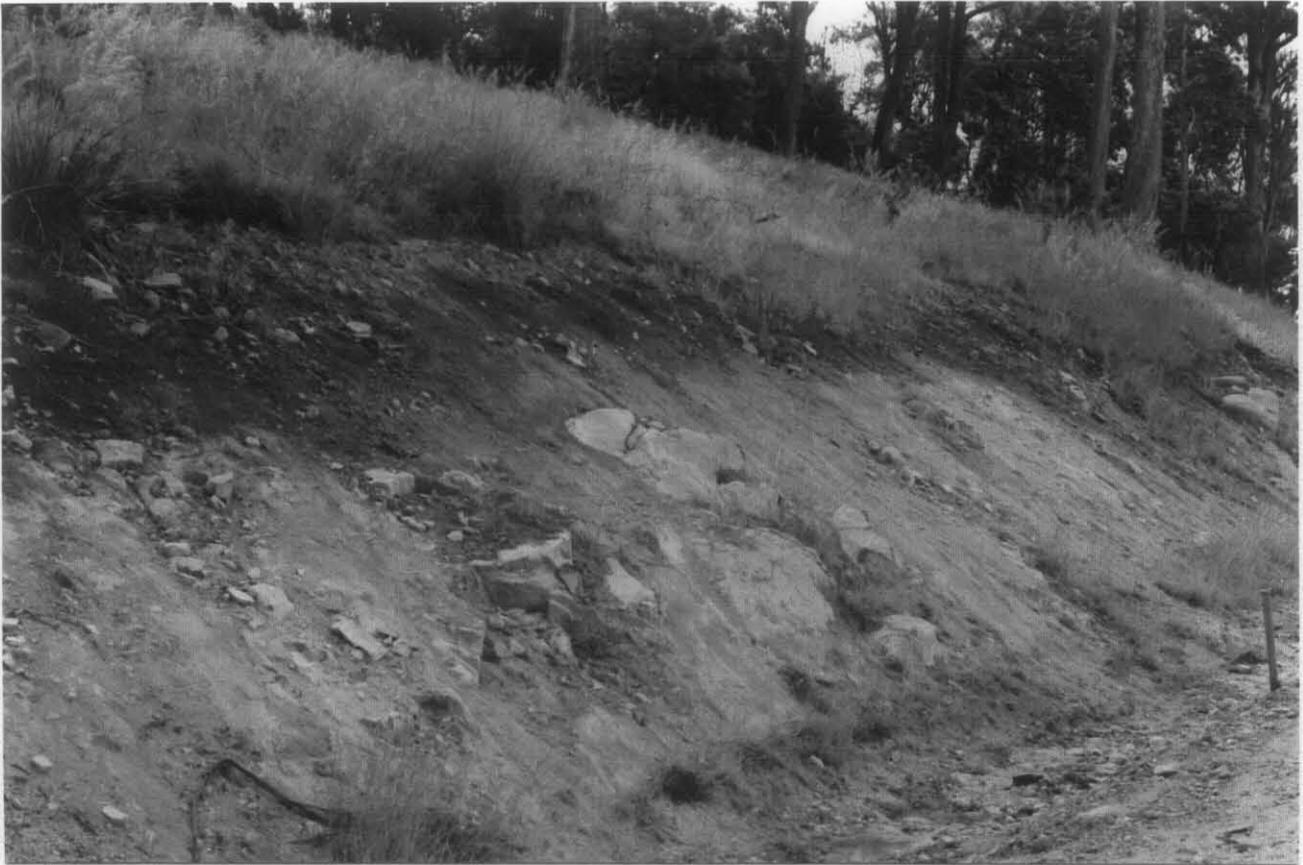
Plate 7. *Steep slope bordering blocks in Blackstone Road subdivision south of Lakeview Court.*

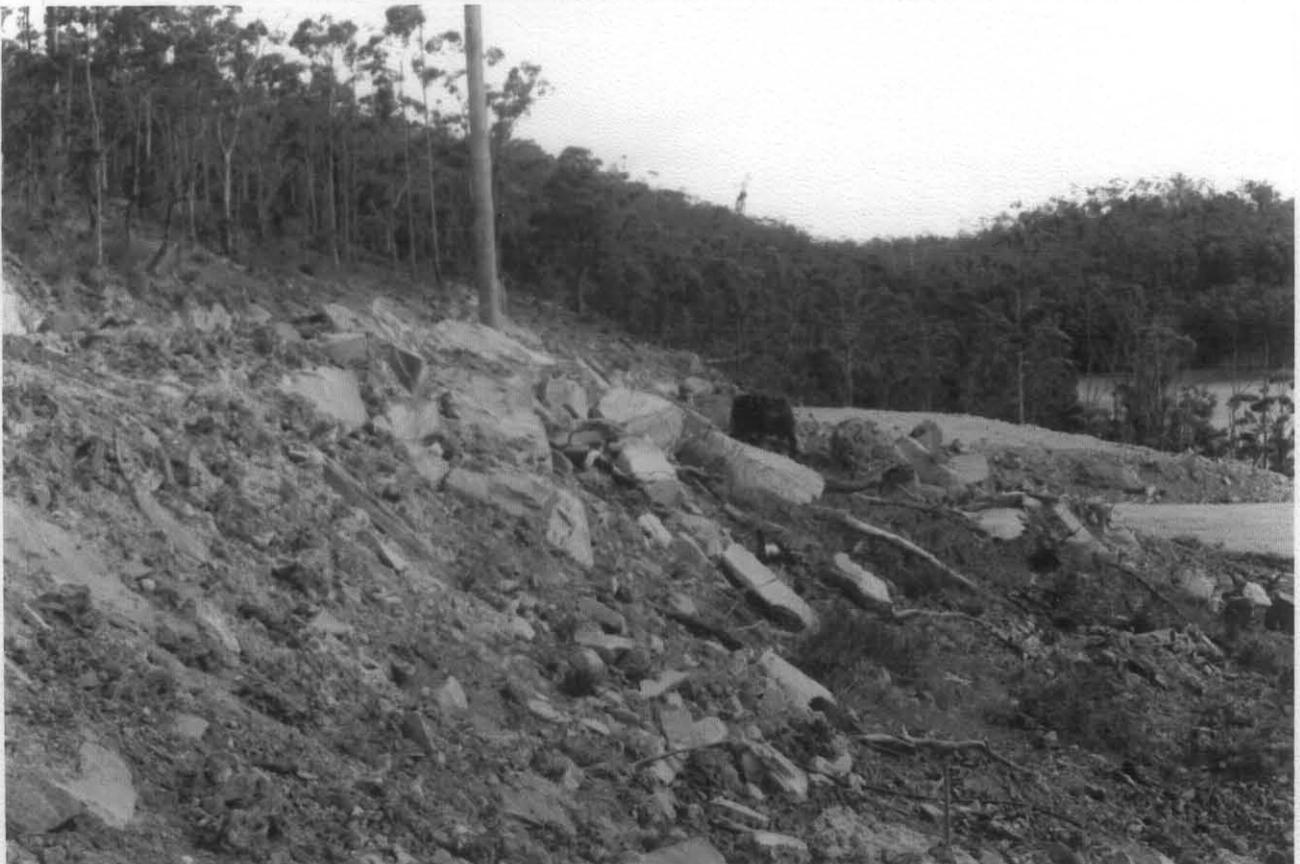
Three of what appear to be future house sites have been constructed at the southern end of Blackstone Road (Plate 8). One of these sites is above and overlooks an existing house. The other two are situated further south; one is at road level and the other downslope below it (Plate 9).

Plate 8. *Prepared sites for future development south of Blackstone Road.*

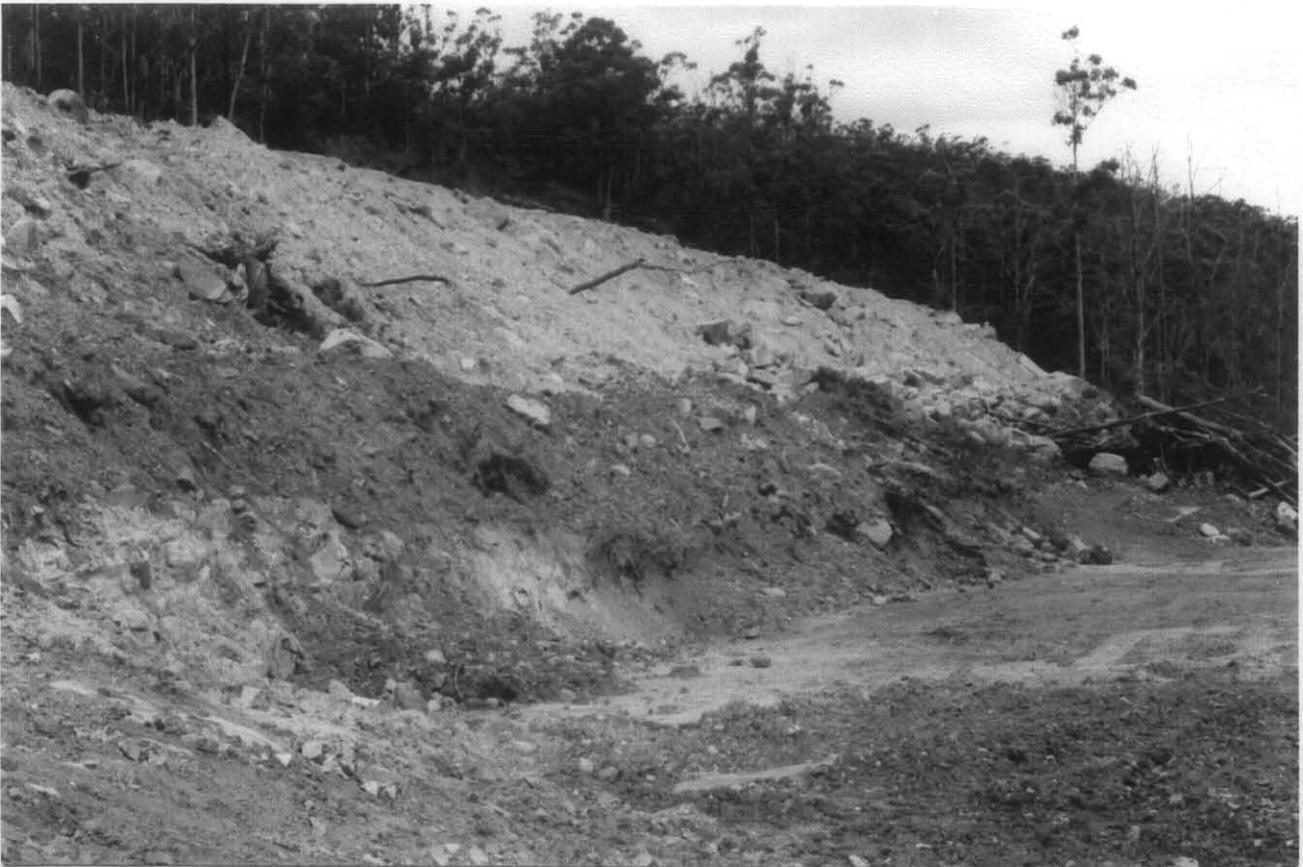
Plate 9. Lower site cut into bank, with embankment of fill separating lower site from upper site.

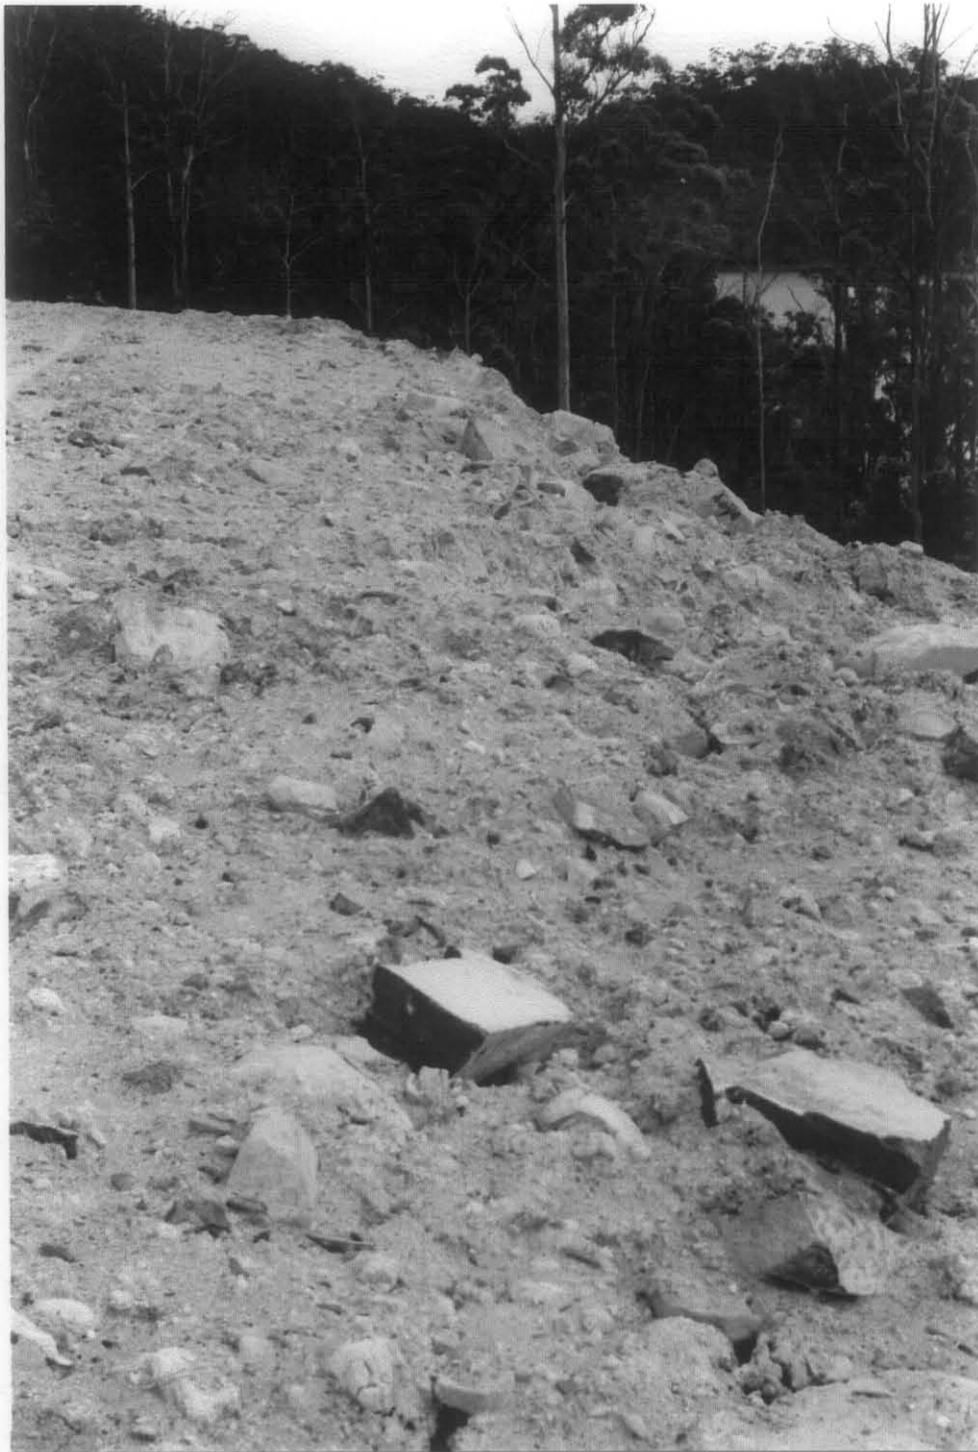
The prepared sites are cut into the weathered dolerite with the material excavated being pushed over on the slope, forming high embankments with $26-32^\circ$ slopes comprising clay, rock, boulders and timber all mixed (Plate 10). The material has been pushed onto the existing soil and vegetation with no slope preparation or drainage. The location of the fill and rock boundary on the sites is difficult to establish, as is the original natural slope, which appears to be at least 26° and may be as high as 30° .

Plate 10. *Embankment material of clay and boulders, showing tension crack near edge.*
