1987/30. Stability assessment of a proposed subdivision at Flinders Street, Beauty Point.

D. J. Sloane

TASMANIA DEPARTMENT OF MINES SITE PLAN

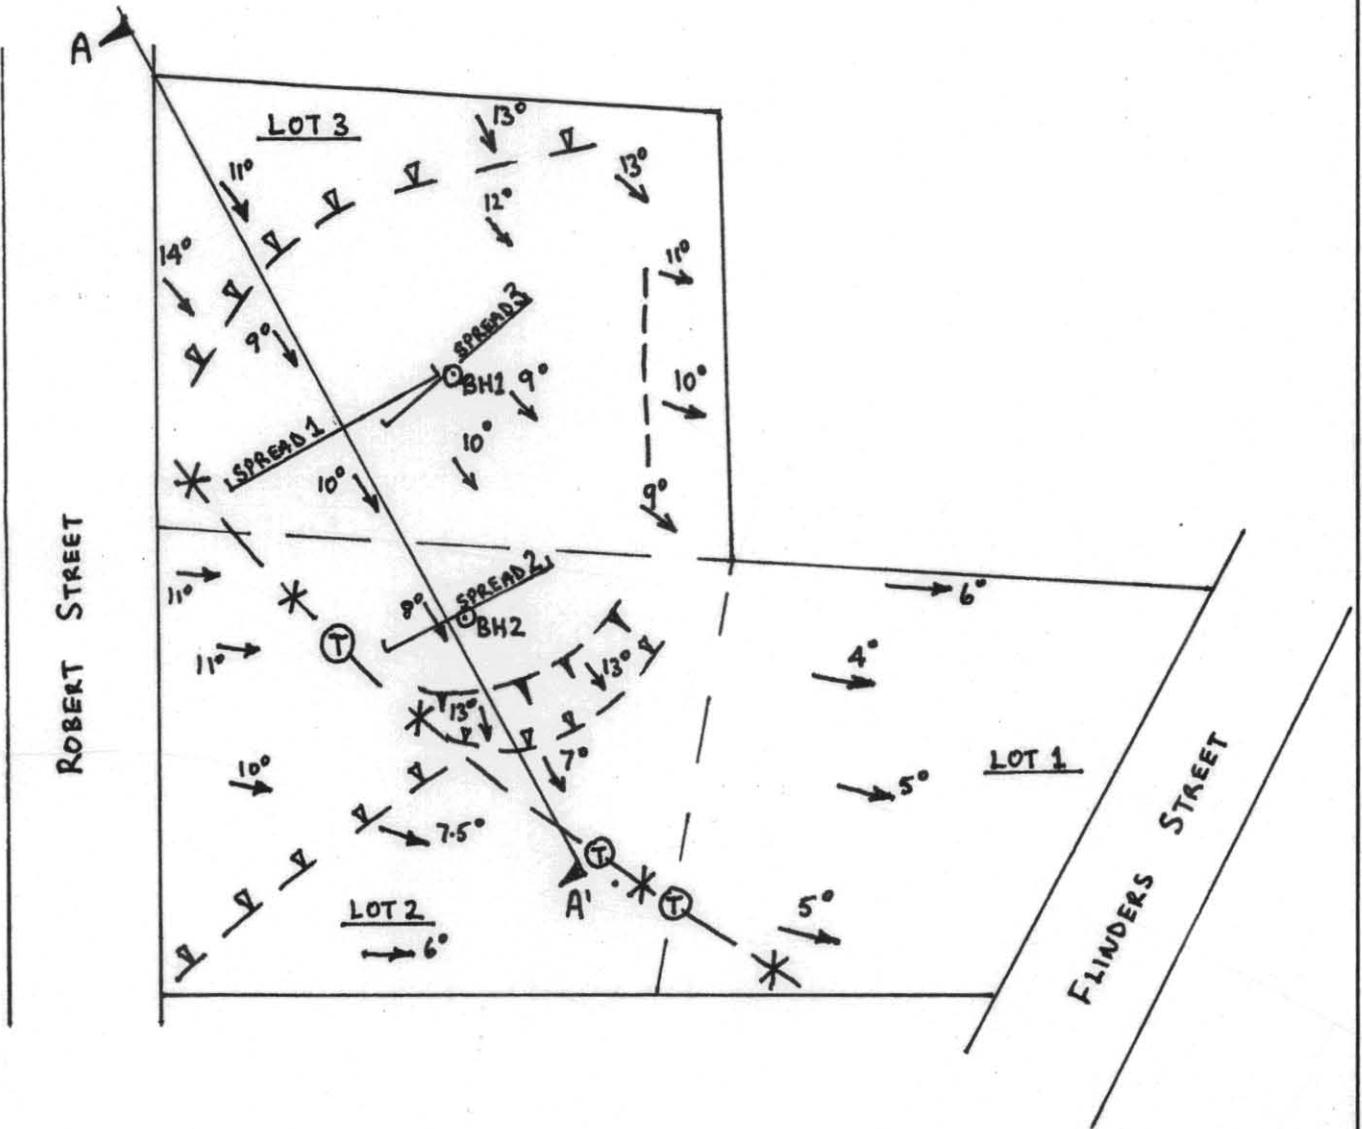
The northern half of the area has slopes of between 8° and 14°. A moderate to steeply sloping section (11°-14°) occurs in the north-western corner of Lot 3, at the rear of a small terrace (8°-10°) which occurs over the remainder of the lot. At the lower edge of the terrace an arcuate, steeply sloping (13°) segment is present on Lot 2. The morphology of the area described above has features which may be associated with an old landslide. The remainder of Lot 2 and Lot 1 has low slopes (4°-7.5°).

A small gully bisects Lot 2 in a NW-SE direction. Tunnel erosion is evident along the base of this gully. Several circular holes have resulted from tunnel collapse. The gully runoff is contributed to by drainage from Robert Street to the west. The owner of the adjacent property to the south reports that flooding occurs adjacent to Flinders Street, with water both appearing out of and disappearing into holes in this area.

Cousins Charts and Bishop's simplified slip circle method have been used. The slip circle chosen for analysis passes through the toe of the steep slope segment on Lot 2 and through the break of slope at the rear of the terrace section on Lot 3. This slip circle has been chosen after careful examination of the morphology of the area.

It is therefore considered that the sloping area of land, zoned Landslip 'B', is unsuitable for building development. The remainder of the area, as indicated on Figure 1, is considered suitable for development. A reassessment of the subdivision layout could be made on the basis of the above advice.

In order to assess, contain and rehabilitate the tunnel erosion which has occurred in the small gully which traverses the site, advice should be obtained from the Department of Agriculture. Continued erosion will result in further tunnel collapse and eventual gullying. Building development must be arranged in order to avoid this erosion hazard, if successful rehabilitation cannot be obtained. It is considered that drainage from Robert Street contributes to the problem and the Beaconsfield Municipal Council should also examine the extent of tunnelling adjacent to, and possibly under Flinders Street.
