UR1987_47

1987/47. Stability assessment of a proposed subdivision at Orana Place, Riverside.

D. J. Sloane

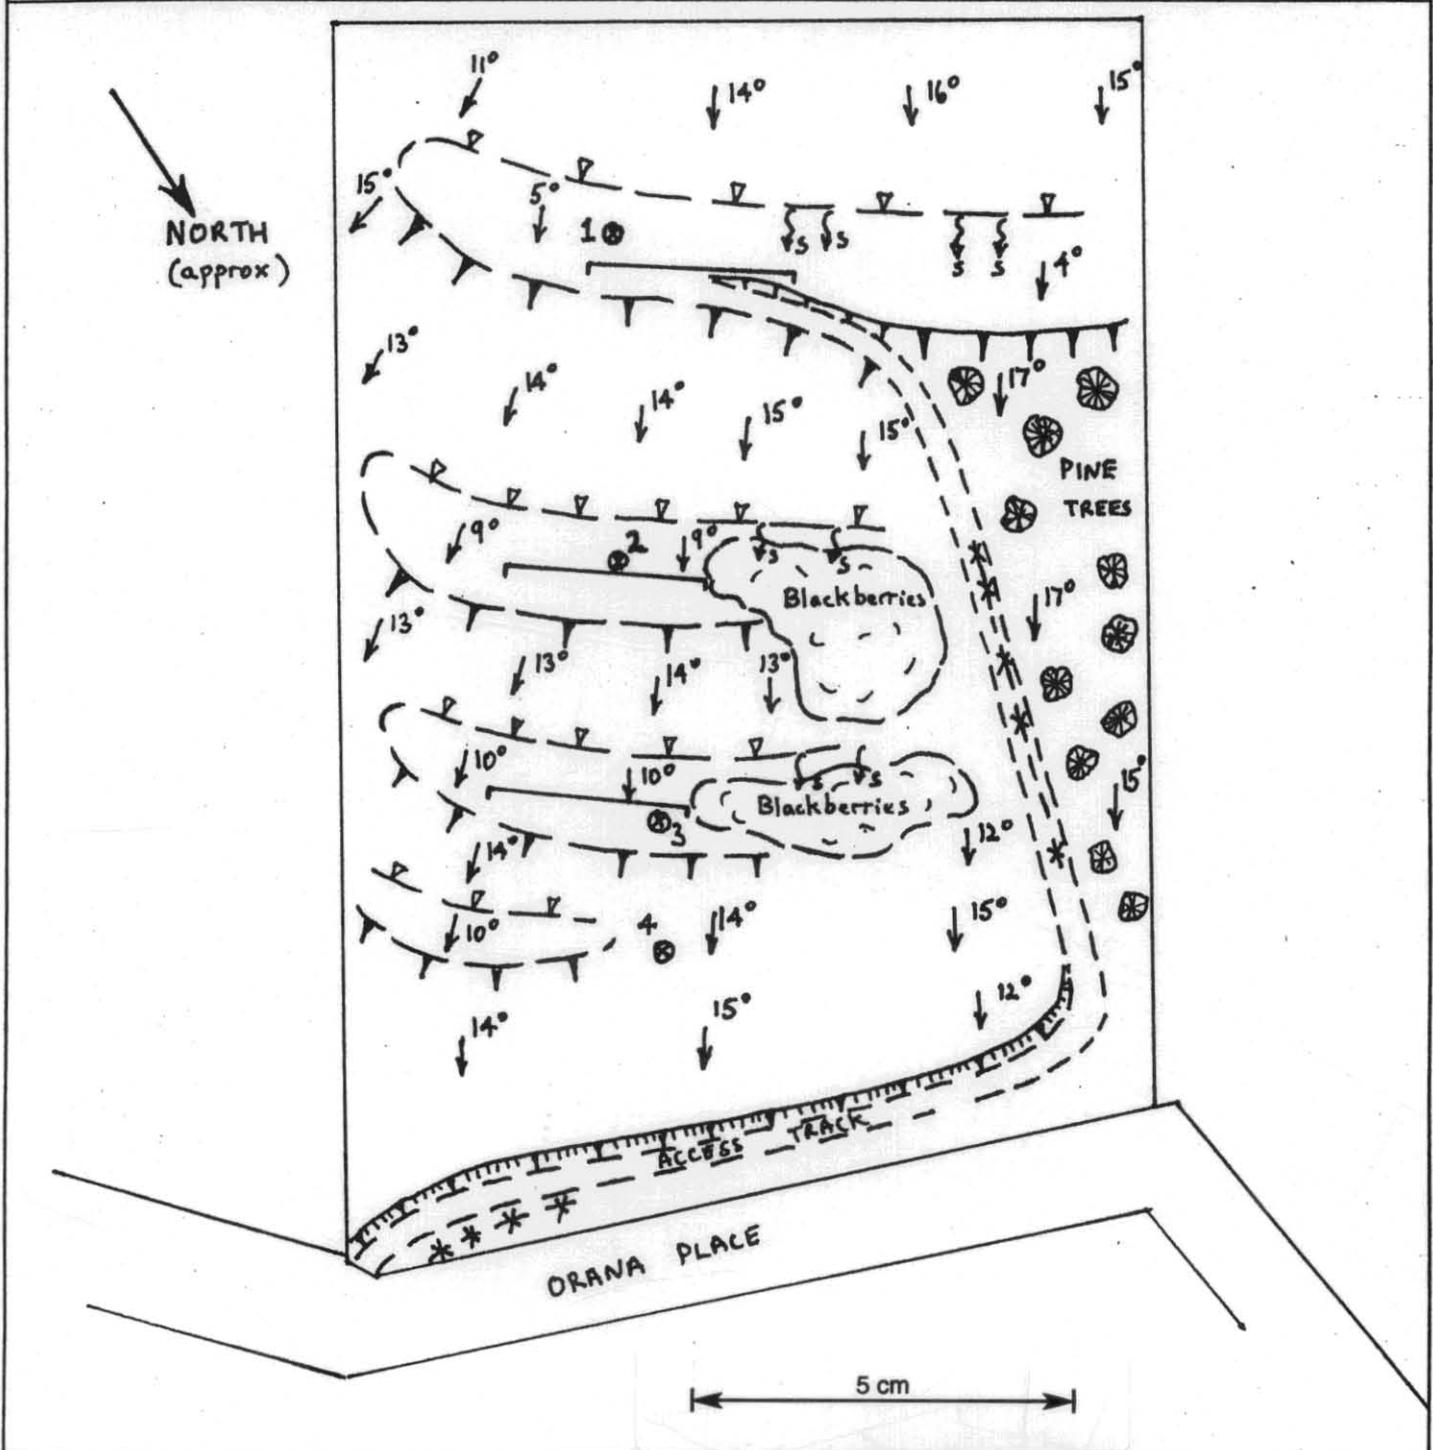
SKETCH PLAN OF SITE

The area under investigation is on the upper part of the escarpment slope. The site has an overall slope of approximately 13°. This overall slope is interrupted by three major benches (fig. 1). The lower benches have a slope of between 9° and 10° while the upper bench has a slope of about 5°. The upper bench has undoubtedly been excavated to a lower slope angle during construction of the access track, and may not be a natural feature. The slope segments which separate the benches are between 13° and 15°. The vegetation indicates that seepage occurs in places at or close to the break of slope at the rear of the benches.

The small slope benches are not laterally consistent and probably represent old landslide features. The slope has been mapped by Knights (1975) as Zone IV of the Tamar Valley Landslip Zone Map, classified as an 'old landslip and adjacent areas'. Stevenson (1972) also reported on the probable existence of a large 'old landslip' adjacent to Orana Place and extending into the northern corner of the lot.

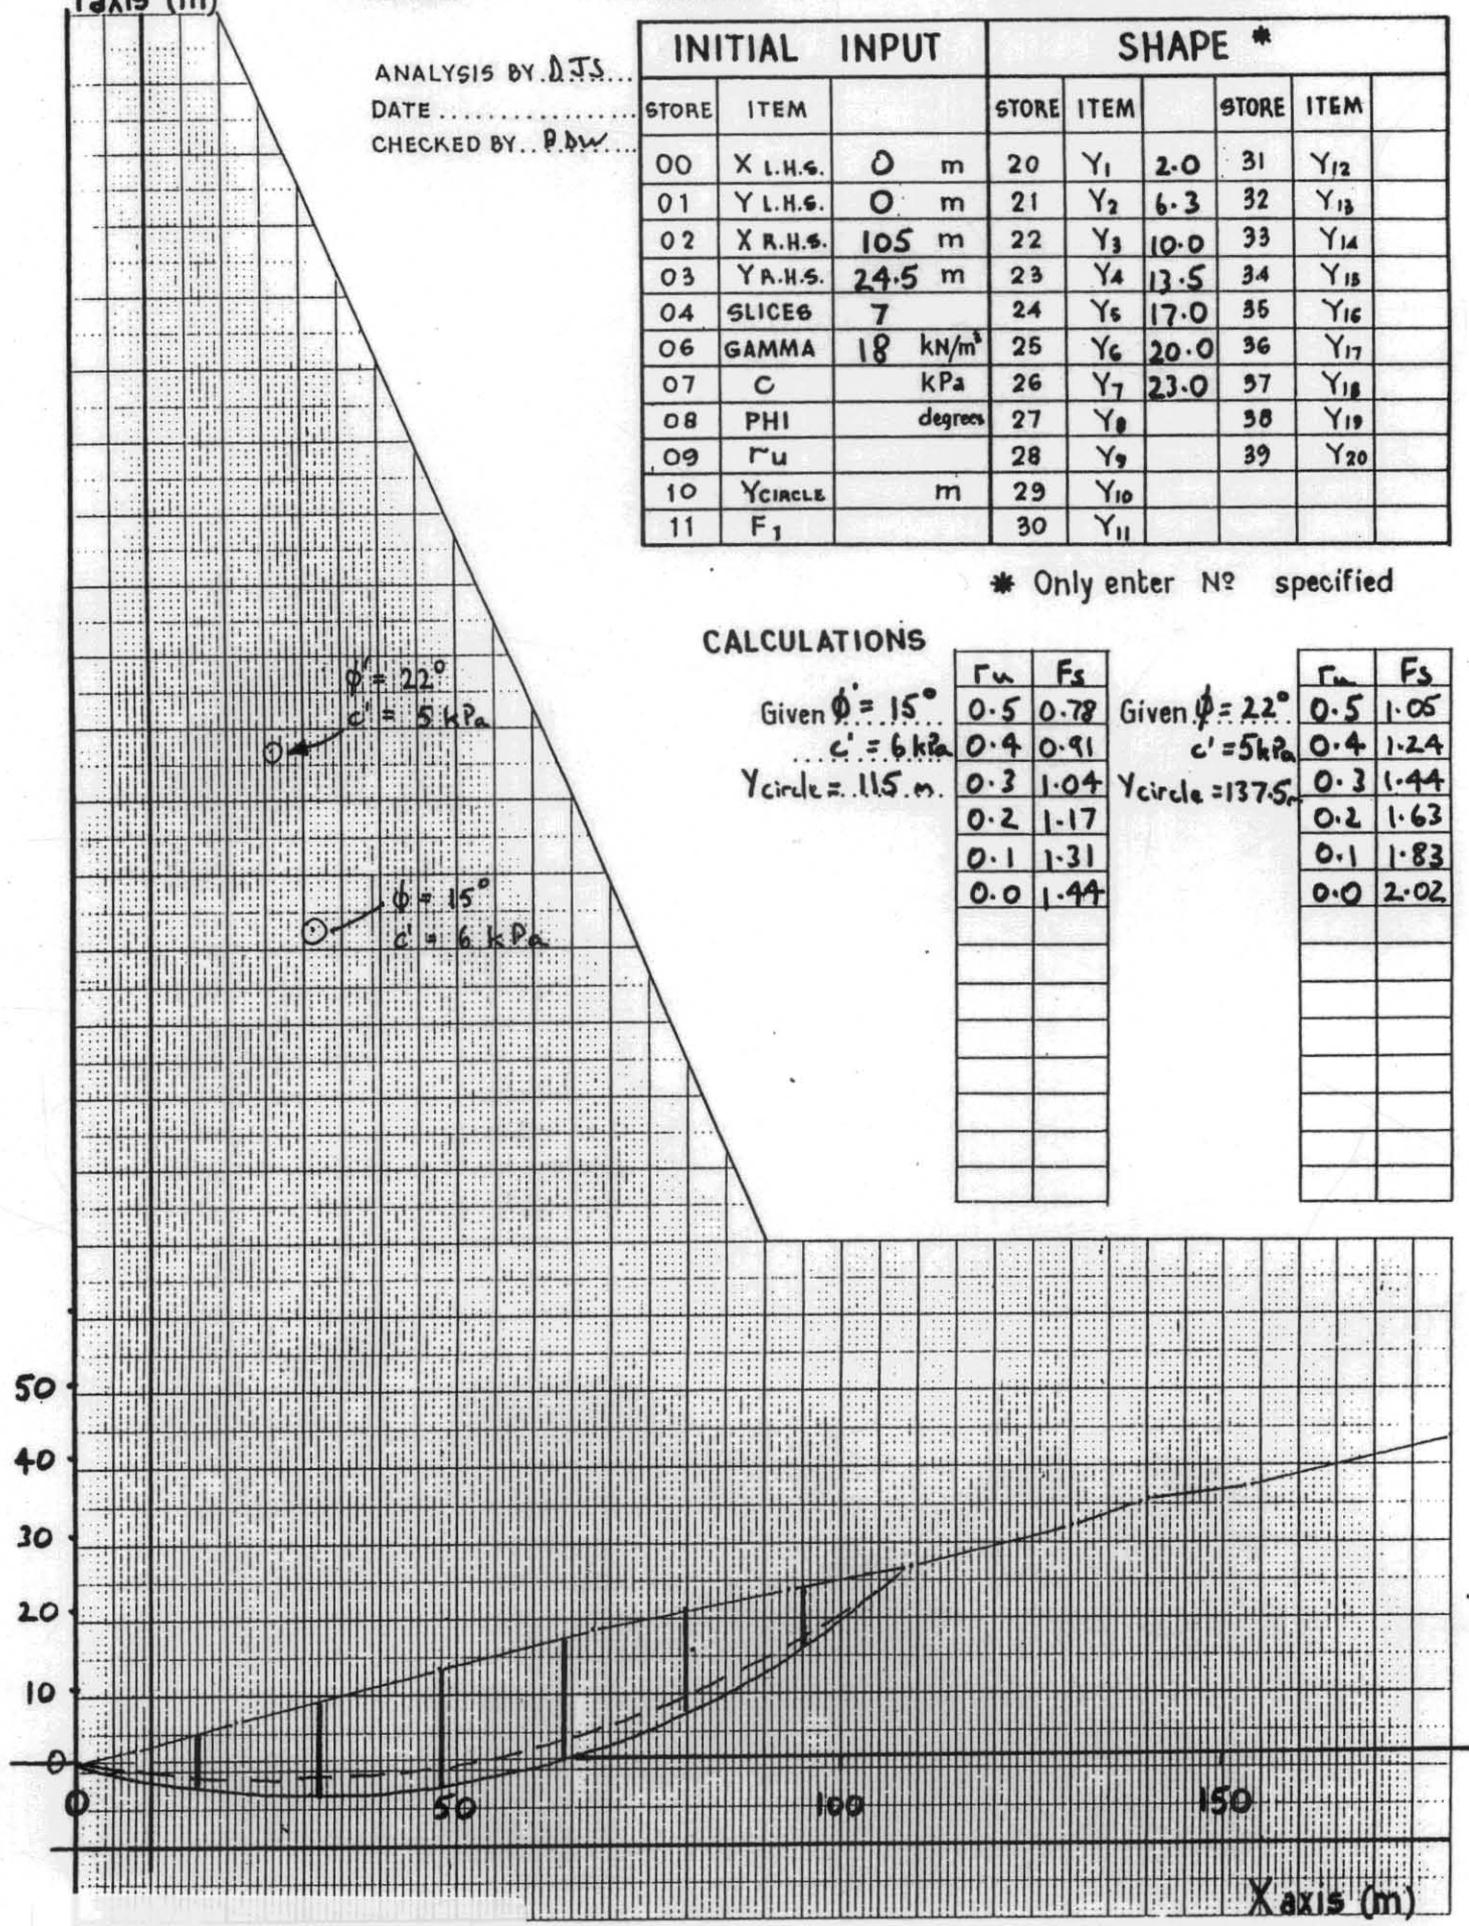
SLOPE STABILITY ANALYSIS - COMPUTATIONS SHEET 1 OF 1

In summary, the lowest acceptable factor of safety is considered to be 1.4 to 1.5. The stability analysis results for the three assumed slip circles are shown in the Appendix. Using the residual strength parameters $\phi' = 15^\circ$ and $c' = 5 \text{ kPa}$, the results indicate that the area is potentially unstable unless fully drained conditions can be assured for each slip circle. This indicates that drainage would be required to a depth of at least ten metres. Even using the higher residual strength parameters of $\phi' = 22^\circ$ and $c' = 6 \text{ kPa}$, a suitable factor of safety can only be obtained if drainage to depths of between 4 m and 6.4 m can be assured.

In each of the above cases, drainage to the required depth is considered difficult to achieve. The construction of drains may also have a deleterious effect on stability due to removal of lateral support.
