A stability assessment at 9 Orana Place, Riverside.

by D. J. Sloane

Abstract

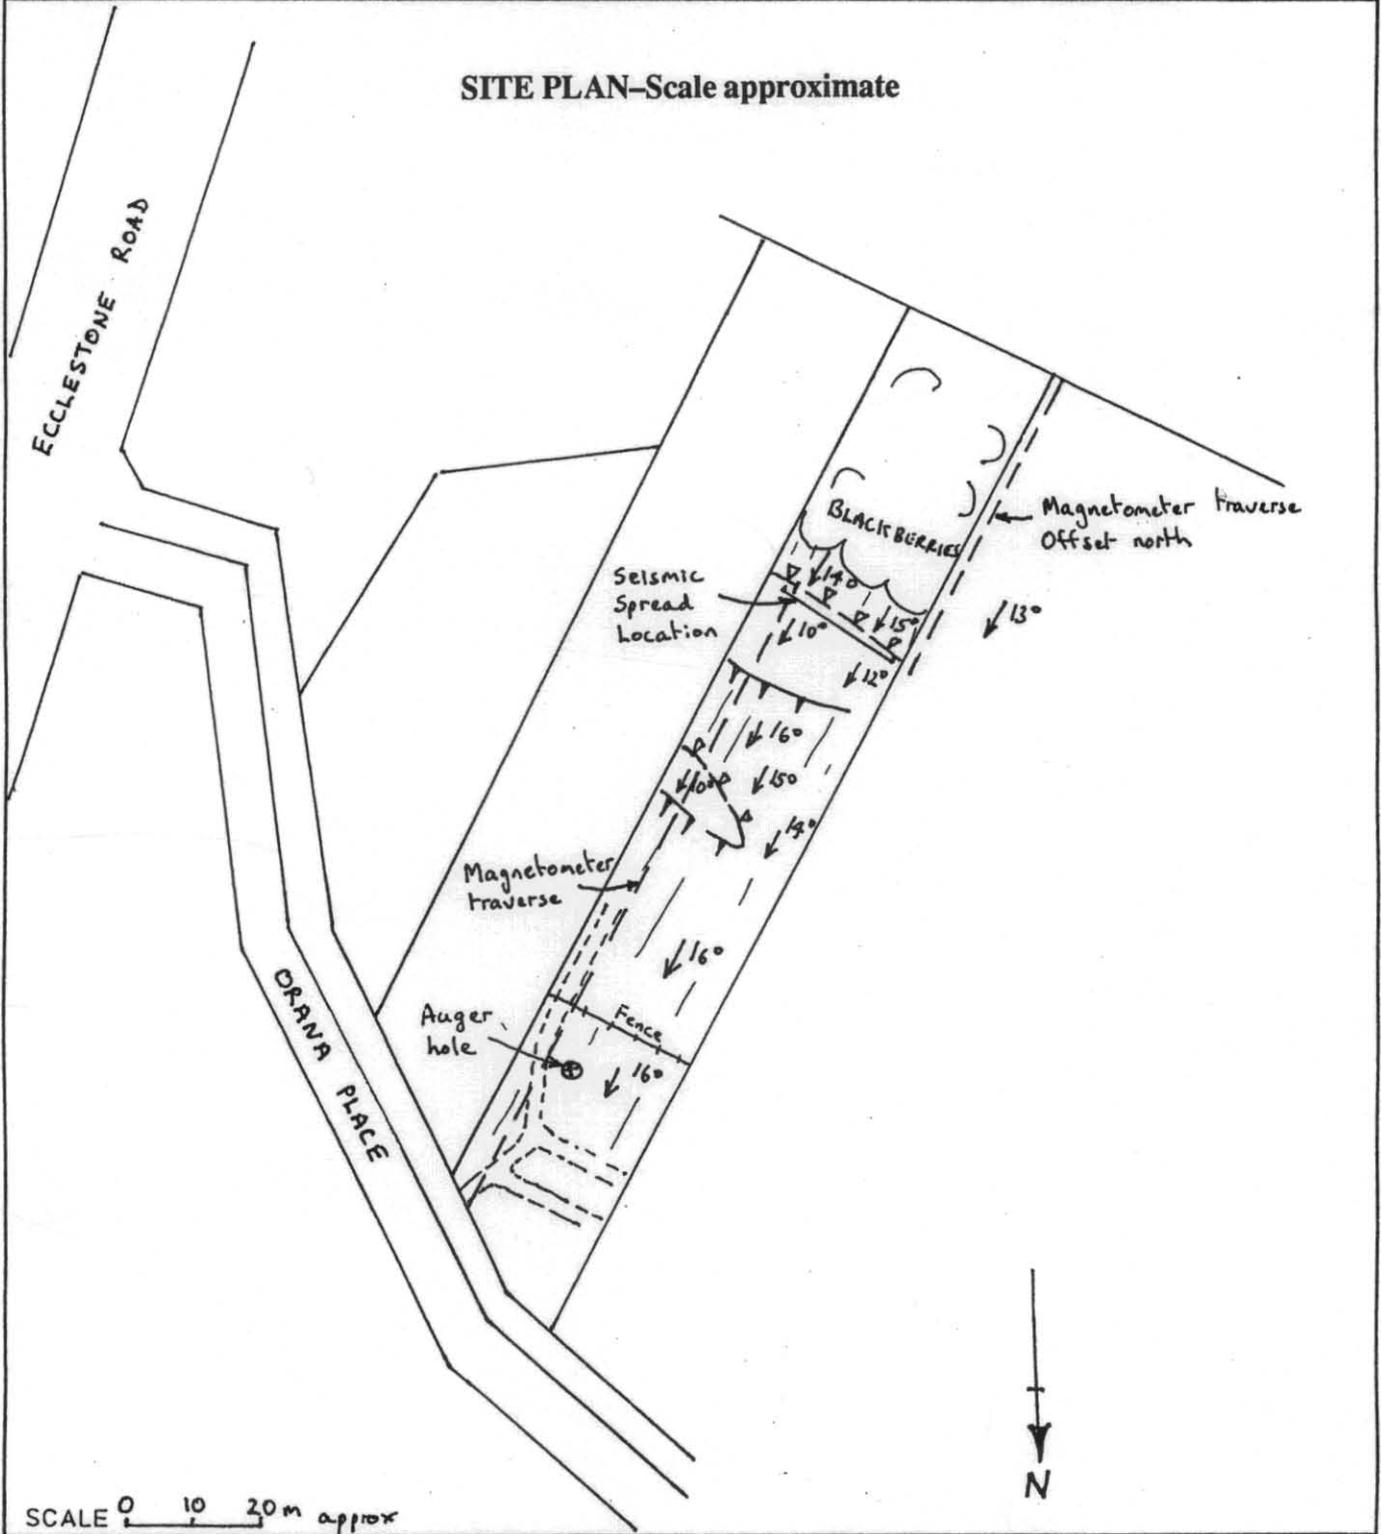
16°. The overall slope is interrupted by two major benches (fig. 1); these benches have a slope of about 10°. The upper bench is between 10m and 15m in width. The slope segments which separate the benches are between 14° and 16°. It is difficult to determine the topography of the upper part of the allotment because of a dense cover of blackberries; however a cleared adjacent area slopes at 13°.

The small slope benches are not laterally consistent and probably represent old landslide features. The slope has been mapped by Knights (1975) as Zone IV of the Tamar Valley Landslip Zone Map, classified as an 'old landslide and adjacent areas'. Stevenson (1972) also reported on the probable existence of a large 'old landslide' adjacent to Orana Place to the north. An active landslide is evident adjacent to Ecclestone Road, to the south-east of the area under investigation.

A seismic spread was fired on the major slope bench; the location is shown in Figure 1. The geophone and shot point spacing was two metres. In summary the results show that bedrock does not occur at shallow depth, and clay or sandy clay extends to depths of at least 10 m from the ground surface.

As a result of the investigations it can only be concluded that the property is potentially unstable and therefore unsuitable for development. A suitable house site cannot be realistically recommended.

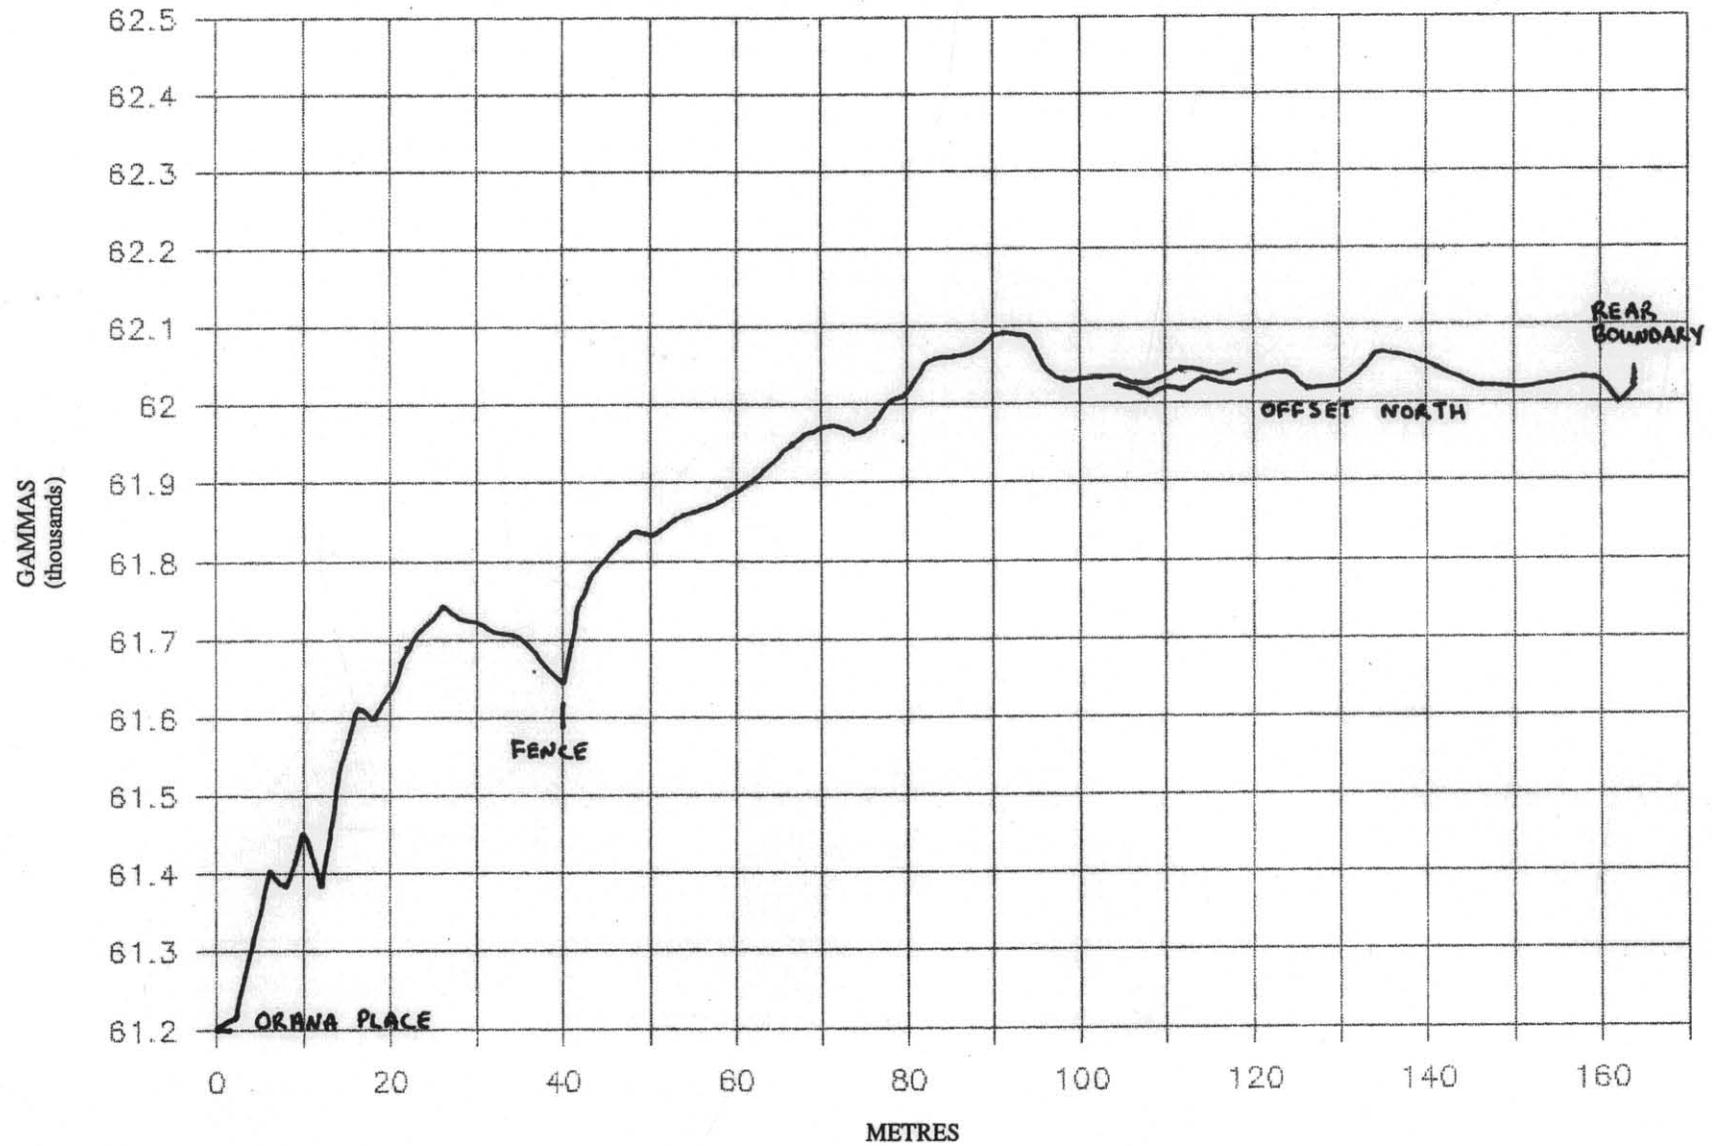
Magnetometer survey—Lot 2, Orana Place, Riverside

A magnetometer survey was conducted along a central profile of the lot, with readings taken at two metre intervals. The survey showed that dolerite bedrock was not present close to the ground surface. The survey showed subdued results with recorded readings between 61.2×10^3 and 62×10^3 gammas. The results tend to indicate a deep, sloping dolerite interface, with a greater thickness of sediment cover towards the base of the slope.
