UR1987-58

1987/58. Slope stability in an area of the Douglas - Apsley State Forest.

D. J. Sloane

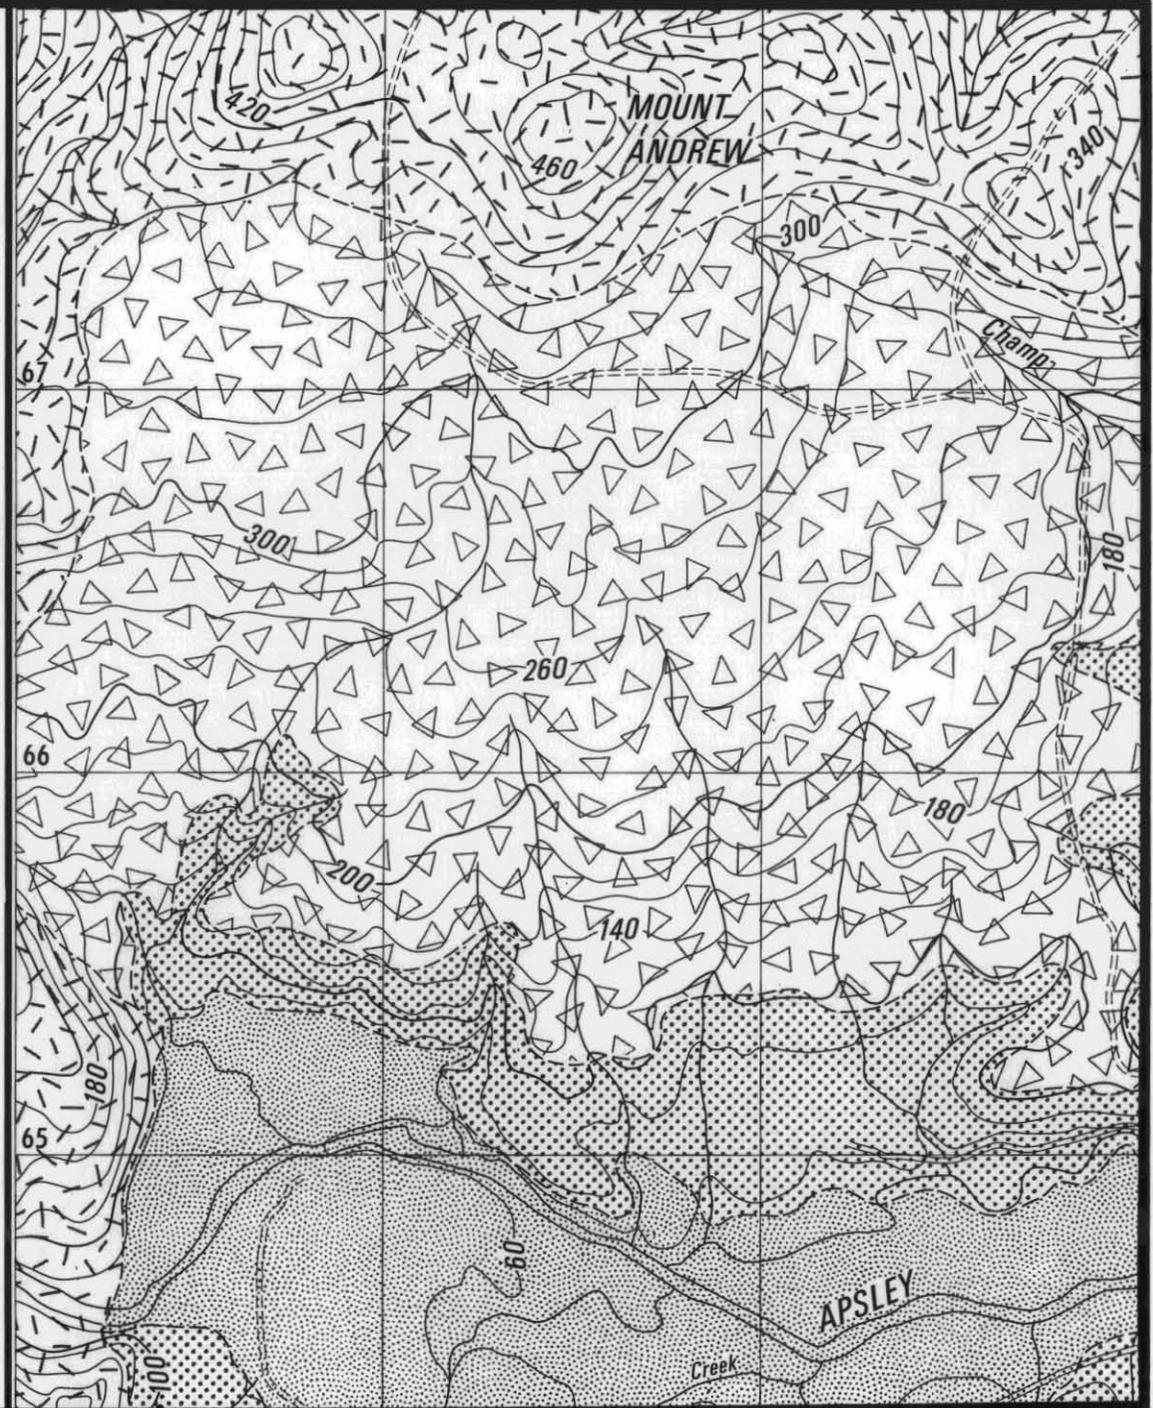
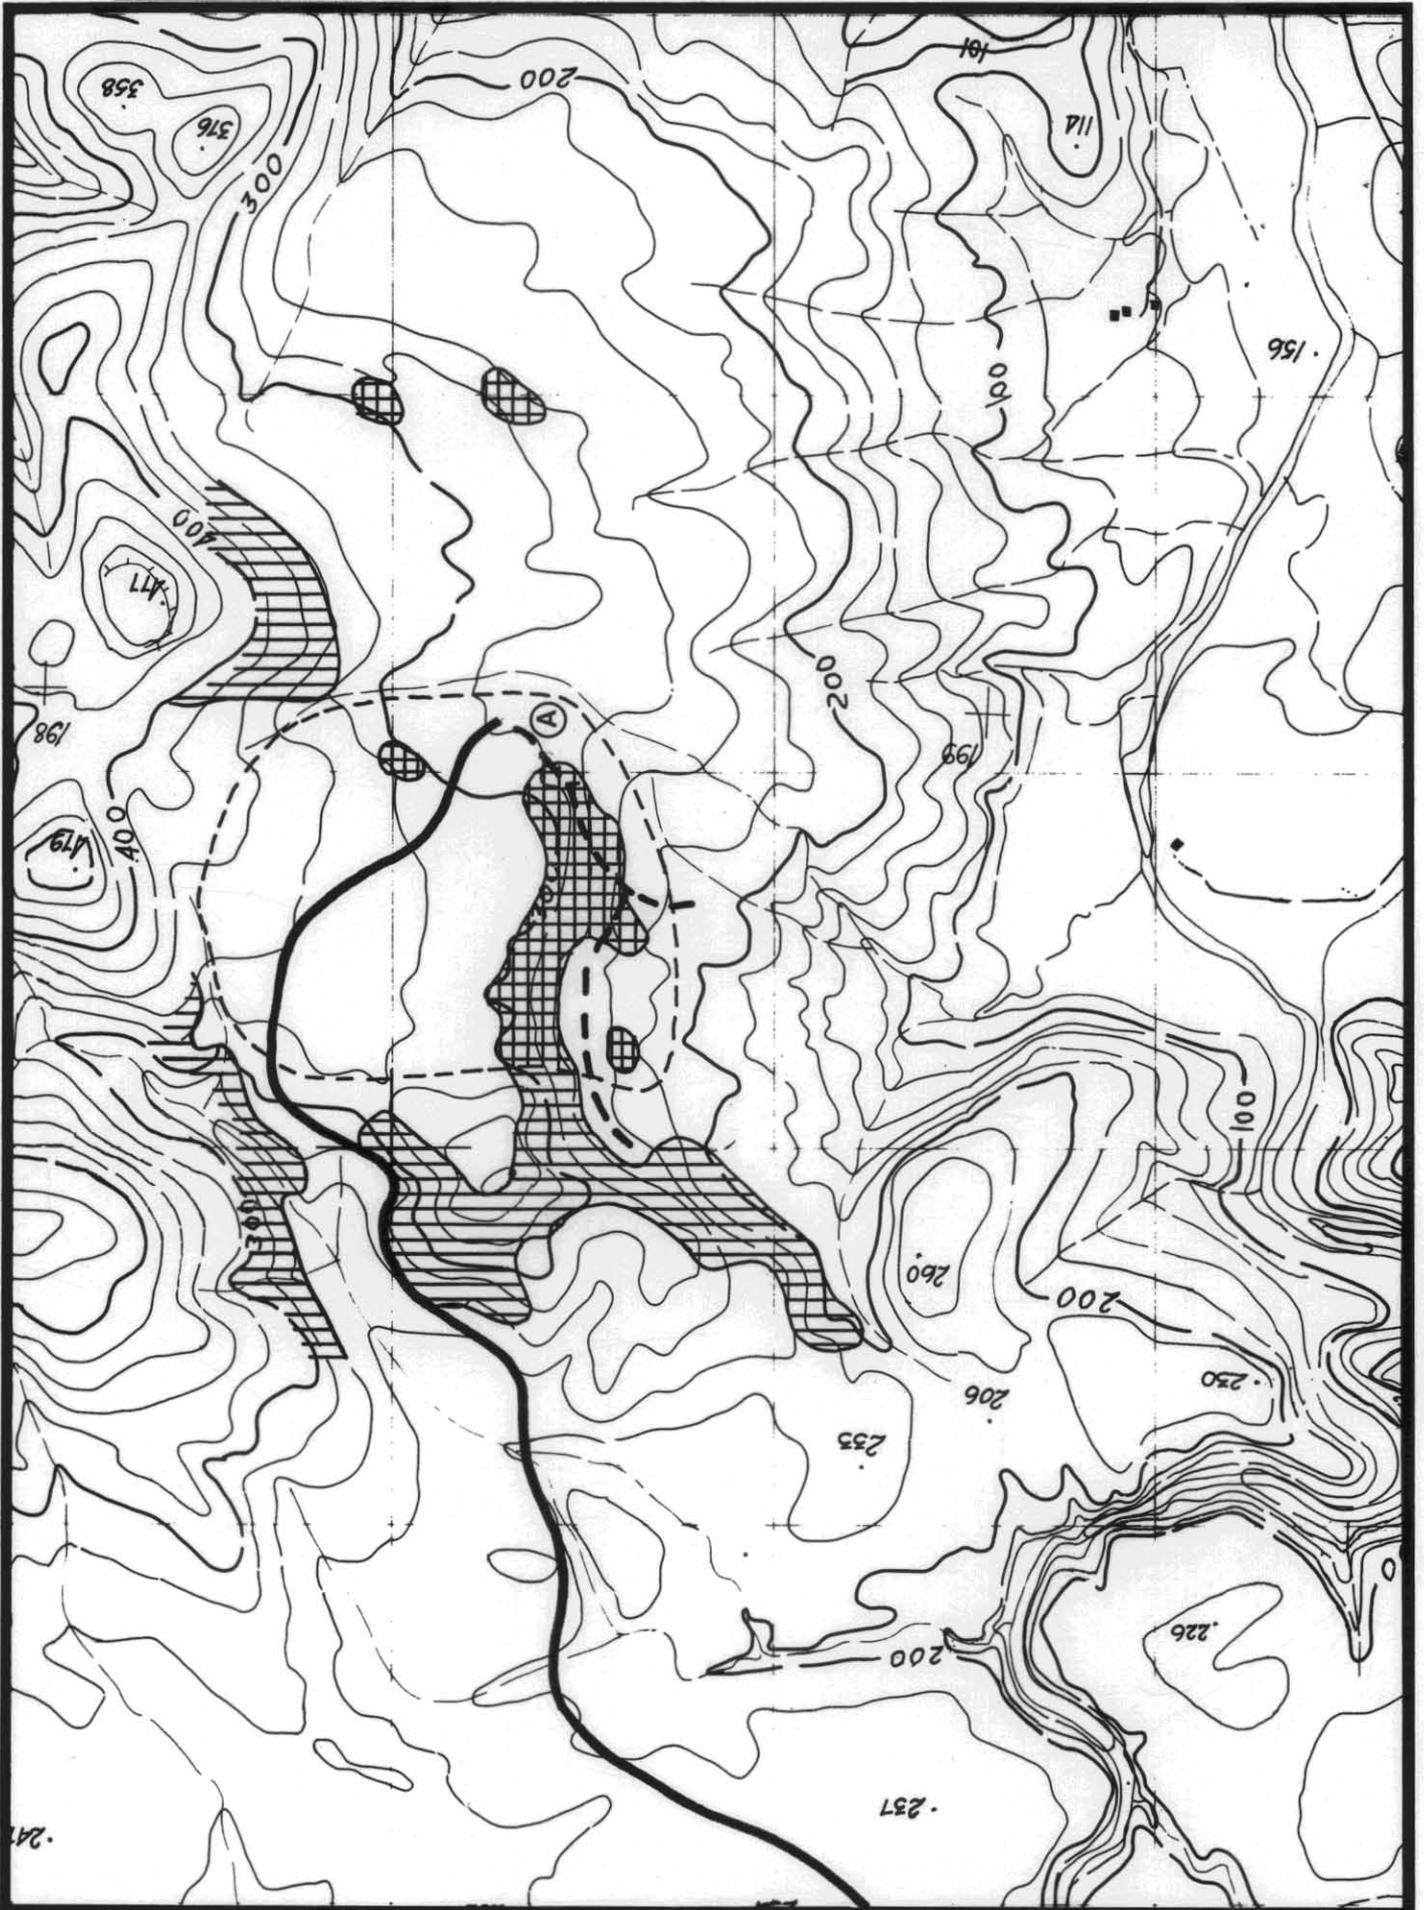
Figure 1.

Good geological maps of the area are available, and part of a map covering the Coupe 50 region has been reproduced as a transparent overlay (fig. 1). The accompanying section of the topographic map has been marked with the proposed road route, and areas of slope greater than 15° (27%) have been outlined. This slope angle is considered to be a threshold slope angle for dolerite talus overlying Triassic rocks. Previous investigations show that instability problems have occurred above this angle.

The combination of the transparent geology overlay and the topographic map indicating the steep slopes is very useful for initial planning. These indicate that the safest route is in fact the route planned by Mr Robbie, and visual inspection confirms this. Site inspection has also confirmed that the steep bench edge in the southern part of the coupe has slopes up to 24° (40%), and weathered mudstone is also exposed in places. The dolerite talus along this slope is therefore extremely thin.

It is difficult to determine positively if old landslides are present on the steeply sloping area of the coupe. Several small benches were observed, together with small talus lobes and minor areas of possible drainage disruption. The areas of weathered mudstone outcrop are considered to be moderately to highly erodable.

It is recommended that the steeply sloping area outlined on the topographic map should be avoided with regard to roading and conventional harvesting methods. The boundary to this area is approximately at the 300 m contour level. It is considered that the area could probably be logged by cable methods at a later date, as this method minimises ground disturbance. Field discussions indicated that it is also advisable not to continue the coupe road beyond point A on the accompanying map. Beyond this point the proposed route traverses the foot of steep slopes before reaching a lower bench. The area of suitable forest in this area is small, and therefore roading is considered uneconomic.

The main access road from 'O' road is considered well planned and is not likely to be affected by potential instability problems. Mr Robbie has previously recognised areas of potential and old instability and avoided them in planning the road route.
