**TASMANIA DEPARTMENT OF MINES
UNPUBLISHED REPORT 1987/75**

Inspection of land at Craythorne Road, Rosevears

by W. L. Matthews

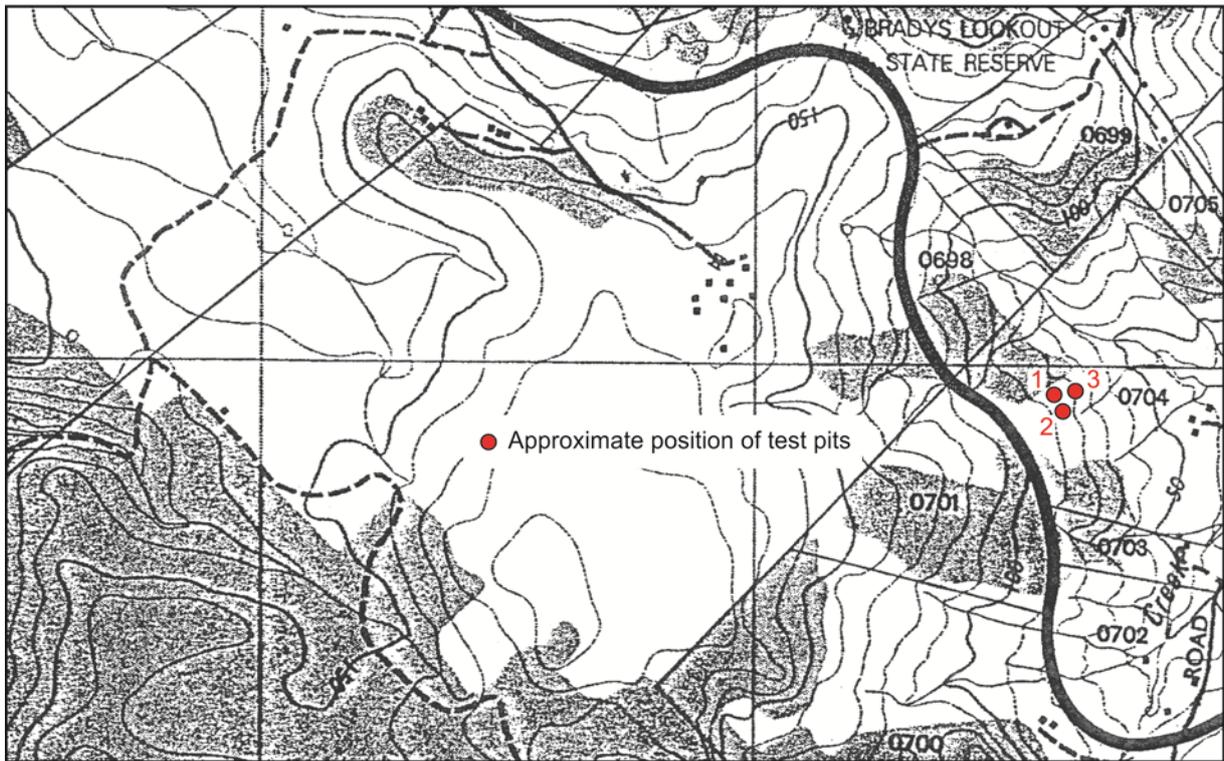
Figure 1

Three test pits were dug near the favoured house site. The approximate locations of these pits are shown in Figure 1, with the test pit logs shown in Appendix 1.

The near-surface material in the upper two pits consists of soil and clay with some basalt boulders. Dominantly clayey material occurs at lower levels. The lower pit (3) consists of clay and silty clay for the whole depth. No free water entered the pits.

It was thought advisable to dig some test pits on any area being considered for a house site to examine subsurface material and groundwater conditions. Depending on what is encountered, this may be only a first stage of the investigation, particularly for the more risky sites.

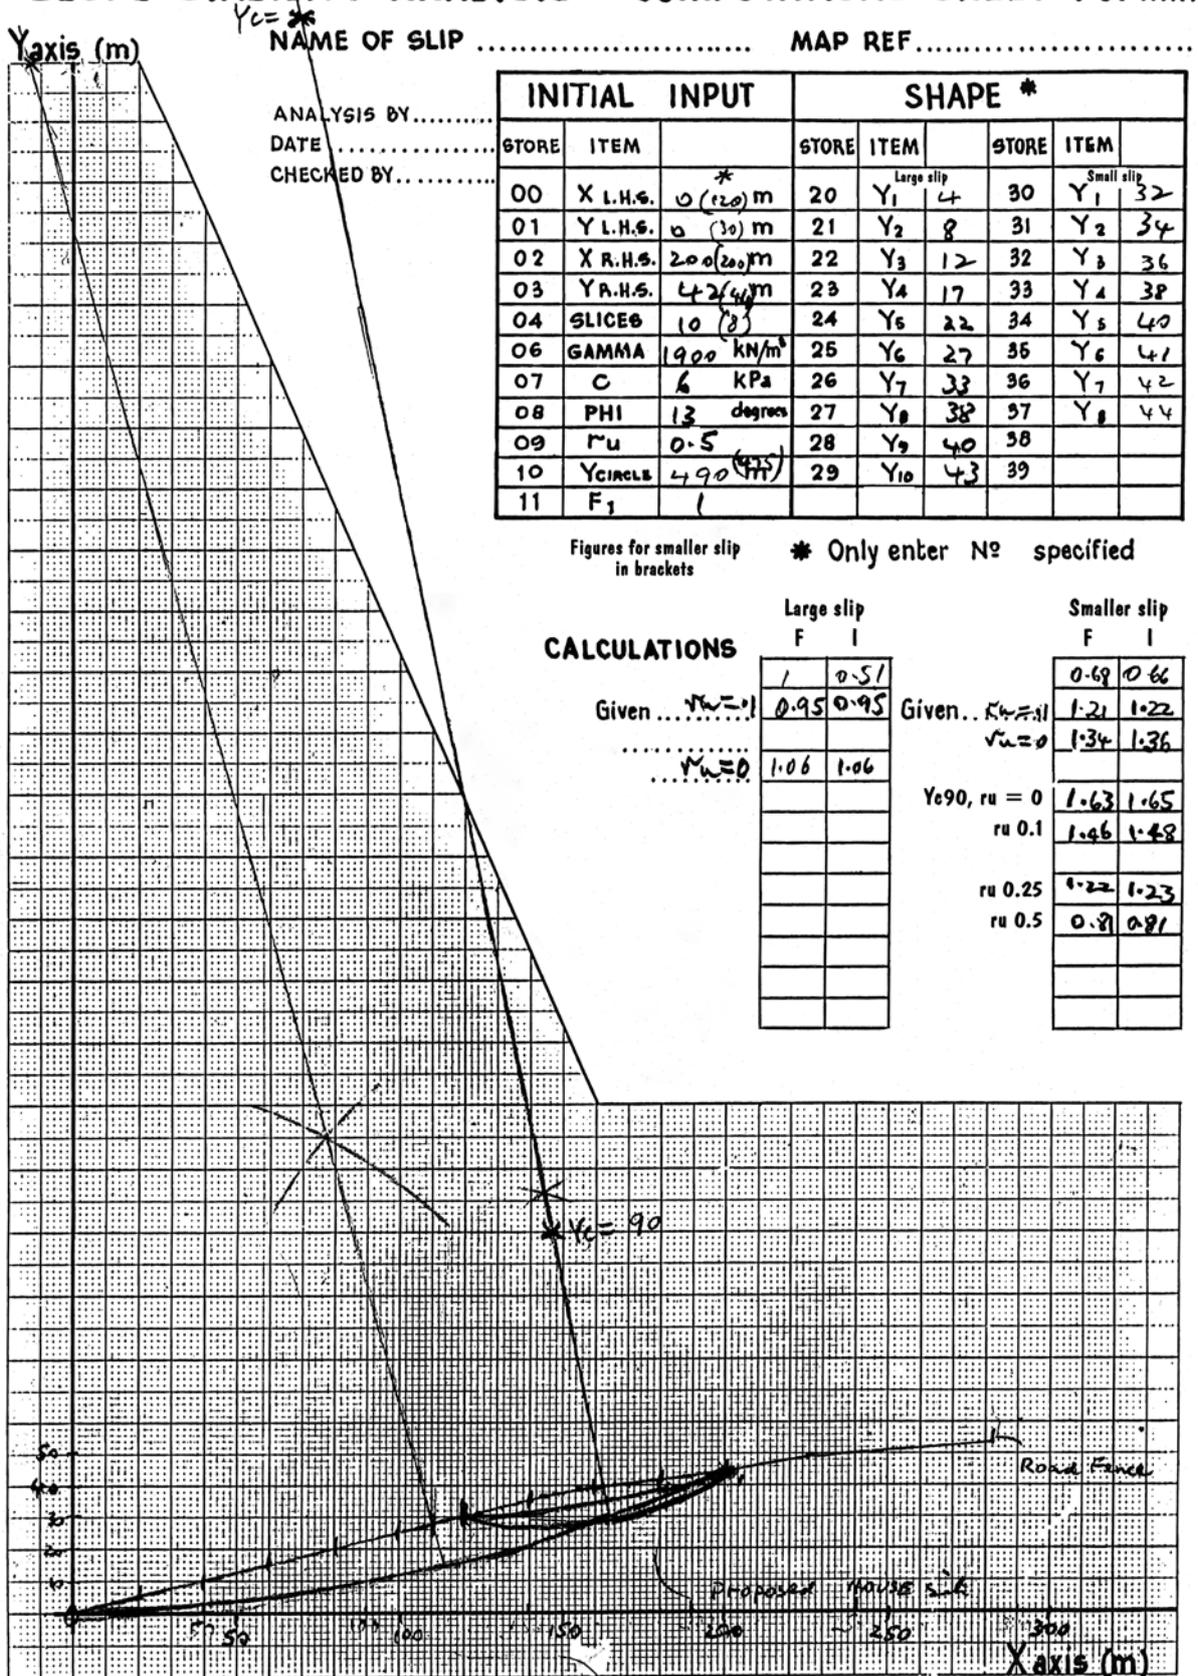
Figure 2

Trial slips have been drawn across the area and the above strength value has been used to calculate safety factors under varying conditions (fig. 2). When a possible large slip of about 200 m is considered, safety factors (F) suggesting high risk of instability are calculated (F values of 1.3 or greater are regarded as reasonably safe). When smaller slip circles are used values of F are fairly high under some conditions. If the water level in the theoretical slip is high (r_u value),

the F value is low; while if the water level is low, high F values are obtained.

The proposed house site appears to be in a relatively well drained situation, i.e. it is on a ridge structure with small valleys on either side and about 100 m apart. This suggests that the area will probably not accumulate water. However groundwater conditions at deeper levels should be examined and drilling to depths of 10–15 m is suggested. If material with similar shear strength to that obtained in the pits is encountered and water levels in the holes are low or absent, then this may be a favourable sign as far as development of the site is concerned. It will not be possible to say that there is no risk of landslip affecting the site, but it might be an indication that the risk is reasonably low. If on the other hand lower strength material is obtained and/or water levels are relatively high, it is probable that the risk would be considered too great for development to proceed.
