**TASMANIA DEPARTMENT OF MINES
UNPUBLISHED REPORT 1987/77**

Inspection of house sites near Danbury Park, Legana

by W. R. Moore and W. L. Matthews

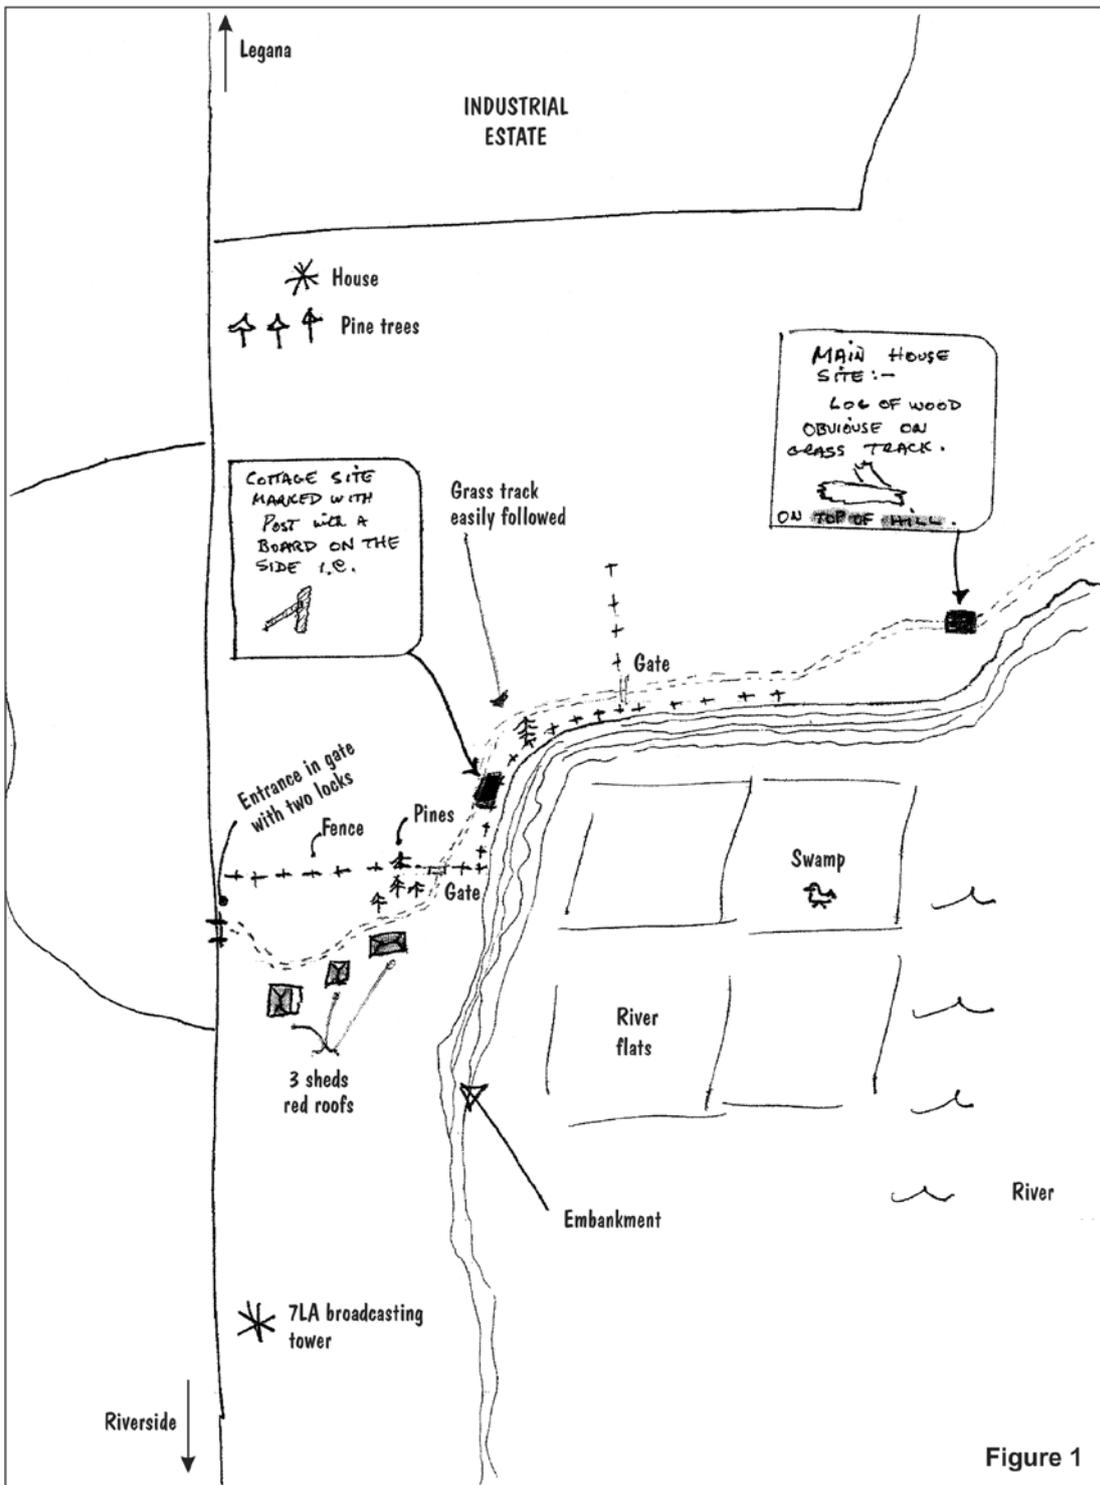
Figure 1

A brief inspection was made of two proposed house sites in the area between the West Tamar Highway and River Tamar opposite Danbury Drive, south of Legana (fig. 1).

The two proposed house sites (fig. 1) are on top of the steep slopes mentioned above. There are signs of probable old landslips on these slopes near each house site and because of this, it is recommended that houses be sited away from the top of the slope on the more gently sloping land. For the cottage, a site 16–18 m (or no part of the house closer than the post with a board on the side) is suggested and for the main house a site no closer than about 20 m from the top of the slope (a few metres further than the log of wood) is recommended. The latter site is a little more elevated.

These sites are regarded as reasonably safe from any future landslips provided some precautions are taken in developing them. Drainage from stormwater, sullage and septic tank water should be piped away from the steep slope and dispersed to the north or northwest of each site. Trees should be left on the steep slopes or more should be planted, and excavations and disturbance of the steep land should be avoided as far as possible. If a landslide occurs on the steep slopes, particularly near the house sites, remedial measures should be taken as soon as possible afterwards so that wider development of the slip is prevented.

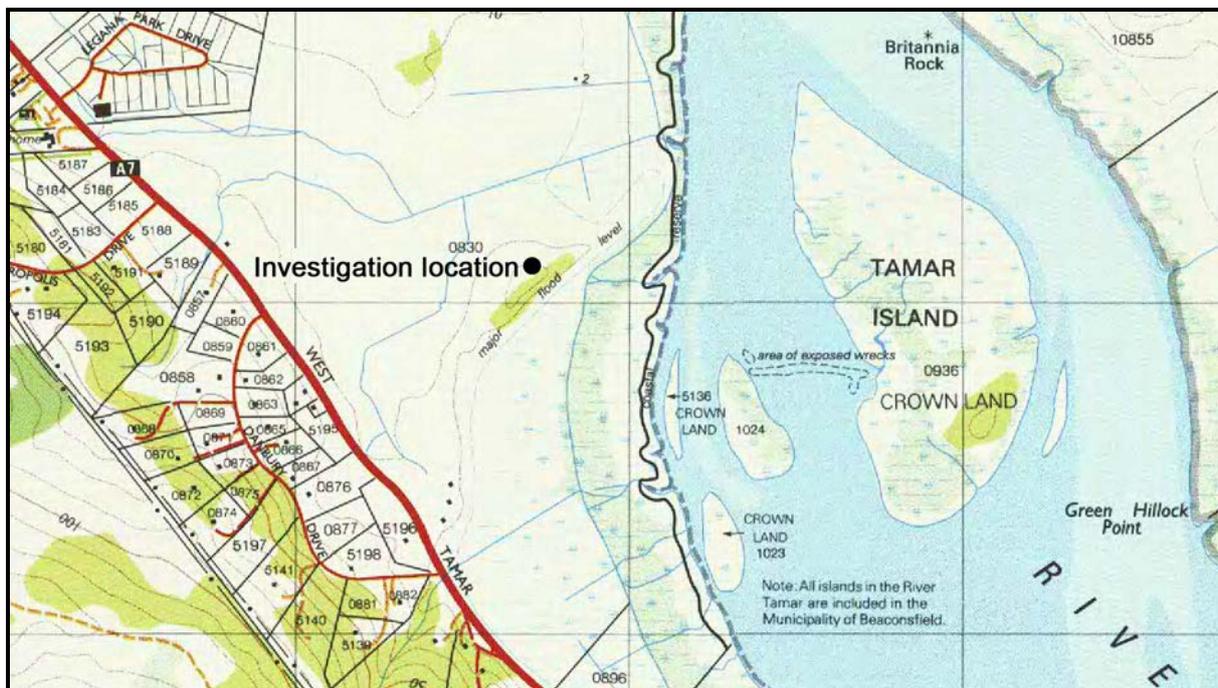
Figure 2

Three trenches were dug on the proposed house site on 7 September (fig. 2, 3). Lithological logs of these trenches are attached (Appendix 2). The soil laboratory testing results from clay samples collected from trenches 1 and 2 are shown in Appendix I.

At the proposed site (fig. 2) it would appear prudent to place the house as far away from the steep bank as is practicable, particularly as slope failures have occurred on this bank as shown by the old landslide some 35 m south of trench 1. From the three trenches dug it appears that the clay thins to the north, with the hard sandy clay occurring at shallower depths to the north (fig. 4). This layer, as well as become more shallow, becomes sandier to change from a sandy clay to a clayey sand.

In trench 1 the thickness of the clay, including the soil, is 2.6 m; it is 1.7 m in trench 2, and 1.5 m in trench 3.

In view of all this evidence it is recommended that no building should occur until 20 m back from the edge of the steep bank and with the house preferably sited between trenches 2 and 3 on the flattest area of the low promontory. In addition with such expansive clay, seasonal vertical movements can be anticipated at this site and the foundations should be designed to compensate or withstand these seasonal movements. With such sensitive clays occurring at this site, adequate drainage is essential. The planting of trees and shrubs is also recommended.

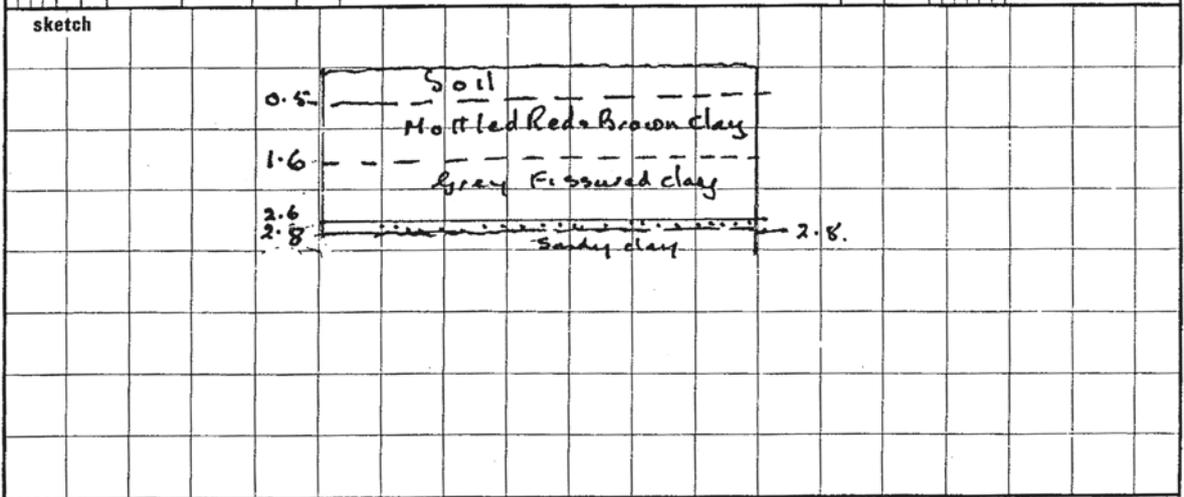
excavation no. 1
sheet 1 of 1

penetration 1 2 3	support water	notes samples, tests	metres R.L. depth	graphic log	classification symbol	material soil type: plasticity or particle characteristics, colour secondary and minor components	moisture condition	consistency density index	hand penetr- ometer kPa	structure, geology
									25 50 100 400	
					OH 1 CH	Clay Dark Brown Highly plastic and organic	V	ST		Soil
			52 - 1.0			Clay - Red - Brown Mottled. Highly plastic Some roots. Some plant roots.	M			Sub Soil clay
			53 - 2.0		CH	Clay with Sand - Some Roots Clay - Grey - Highly plastic Shear polished & faceted Sand fine less than 15%.	V	ST		sheared clay
			54 - 3.0		CH Sc	Sandy clay Yellow. Clay - Highly plastic shear Polished and faceted less than about Sand fine Yellow 75%	H			Possible Hard Pan
						At 2.8 Depth. Backhoe Stopped. Trench Too deep To inspect except from surface [All samples undisturbed]

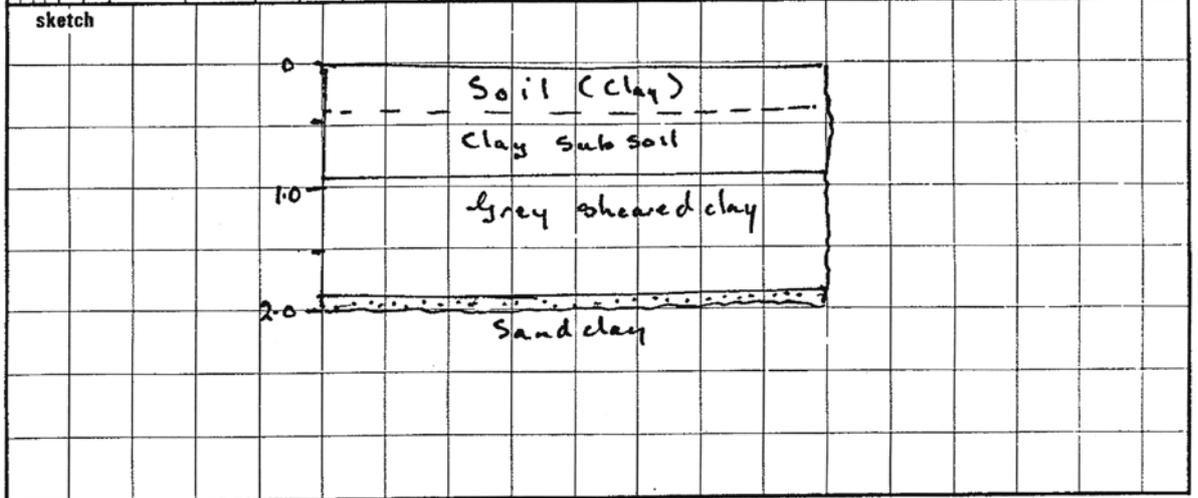
excavation no. 2
sheet 1 of 1

penetration 1 2 3	support water	notes samples, tests	metres		graphic log	classification symbol	material soil type: plasticity or particle characteristics, colour secondary and minor components	moisture condition	consistency density index	hand penetr- ometer kPa	structure, geology
			R.L.	depth							
						OH	Clay Dark Brown organic		st		Soil
							Clay Red Brown Mottled highly plastic		V st		Subsoil
	un supported	None	SI -	1.0		CH	Clay Grey Highly plastic shear faceted and polished		M st		Sheared clay
				2.0		CH	Sandy clay Sand +18% Fine clay Yellow highly plastic		H		sandy clay
<p>Sequence established Backhoe stopped at 1.9m. [Sample undisturbed]</p>

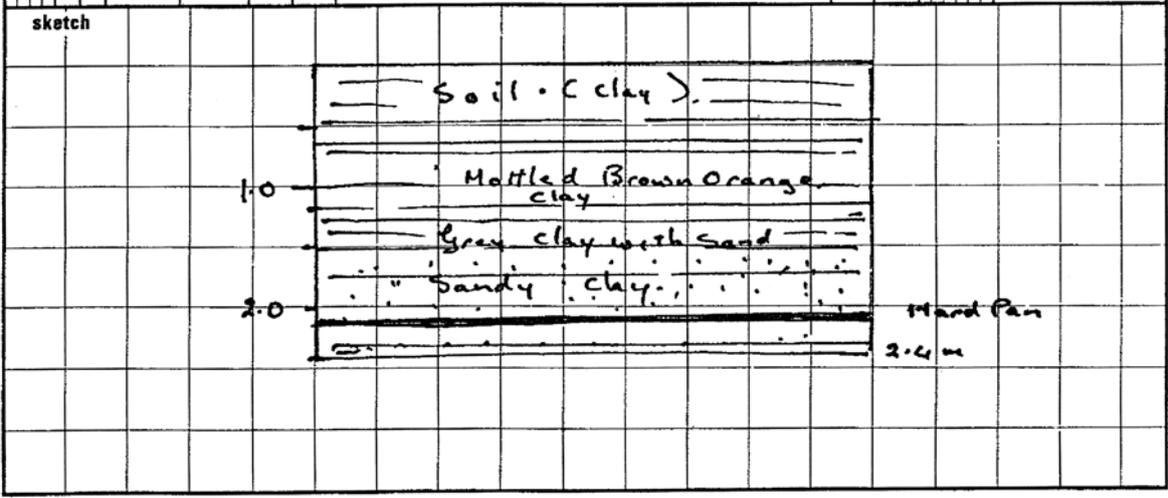
excavation no. 3
sheet 1 of 1

penetration 1 2 3	support	water	notes samples, tests	metres R.L. depth	graphic log	classification symbol	material soil type: plasticity or particle characteristics, colour secondary and minor components	moisture condition	consistency density index	hand penetr- ometer kPa	structure, geology
				1.0		OH	Clay - Dark Brown - Organic becomes highly plastic				Soil
				1.0		CH	Clay Mottled Brown - Orange Highly plastic				Sub soil
				1.0		CH	Clay with Sand Clay Grey Highly plastic Sand Fine 10-15% Poorly graded.				Clay with Sand
				2.0		Sc	Clayey Sands. Brown clay 10%. Sand Fine Poorly graded 4mm Ironstone band at 2.2m				Sandy clay
							Hole stopped at 2.4m
