**TASMANIA DEPARTMENT OF MINES
UNPUBLISHED REPORT 1987/78**

**Inspection of a proposed subdivision
at Freshwater Point, Legana**

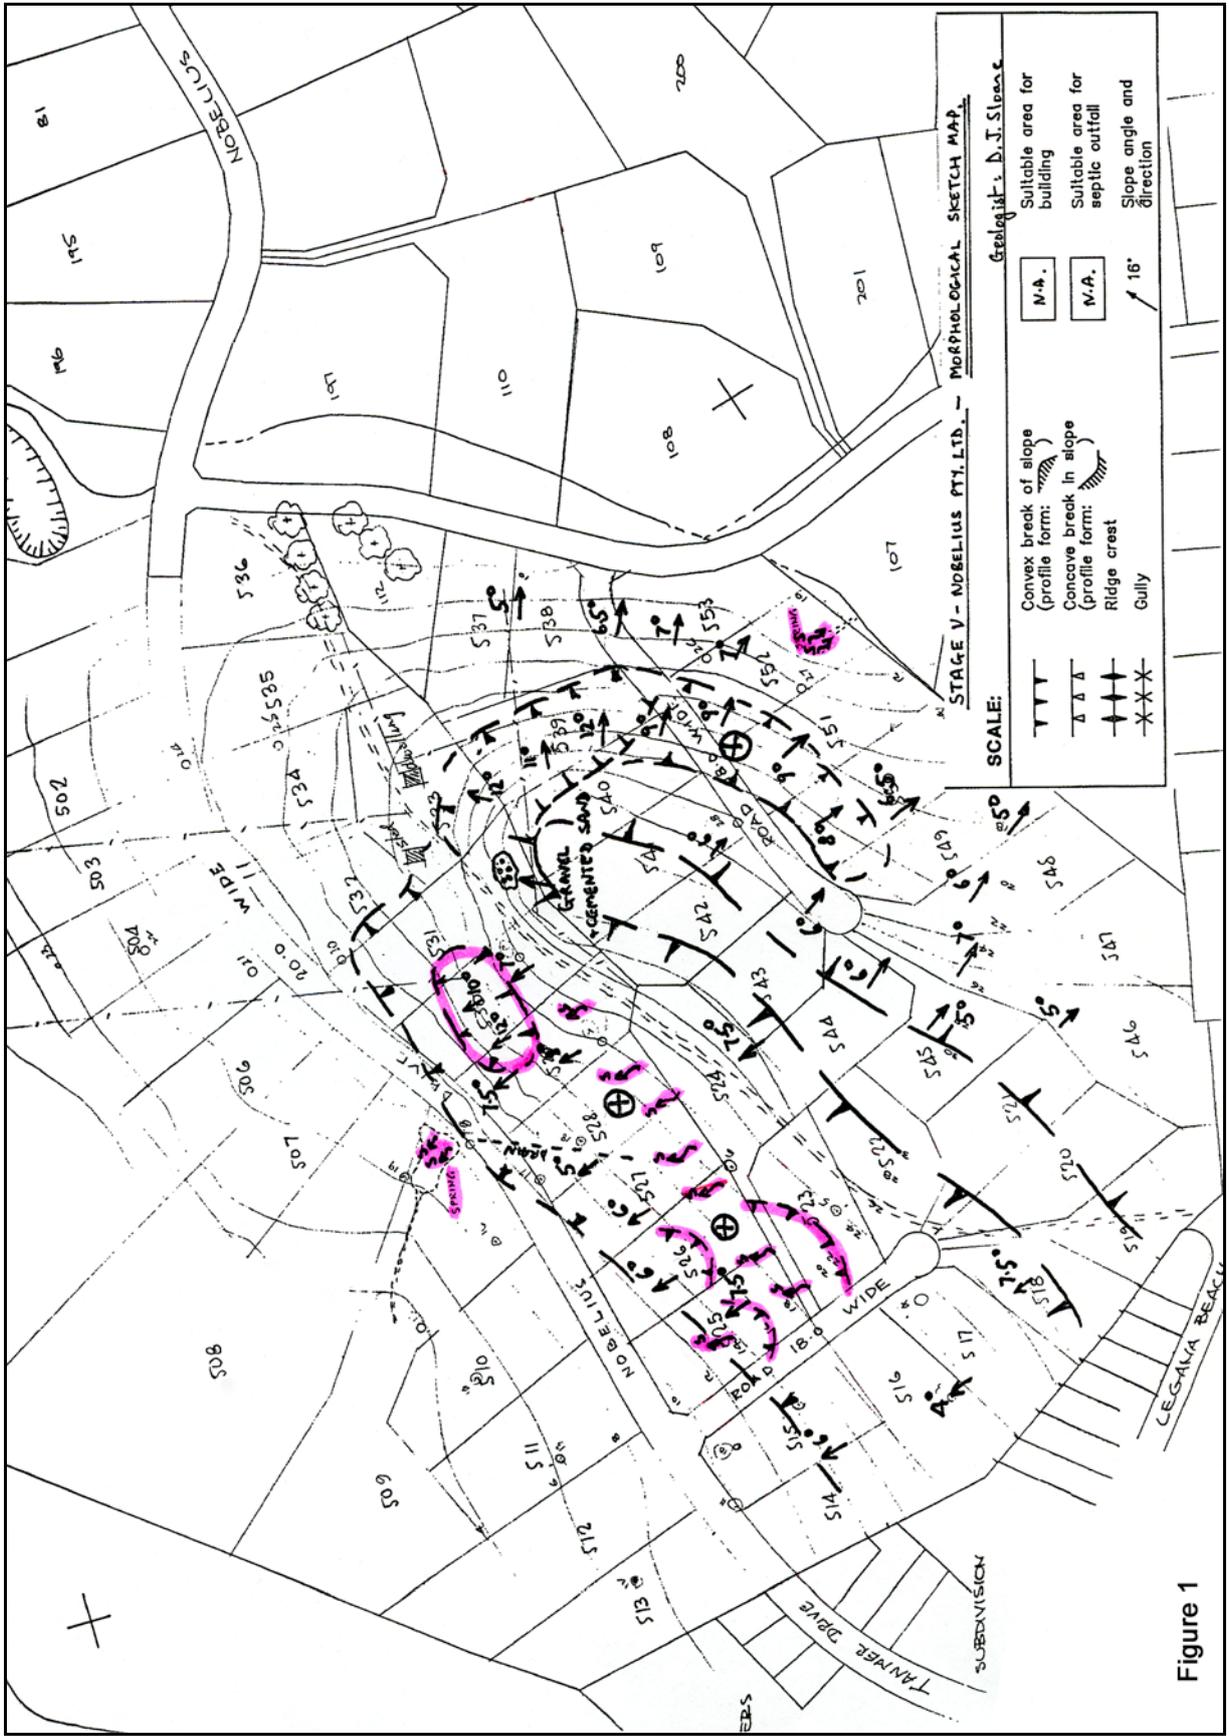
Figure 1

A proposed subdivision at Freshwater Point, Legana has been inspected. The slopes have been classed into three categories on the subdivision plan. Figure 2 shows those areas steeper than 8°. These areas are considered to be potential landslip areas if underlain by Tertiary clay. The ridge crest may be underlain by cemented sand and gravel which can be seen exposed in the small quarry adjacent to the existing dwelling. The steepest slopes occur around the eastern end of the ridge (fig. 1) where slopes of up to 12° have been measured. If these steeper areas are underlain by gravel they can be considered stable. It is therefore considered necessary to determine the stability of the upper, steeper, sections of lots 550, 551, 552, together with the lower part of lot 540 and all of lot 539. The remainder of the southeast facing ridge slopes are considered to be simple in profile with slopes of less than 8°, and are therefore considered stable. No evidence of seepage was observed at the time of inspection, apart from the small seepage area at the base of the slope; this is indicated on Figure 1.

It is recommended that further investigations are conducted in order to confirm the stability of those lots in question. If septic tank approvals are required then the possible area of seepage along the northwestern facing ridge slope should be investigated, especially considering the area may be an old shallow earthflow. It is suggested that further investigations consist of at least three backhoe test pits to depths of about two to three metres. Materials should be inspected and samples taken for analysis.
